Handbook of Materials Failure Analysis With Case Studies from the Aerospace and Automotive Industries Handbook of Materials Failure Analysis With Case Studies from the Aerospace and Automotive Industries

Abdel Salam Hamdy Makhlouf

Mahmood Aliofkhazraei

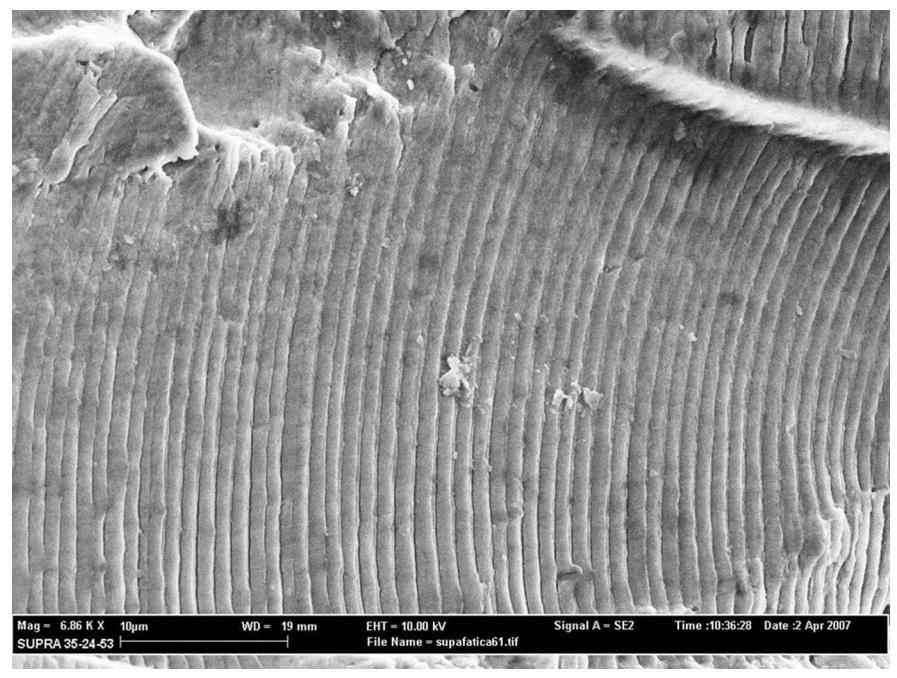
SEM micrograph of C zone at a location close to the initiation point.

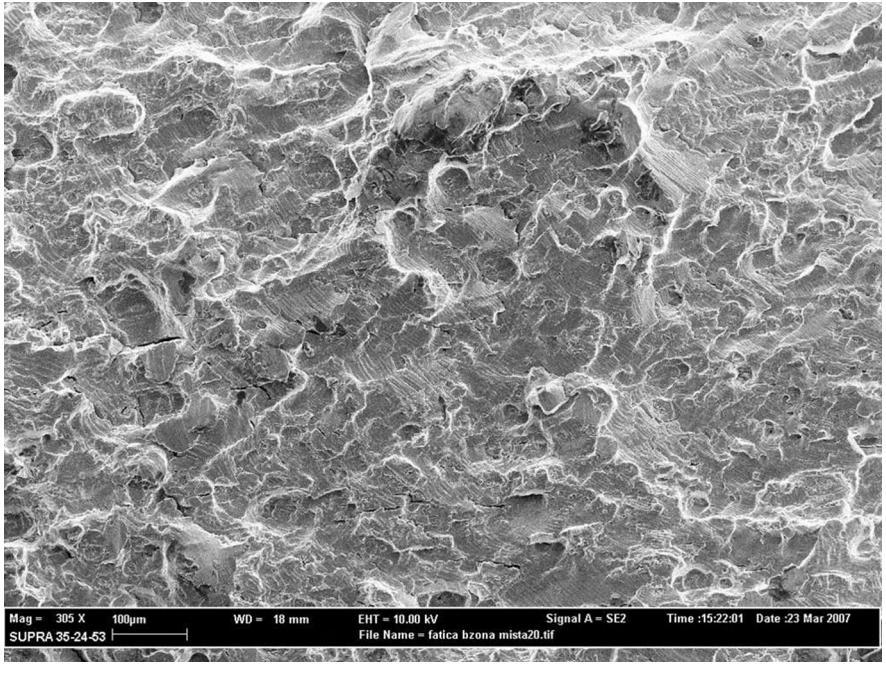
FIGURE 5.7

SEM micrograph of the fracture surface of the crack in the stable propagation. Zone C.

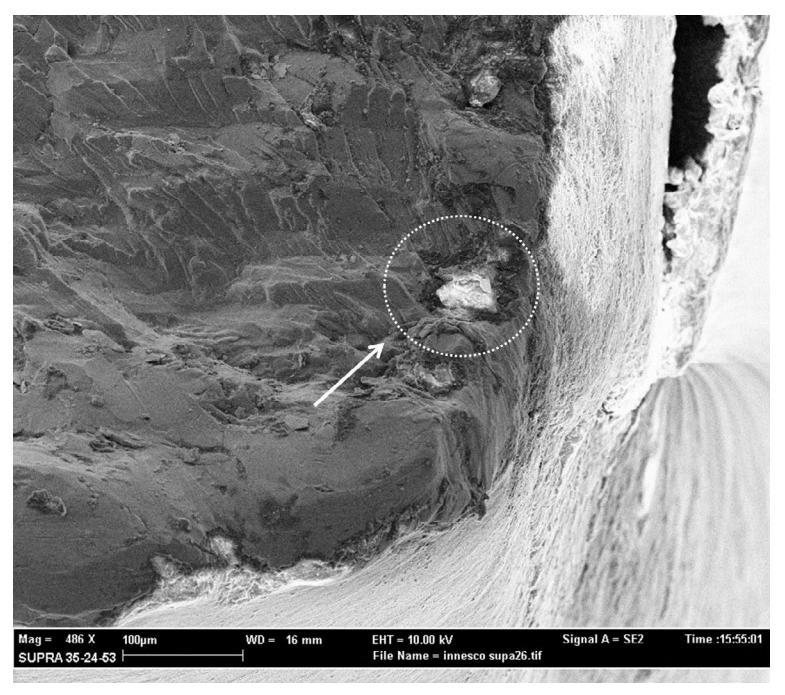
FIGURE 5.8

SEM micrograph of the fracture surface of the crack in the unstable propagation. Zone C.

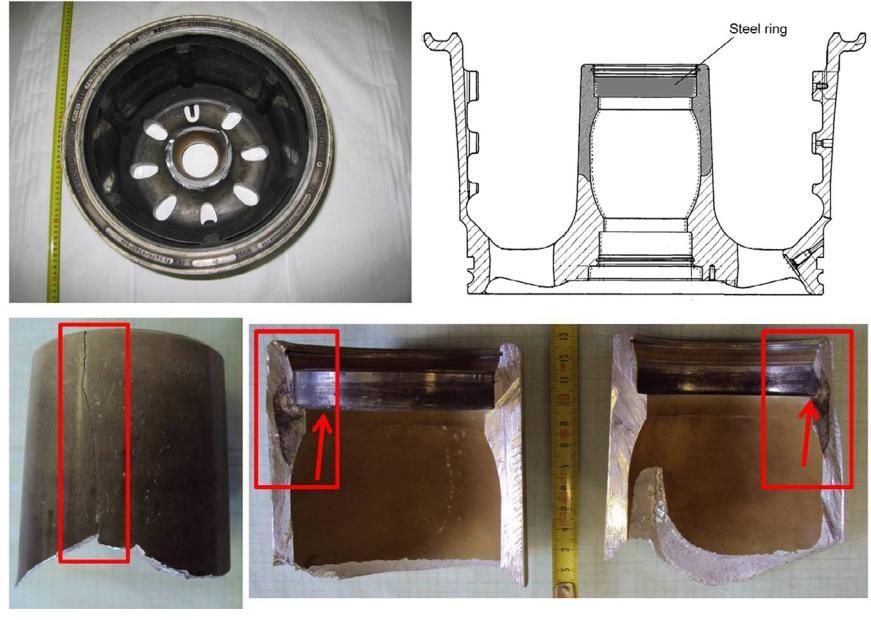
FIGURE 5.19 Fatigue crack in the AA2014 T6 AMX main wheel.

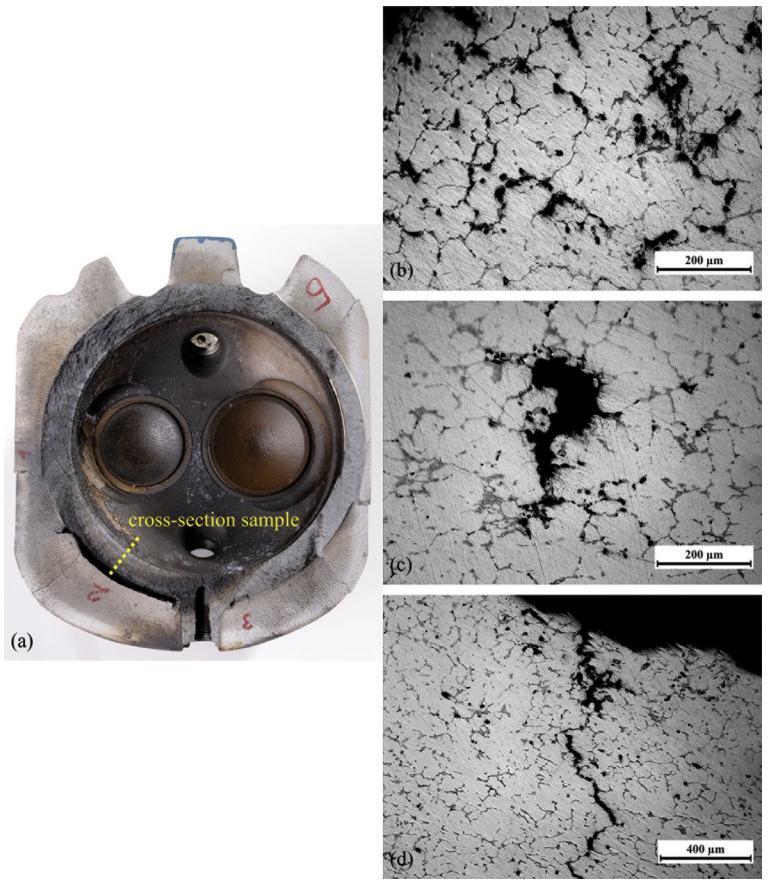
(a) Macrograph of fracture surface of CH I with location where metallographic sample was taken, (b) grouped shrinkage pores in CH I material, (c) typical shrinkage pore (black) surrounded by primary dendrites (white) and eutectic phase (gray needles in a white matrix), and (d) intergranular crack due to the linking of shrinkage pores.

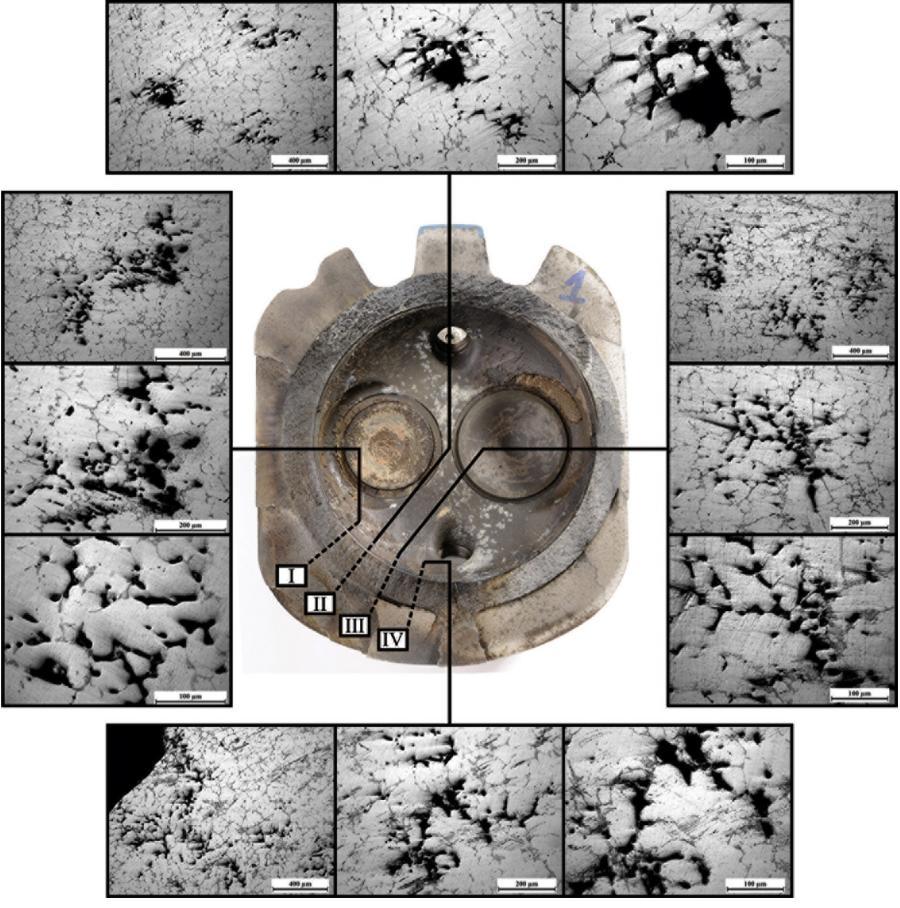
Macrograph of fracture surface of CH II showing locations where metallographic samples were taken with optical micrographs of samples I-IV.

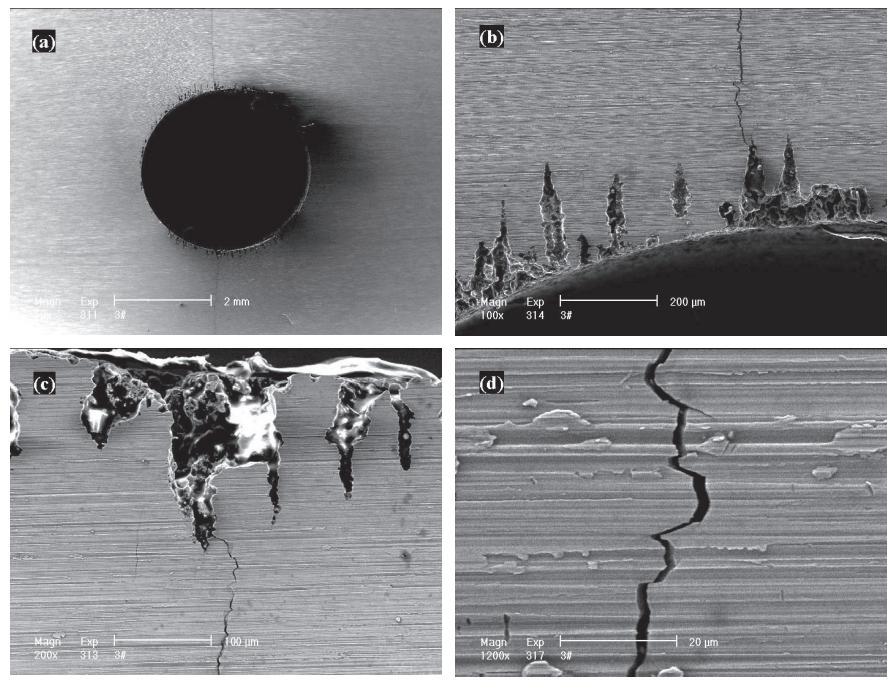
SEM observation on external surface in oil-hole region showing black spark-like openings and main cracks: (a) general view, (b) at upper edge, (c) at low edge, and (d) tortuous crack morphology.

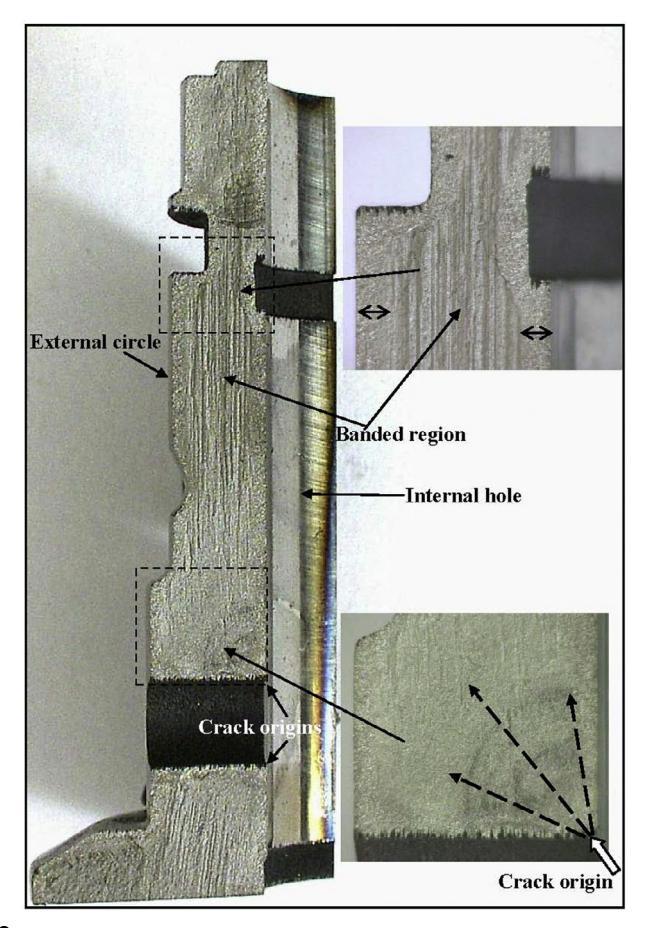
Macro-fracture surface of cracked plunger-sleeve.

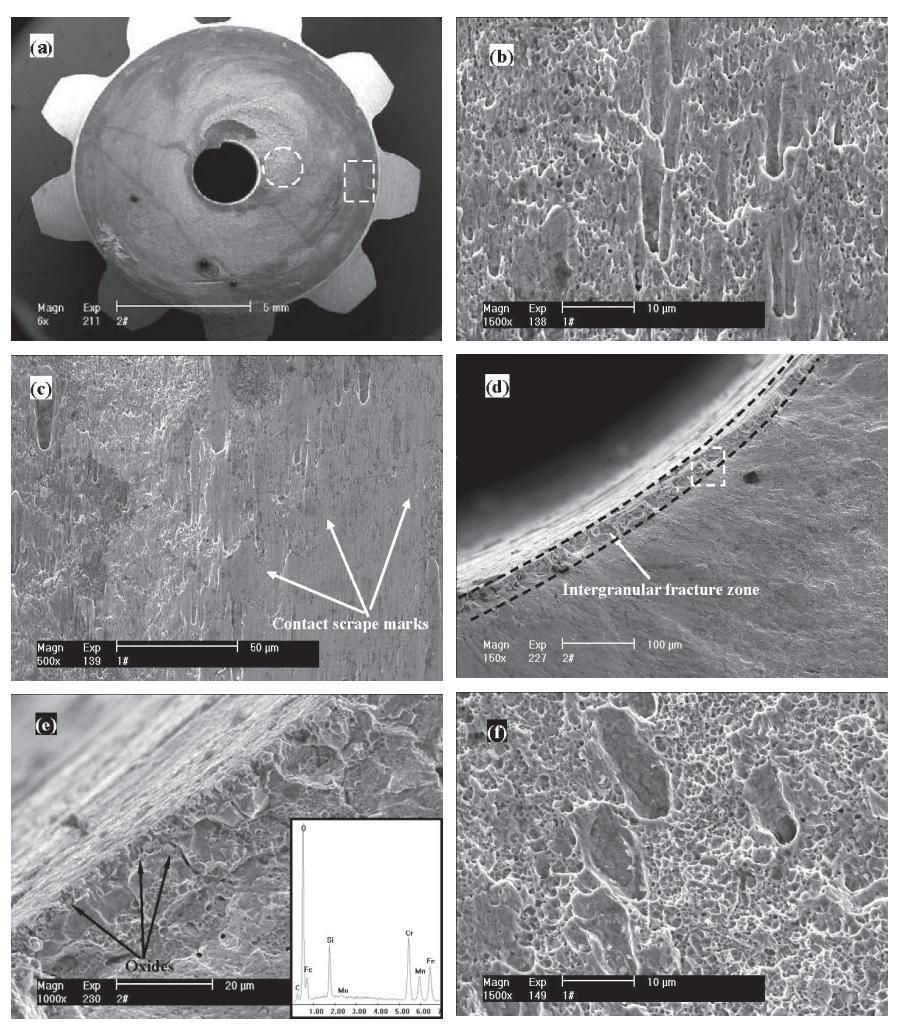
SEM observation on fracture surface and EDX spectrum of inclusions: (a) general view, (b) boxed zone in (a) showing parabola dimples, (c) showing scrape marks, (d) region close to internal hole, (e) boxed zone in (d) showing intergranular facets associated with dimples and precipitates and EDX spectrum, and (f) circled zone in (a) showing dimple morphology in the instantaneous region.

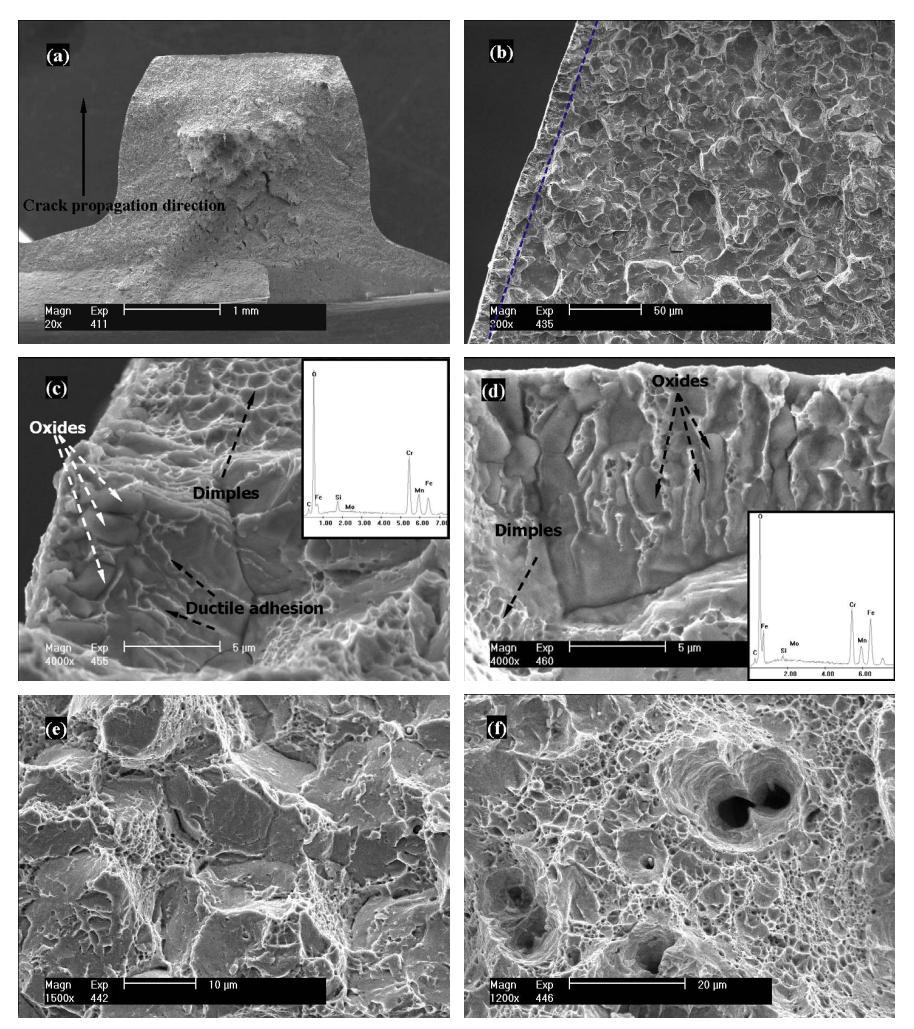
SEM observation on the fracture surface prepared artificially and EDX spectrum of inclusions: (a) general view, (b) showing the interface corresponding to internal oxidation layer, (c) showing intergranular facets associated with the oxides and dimples (at the flank) and EDX spectrum, (d) showing intergranular facets associated with the oxides and dimples (at tooth groove) and EDX spectrum, (e) showing intergranular fracture in subsurface corresponding to carburized layer, and (f) showing dimple morphology in the middle region.

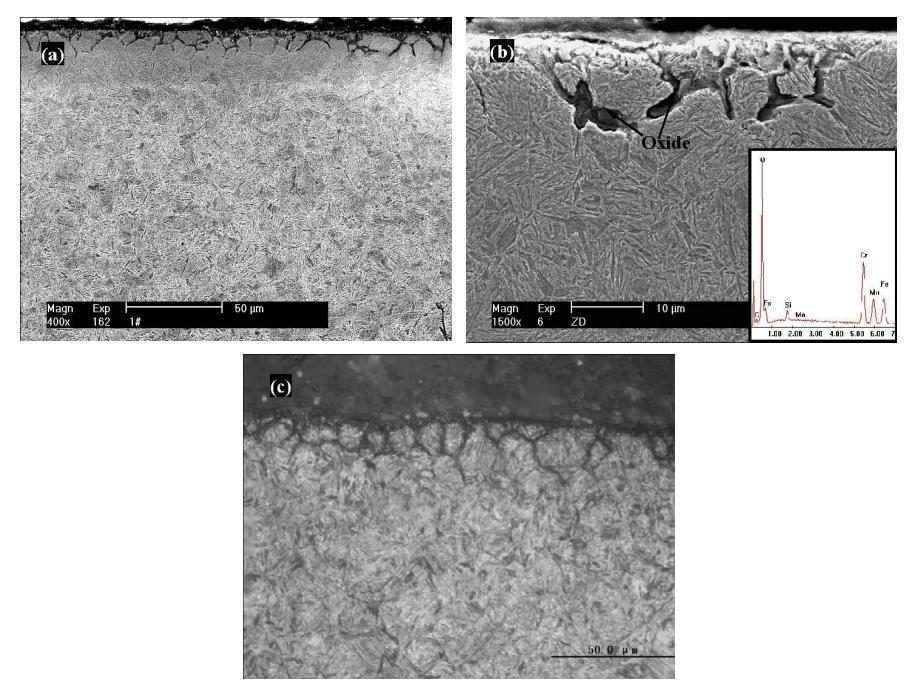
Microstructure of carburized layer and EDX spectrum of inclusions: (a) SEM observation showing internal oxidation morphology (tip region), (b) showing oxides in the grain boundaries and EDX spectrum, and (c) OPM observation showing nonmartnesite thin film alongside the grain boundaries in the internal oxidation zone.
