Handbook of Materials Failure Analysis With Case Studies from the Aerospace and Automotive Industries Handbook of Materials Failure Analysis With Case Studies from the Aerospace and Automotive Industries

Abdel Salam Hamdy Makhlouf

Mahmood Aliofkhazraei

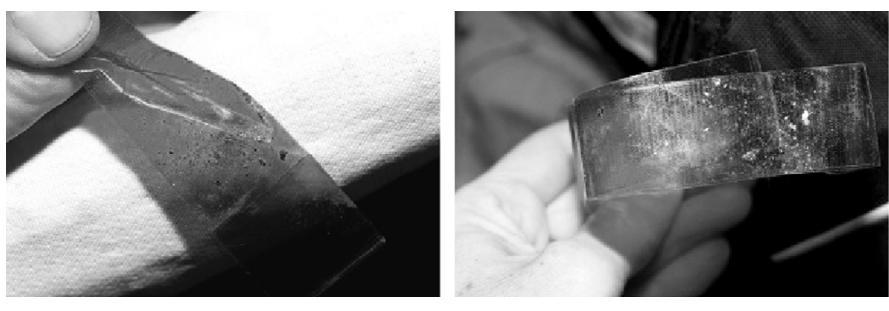
FIGURE 3.4

The priority for the fourth EVA abruptly changed when a tear occurred in a blanket during the deployment of a portside solar array, which was one of the Discovery crew's primary mission objectives. With the available time for the STS-120 mission quickly dwindling, the fourth EVA was dedicated to fixing the solar array issue; further inspection of the starboard SARJ was postponed to a later mission [12]. The initial root cause investigation for the SARJ anomaly would be solely dependent on the three pieces of polyimide tape with debris collected during Tani's EVA as shown in Figure 3.4.

On-orbit images of debris samples on polyimide tape that needed to be returned to Earth for failure analysis.

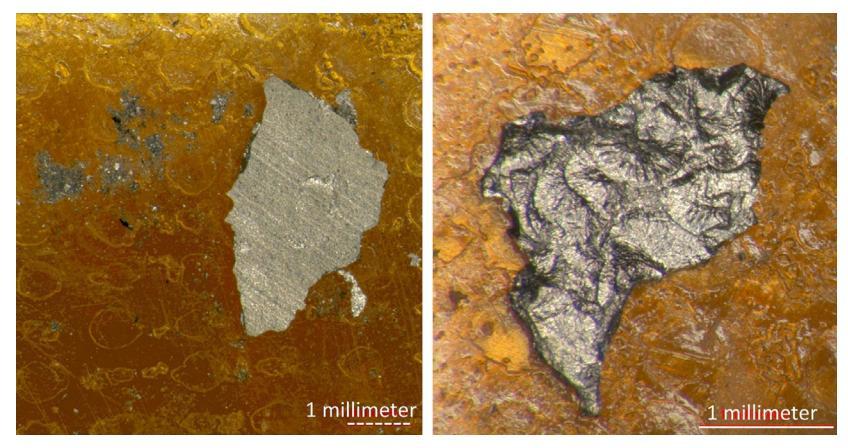
FIGURE 3.6

Stereomicroscopic inspection revealed that the shards included both original surface finish (left) and fracture features (right).

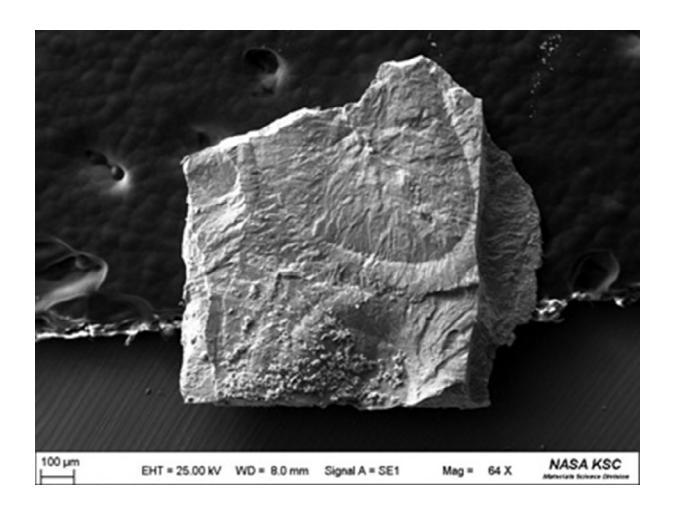
FIGURE 3.7

SEM observation of the debris revealed the clues that started to tell the story about what had happened to the SARJ race ring. The machine markings on some of the larger fragments were again confirmed via the SEM and when one of these fragments was flipped over, fracture features were revealed. The debris shards displayed classic evidence of Hertzian contact stress failure, with fracture paths parallel to the outer surface [14]. These fracture features were relatively brittle in nature, resembling a progressive failure with crack arrest marks clearly evident (Figure 3.7). Niobium-rich precipitates, verified via EDS and typical for this alloy, appeared at the subsurface initiation sites of the fractures.

SEM micrograph of a larger starboard SARJ chip showing subsurface crack initiation at Nb-rich precipitates and crack arrest marks.

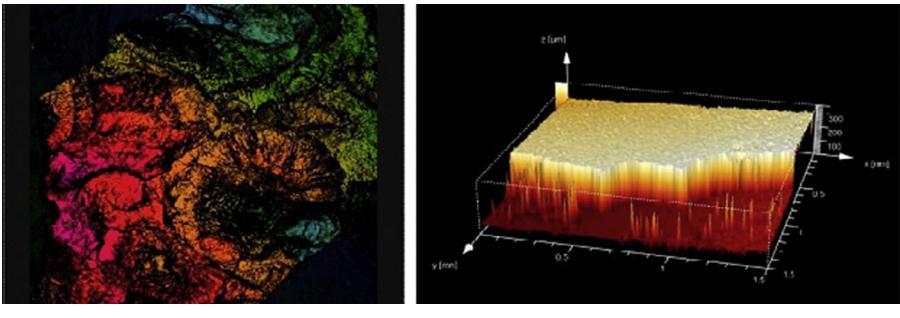
Laser confocal microscopy was utilized to nondestructively measure the thickness of the starboard SARJ debris.

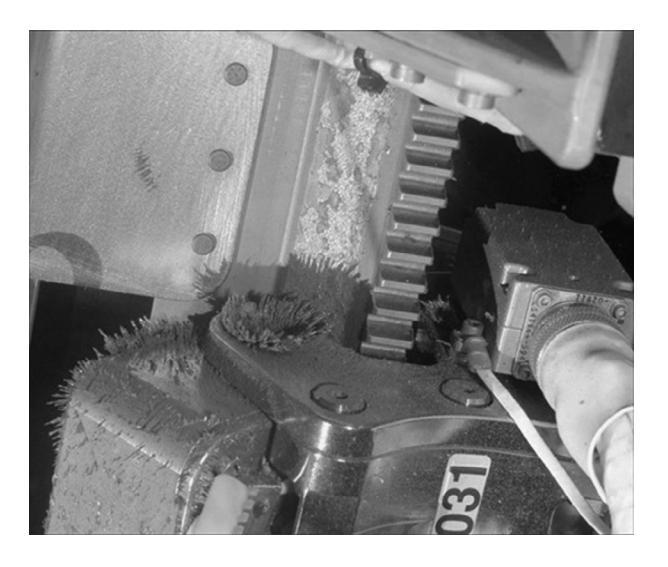
FIGURE 3.9

In December of 2007, approximately a month after the original failure analysis at the KSC laboratory, Expedition 16 astronauts Dan Tani and Peggy Whitson performed a nearly 7-h EVA which focused on inspecting the starboard SARJ race rings and bearings beneath 16 of the 22 drive lock assembly covers. Various amounts of the similar types of debris were observed, while one of the TBAs was removed for evaluation back on Earth. During EVAs 13 and 14, 29 tape samples, containing hundreds of fragments of debris, were collected. High-resolution photographs of the raceway surfaces revealed surface degradation with debris adhering to the TBAs (Figure 3.9).

On-orbit photograph of one of three raceway surfaces of the starboard SARJ during Expedition 16 EVA showing damage to the race and magnetized debris on the TBA.

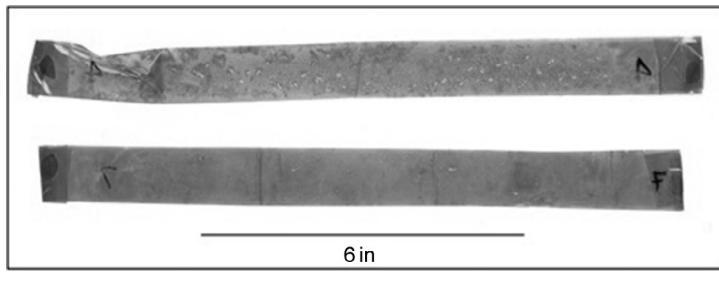
FIGURE 3.10

covered a significant amount of the tapes' surface areas. Based on thickness, composition, and microstructure, fracture was limited to the nitrided case of the primary race ring. Fragment thicknesses were comparable to those from the previous analysis and within the range of the hardened nitrided case specifications, which was required to be less than 170 μ m. EDS verified the presence of nitrogen throughout the fragments. Etching of cross-sectional samples revealed the nitrided case layer microstructure and transgranular secondary microcracking. The SARJ fragments did not display a martensitic core microstructure or case-core interface, indicating that the spalling was limited to the nitrided case. Figures 3.10–3.13 show representative samples from the investigation [17,18].

Photograph of two representative SARJ sample tapes from the Expedition 16 spacewalks showing dust-like fine debris covering the majority of the adhesive tape surface as well as some larger fragments that were evident when visually inspected.

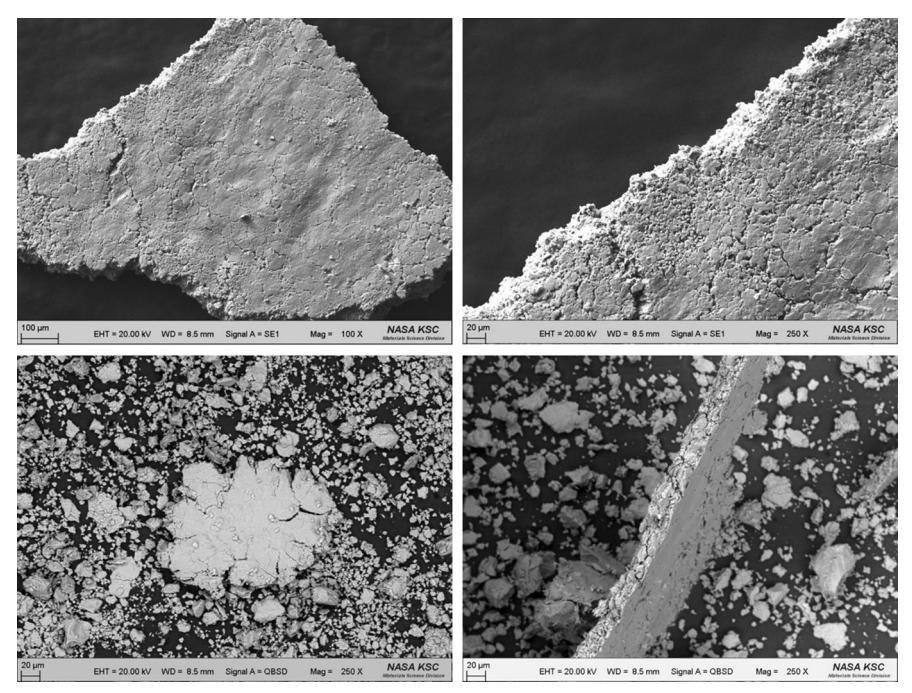
FIGURE 3.11

Representative SEM micrographs of agglomerated (top) and extruded (bottom) SARJ particles from Expedition 16 EVA.

to stay within the SARJ, causing the larger chips to be pulverized and then agglomerate. An additional conclusion by the investigation team was that the SARJ design had a kinematic susceptibility to tip due to roller mistracking, which, combined with the high frictional forces, led to high roller-edge stresses and resulted in the 15-5PH race surface spalling at the nitride case [20].

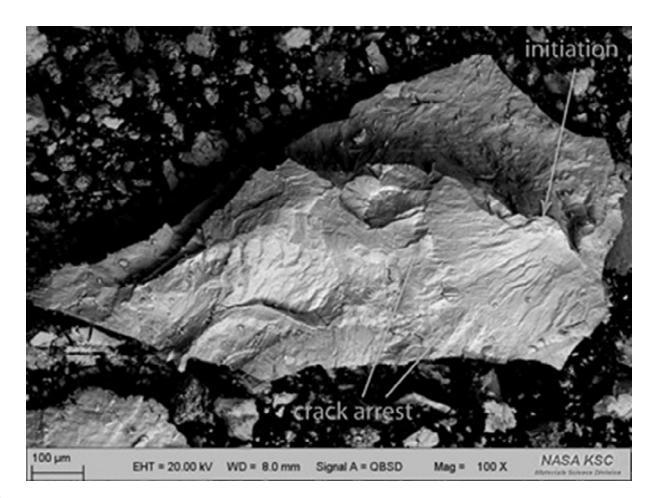
FIGURE 3.12

Fracture features of the Expedition 16 EVA samples were similar to those from the original STS 120 samples, with subsurface crack initiation and crack arrest marks.

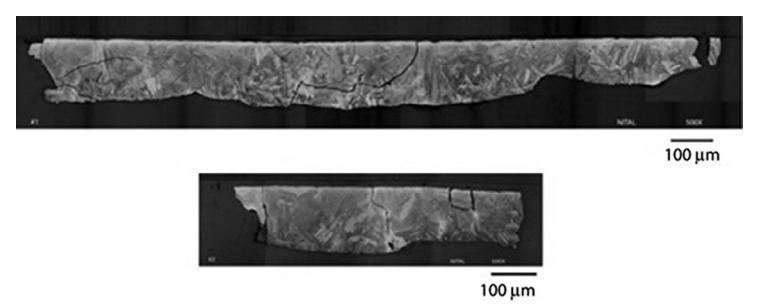
FIGURE 3.13

Etched starboard SARJ fragment showing transgranular crack propagation and fracture within the nitride case of the 15-5 PH race surface.

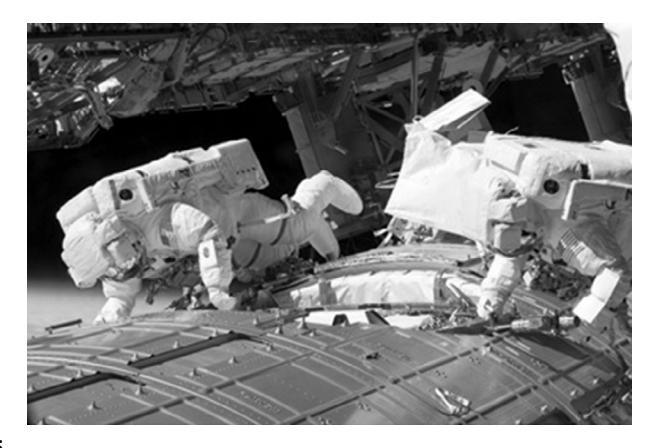
FIGURE 3.15

Astronauts Mike Fossum and Ron Garan testing a grease gun specifically designed to aid in cleaning of the starboard SARJ race ring debris.

The starboard SARJ was not allowed to function in normal mode until the debris was cleaned and the race surface was again considered to be fully functional. During STS-124 in June of 2008, spacewalkers Mike Fossum and Ron Garan demonstrated techniques to clean the debris, including using a specially designed grease gun to lubricate the outer race ring (Figure 3.15), and replaced one of the TBAs [21]. The port SARJ, which was functioning nominally, was inspected. Small amounts of debris were collected and returned to Earth for analysis.

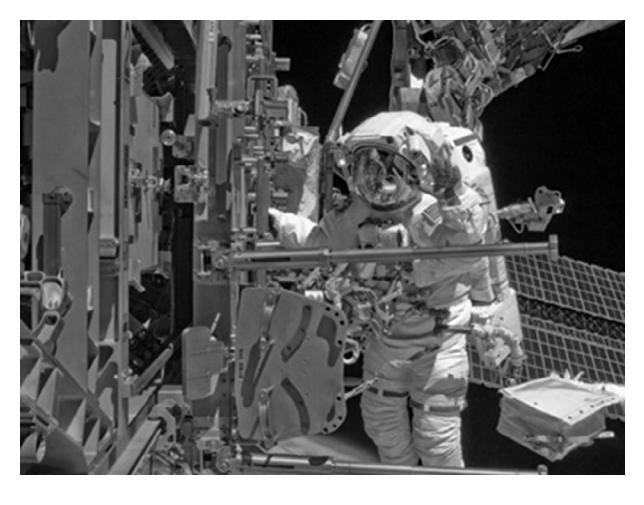
FIGURE 3.16

Astronaut Shane Kimbrough removing debris and applying lubrication around the starboard SARJ during the STS-126 mission's second spacewalk.

After the investigation team concluded that high frictional forces due to a lack of lubrication were causing the spalling, NASA decided to use Braycote grease during the STS-126 mission (Figure 3.16) in November of 2008 to provide a lower coefficient of friction. Braycote grease is vacuum-stable grease that was designed for the extreme environment of space. On the starboard SARJ, the debris was cleaned using terry cloth EVA wipes and a scraper tool for the flattened pieces, followed by a greased wipe on all surfaces. The grease gun that was tested during STS-124 was used to apply the Braycote to both the starboard and the port SARJ race ring surfaces. The SARJs were then rotated to allow the rollers in the TBAs to spread the lubricant. The TBAs on the starboard SARJ that had suspect gold plating and were covered with debris were replaced during an EVA in the course of STS-126 [22]. Although the starboard SARJ has a redundant inboard race ring, it was decided at the time not to use the redundancy so as to maintain an available back-up. At the time it was expected that a long-term fix, including a race re-design, was going to be required.

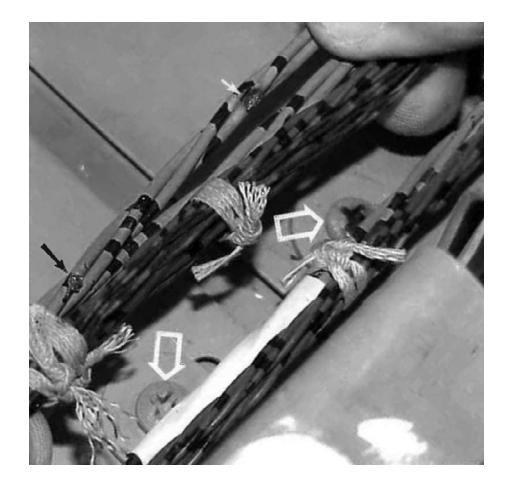
FIGURE 4.2

Following a successful mission, the Columbia returned to Earth on July 28, 1999; post-flight inspection revealed that a main engine controller wire had arced against the head of an adjacent screw (Figure 4.2). Likewise, a second area of exposed conductor was observed on the same wire approximately 2 in. away from the arced region. The second area of damage was also located above a nearby screw.

Arced wire (solid white arrow) and nearby damaged area (solid black arrow) with associated screws (open white arrows) in the midbody aft port-side lower wire tray 11/12 frame.

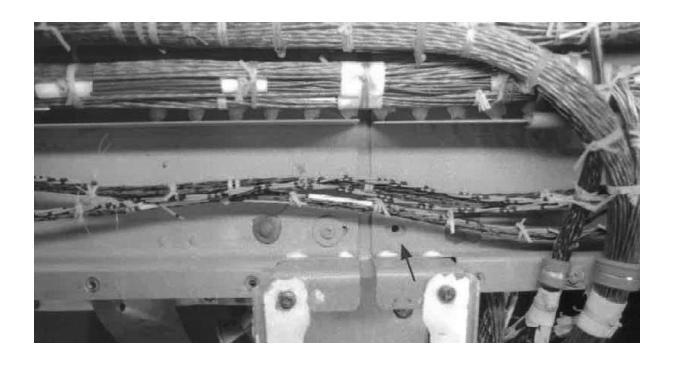
FIGURE 4.3

A failure analysis was initiated to determine the cause of the main engine controller's short circuit. The shorted main engine controller wire and nearby damaged wire were located in the midbody aft port-side lower wire tray 11/12 frame (Figure 4.3). Both the arced screw and the screw beneath the second damaged area had exposed base metal where the screw head slots had been deformed. It should be noted that the wires 180° from the damaged areas appeared undamaged.

Shorted wire bundle with arced screw removed (arrow) in the midbody aft port-side lower wire tray 11/12 frame.

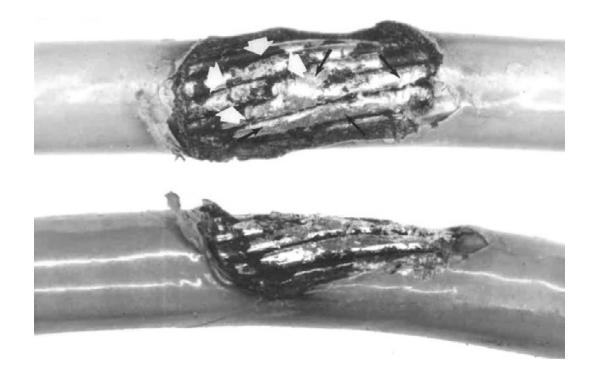
FIGURE 4.4

Visual and low-magnification examinations of the various wires were performed. The arced conductor wire (Figure 4.4) displayed several areas of mechanical damage adjacent to areas that appeared melted, corresponding to the region of arc tracking. Dark deposits of apparently burned material were evident over much of the exposed areas. Deposits were also evident covering some of the nearby mechanically damaged area. The topcoat adjacent to the shorted area appeared deformed. Similar examination of the screw head that the wire arced against revealed a definite region of arc-tracking damage (Figure 4.5). Raised areas of bare base metal were also evident on the sides of the slots in the screw head; these raised areas were devoid of paint.

Rotational view of shorted wire displaying arced region (white arrows) and mechanically deformed region (black arrows).

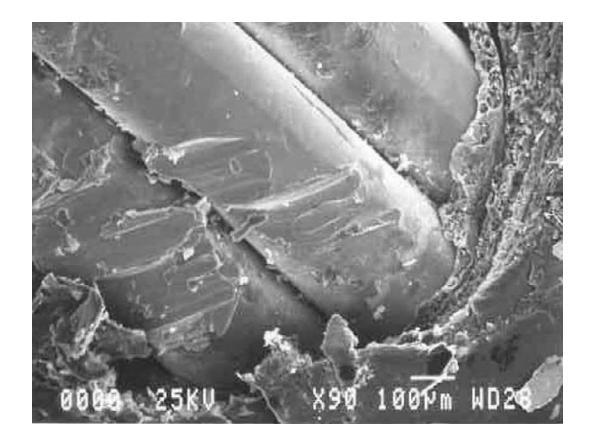
FIGURE 4.7

SEM micrograph of the damaged region of the shorted wire. Mechanical damage is evident on the conductors (denoted "MECH"). The melted region is between the "MELT" and "MVC" zones. Magnification: $27 \times$.

Next, the wires were analyzed via scanning electron microscope (SEM), energydispersive X-ray spectroscopy (EDS), and electron spectroscopy for chemical analysis (ESCA). SEM analysis of the shorted wire verified that the polyimide insulation was missing in the arced area, with the wire's conductors clearly evident (Figure 4.7). It should be noted that the damaged insulation was even and smooth, as opposed to serrated. Three distinct topographical features were evident on the shorted wire: a mechanically damaged zone, a melted zone, and a zone displaying microvoid coalescence (MVC). The mechanically damaged zone appeared gouged (Figure 4.8). The damage was directional, roughly tangential to the length of the wire. The central portion of the exposed area contained a mixture of mechanical damage and melted metal (Figure 4.9). The melting was confined to the outer layer of wire strands and did not appear to penetrate to the inner strands. The final region of the exposed area displayed MVC (Figure 4.10), typical of ductile overload. The overload area corresponds to the region where the wire actually melted and fused with the screw head

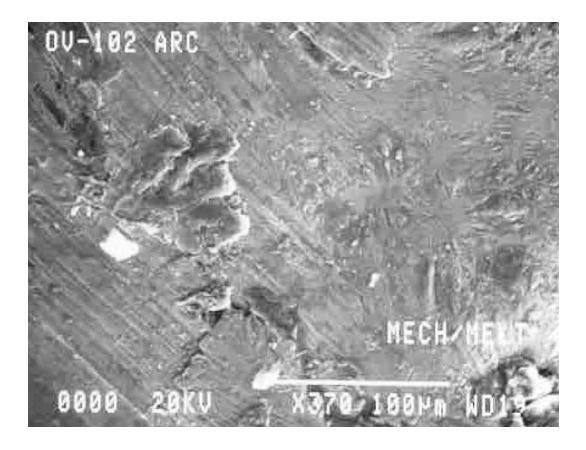
SEM micrograph of shorted wire displaying mechanical damage to the conductors. Magnification: $90 \times$.

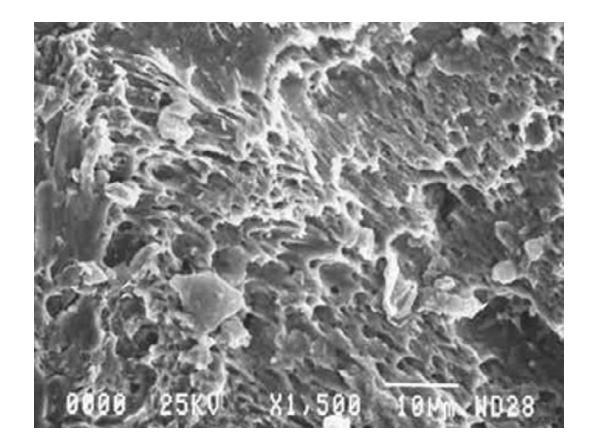
FIGURE 4.9

SEM micrograph of shorted wire illustrating mechanical damage and thermal damage. Magnification: 370 $\times.$

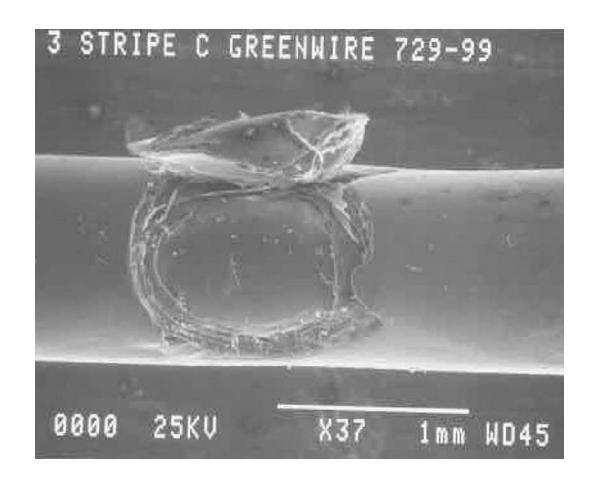
Macrograph of typical damage observed on additional wires.

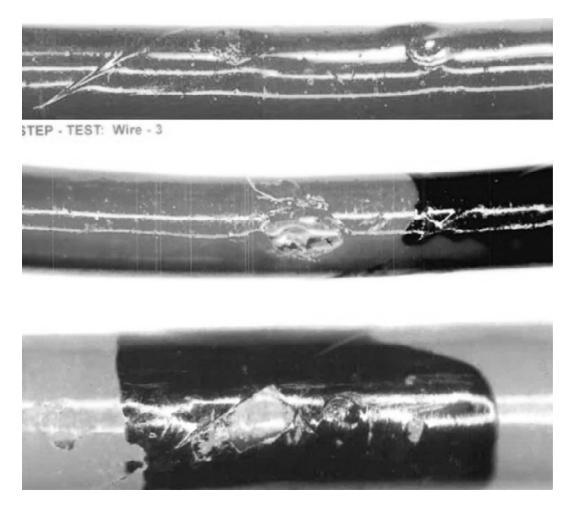
FIGURE 4.15

Typical step-test damage.

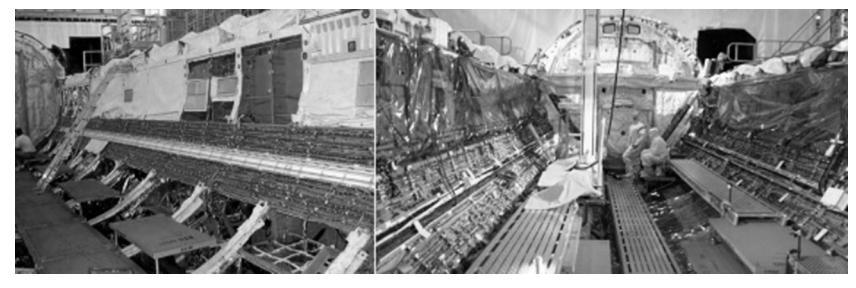
Orbiter midbody before inspection and during wiring inspection. Tags indicate areas of potential damage to the wiring.

unprecedented inspection of wiring throughout the orbiter fleet was undertaken. Accessible areas as well as critical hard-to-access locations were examined using inspection mirrors, flashlights, and $10 \times$ magnification. Manipulation of the wiring was kept to a minimum to lessen the likelihood of introducing any further damage. Between the four orbiters, the Atlantis, the Columbia, the Discovery, and the Endeavour, approximately 3000 suspect indications were identified (Figure 4.17) [5]. Of the 3000 discrepancies, nearly 500 involved exposed conductor. Of the exposed conductors, approximately 150 had mechanical damage, although no additional instances of arc tracking were reported.

Following the inspection of the orbiter fleet's wiring, several lessons were learned. It was recommended that similar screws adjacent to wire bundles be examined to make sure no metal was raised on the screw heads, and also that no screws have bare metal exposed. If any were found, the screws were to be replaced or the raised areas smoothed and the screws repainted. The use of convoluted tubing was recommended as beneficial, both as a physical protection for the bundles, as well as an insulator for any conductors which might become exposed.

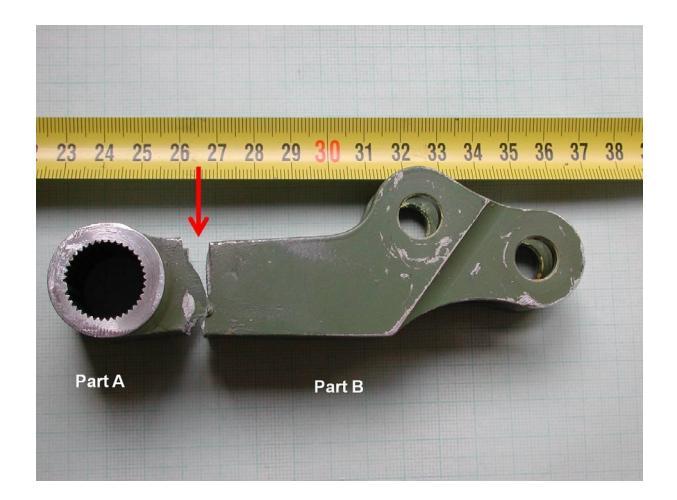
FIGURE 5.2

Figure 5.2 shows the broken component in the as-received condition. The failure occurred close to the fixing hole with the torsion bar. In particular, there is evidence of deep plastic deformations caused either by wear or impact along all the edges of the fixing hole of the torsion bar (see detail of the part A in Figure 5.3) and due to crushing at the lateral surface one (see detail of the part B in Figure 5.3). The crush is located approximately 1 cm far from the fracture surface. The morphology of the fracture surfaces of parts A and B featured three distinct zones. Two of these zones are flat, smooth, and bright surfaces containing beach marks (see zones C and D in Figure 5.4), thus indicating a fatigue crack growth; the third one is rough, dull with coarse grains oriented at about 45° one (see zone E in Figure 5.4), that is the region of the final, unstable fracture. In Figure 5.5, a comparison between the actuator installed on that balancing system and the one traditionally used can be observed. In particular, the lugs of the actuator examined are approximately 1 cm longer (see detail in Figure 5.5).

Macrograph of the two broken pieces of the lever reverse. Zone of failure is denoted by arrow.

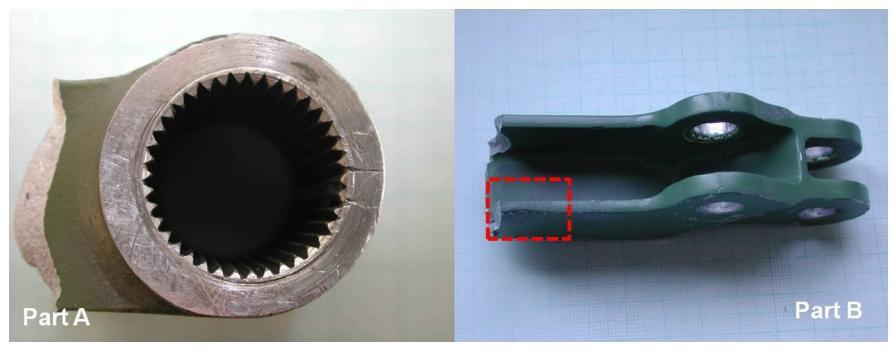
FIGURE 5.3

Macrograph showing plastic deformations of the part A and part B.

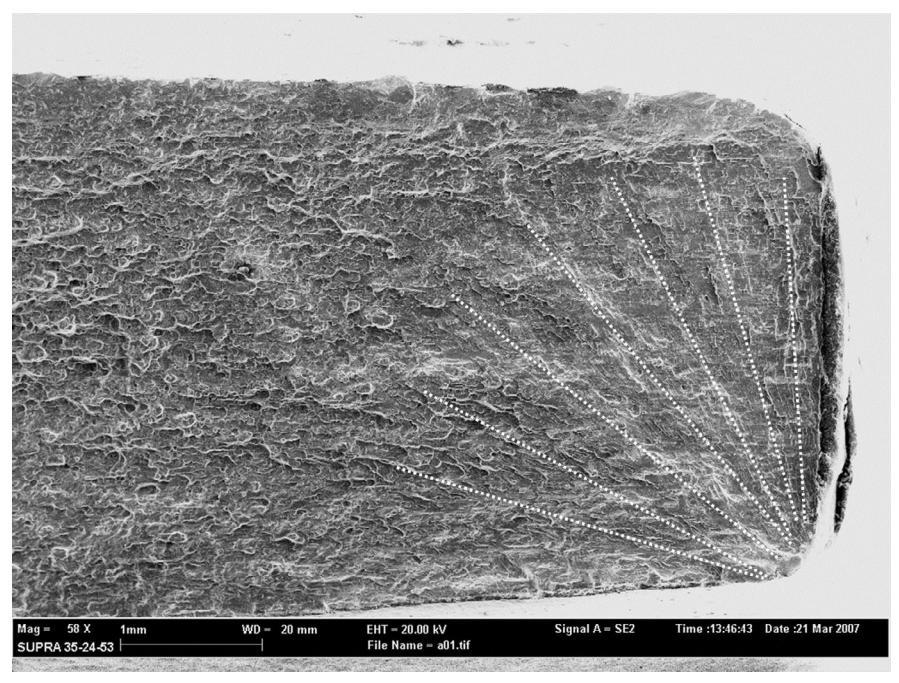
FIGURE 5.6

SEM micrograph of C zone at a location close to the initiation point.

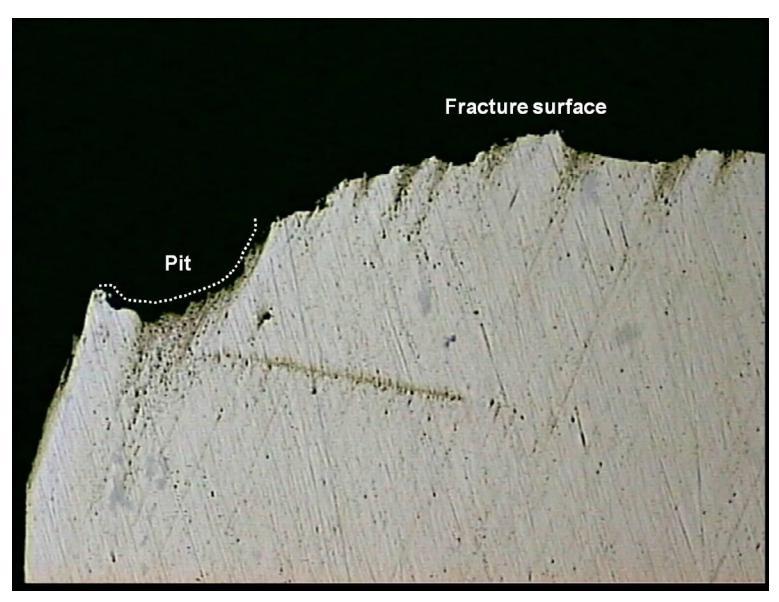
Optical micrograph showing corrosion pit at a location close to the internal edge. Zone C. $200\,\times.$

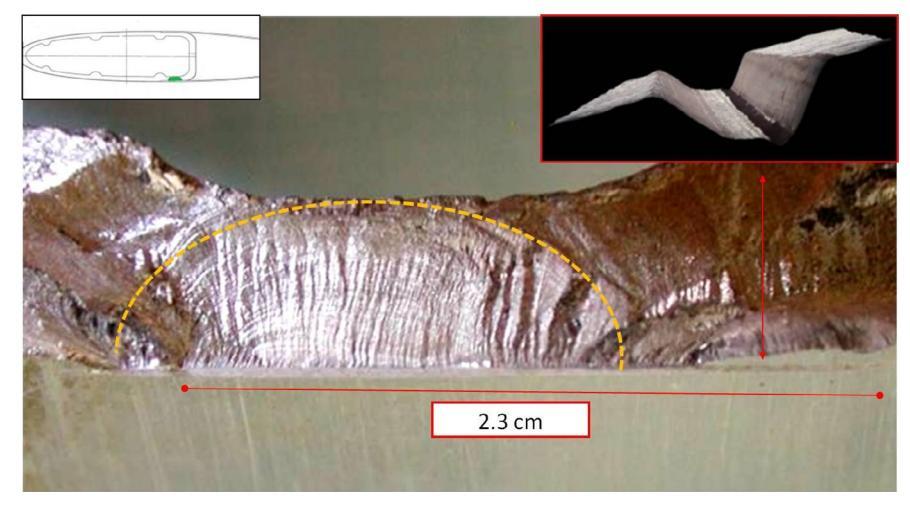
FIGURE 5.14 Blade fracture surface.

The blade fracture occurred between pockets 16 and 17 at the lower corner of the spar section (Figure 5.14, section view, green area). Fractography conducted by means of optical and electronic microscopes showed a progressive fatigue phenomenon.

Zone A was characterized by an incision located on the outer surface and perpendicular to the blade's longitudinal axis (Figure 5.14, top left, detail of spar section view). The incision was v-shaped (Figure 5.14, 3D reconstruction); it was 2.3 cm in length and 190 μ m in depth. Multiple initiation points were found at the incision vertex. From these, beach marks typical of fatigue crack growth departed creating a semi-elliptical front (dashed line in Figure 5.14). The grain morphology was smooth, fine, and bright. After the fatigue achieved the "through-the-thickness" condition, it propagated toward the leading edge and along the backwall (Figure 5.15, top right, detail of spar section view) with flat, coarse grains and beach marks (Figure 5.15).

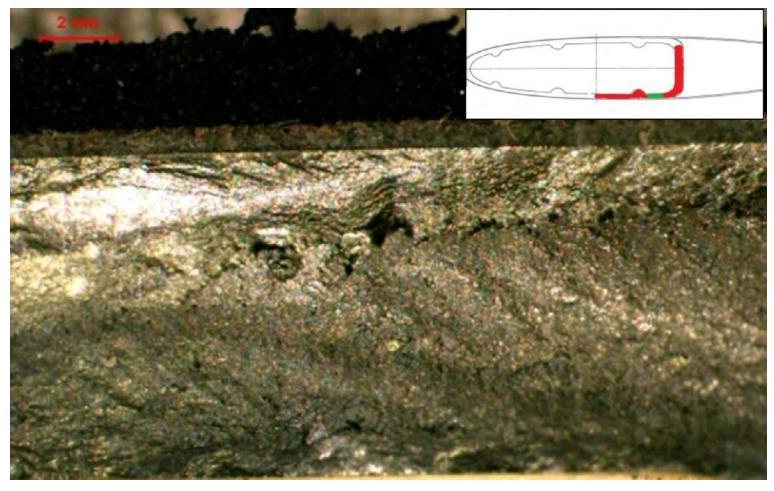
FIGURE 5.15

Fatigue propagation toward the leading edge and along the backwall blade.

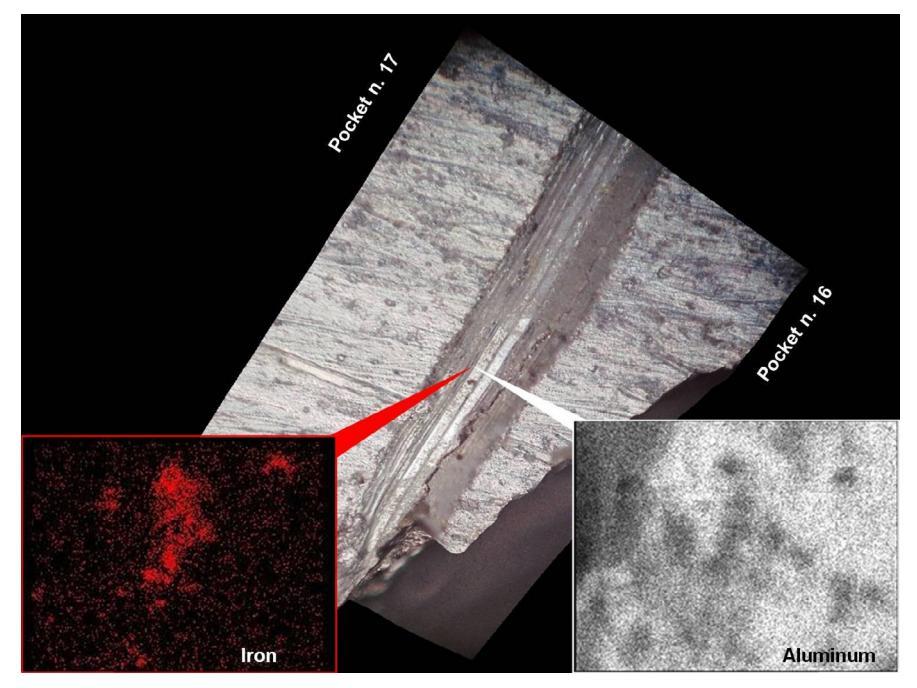
FIGURE 5.16

The composition homogeneity was verified at the initiation area by an X-EDS microprobe attached to the FESEM. An abnormal presence of iron was found in the incision (Figure 5.16).

Abnormal presence of iron found inside the incision.

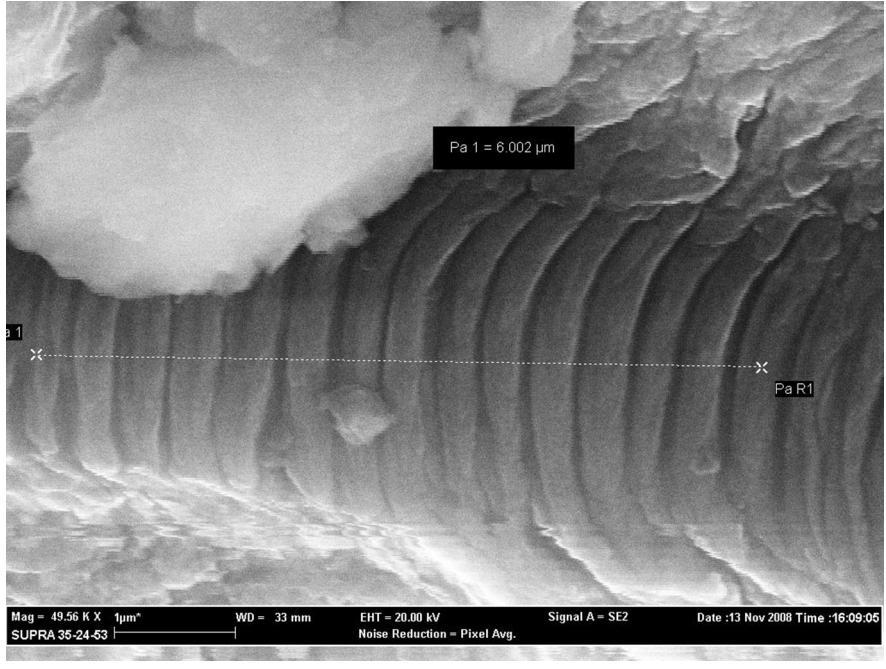
FIGURE 5.17

Samples were collected every 1000 μ m at different magnification, varying from 1000 × to 160,000 ×. Careful examination of the fatigue crack surface showed that striation spacing was found to vary as the crack grew. The striation spacing near the starting point (crack length less than 12 mm) was consistently uniform (Figure 5.17), indicating that only one magnitude of stress was causing crack growth. However, it was not possible to collect any data due to the high magnification required at initial stage area (crack length lesser than 4 mm): 160,000 × was not enough to adequately resolve the image. The striation spacing near the overload was very different and the striations were grouped. In particular, one large striation followed by smaller ones (Figure 5.18), indicates that several stress cycles of different magnitudes were causing crack growth. In such instances, only the larger striations were taken into account.

Striation spacing near the starting point at crack length less than 12 mm.

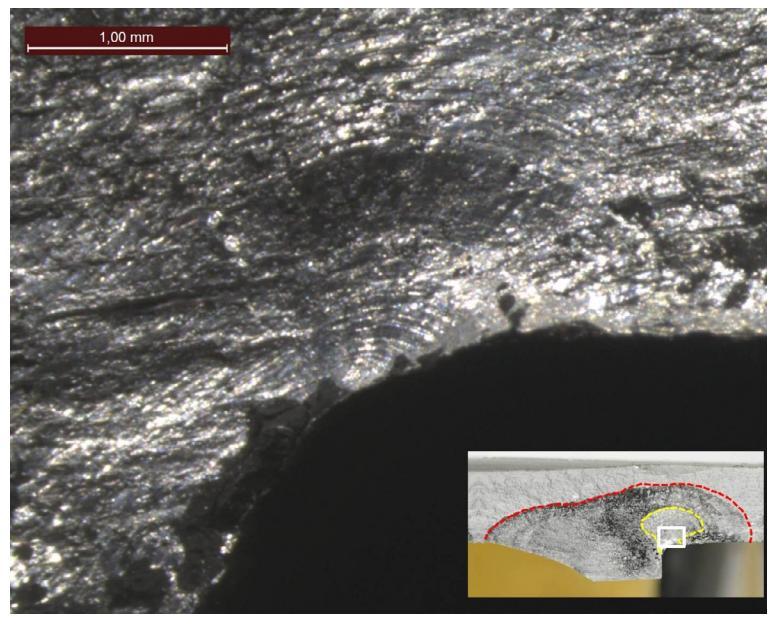
Area 1.

Area 1: Flat, smooth, and bright with beach marks typical of fatigue crack growth (Figure 5.21). These beach marks were concentric to the initiation point and located on the inner corner of the bearing cup housing. This area was roughly circular with 6.5 mm radius. Beach mark spacing was almost constant, about 40 μ m.

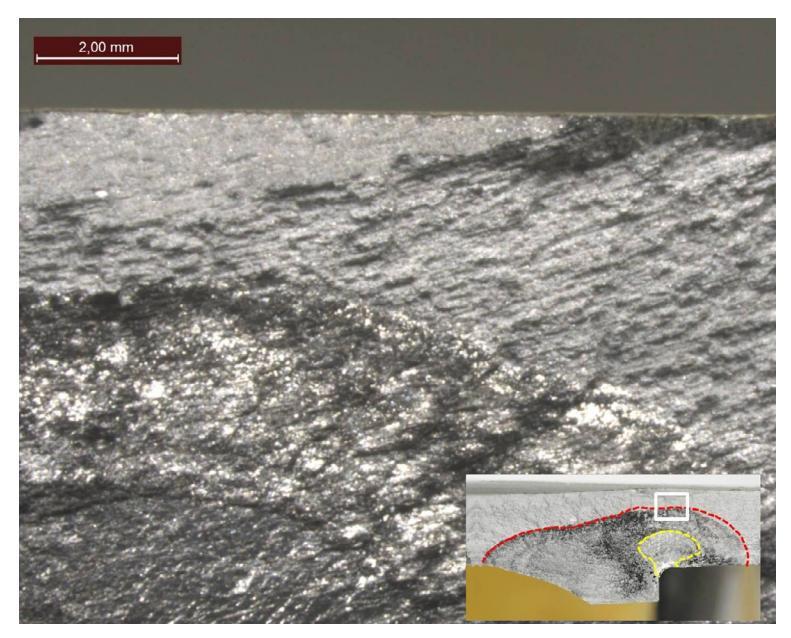
FIGURE 5.22 Areas 2 and 3. Boundary line in red.

Area 2: Flat, coarse grains, containing beach marks (Figure 5.22). Fatigue propagated in this area approximately 10 mm toward the bearing cup and approximately 25 mm in the opposite direction.

Area 3: Rough, dull with coarse grains without beach marks and without black residue. These features are consistent with zone 3 being the area in which the final

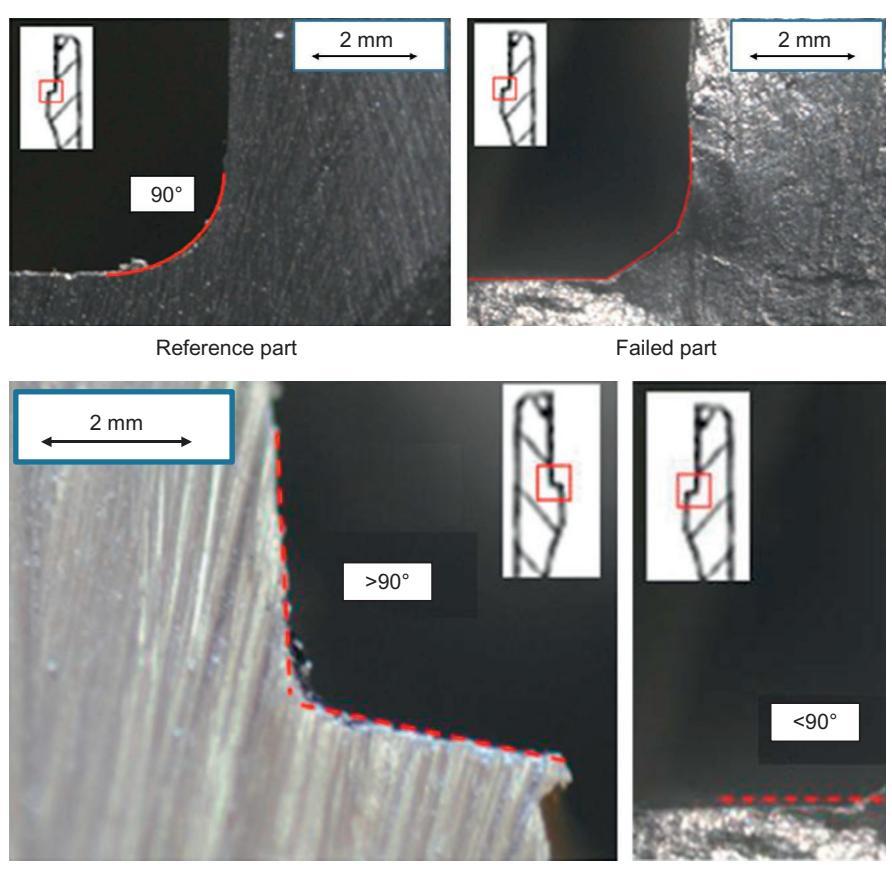
FIGURE 5.23

phase of the failure occurred. The morphology of the bearing cup housing inner corner was compared with a reference part without defects to gather evidence of the cause of fatigue crack initiation. The comparative observation indicated that the initiation point presented deformations (see sharp transition in Figure 5.23, top). As those defects seemed to indicate faulty installation of the bearing cup, further analyses proceeded to ascertain whether similar features could be found on the diametrically opposed section. Deformations were present and the corner angle was greater than 90° (Figure 5.23, bottom).

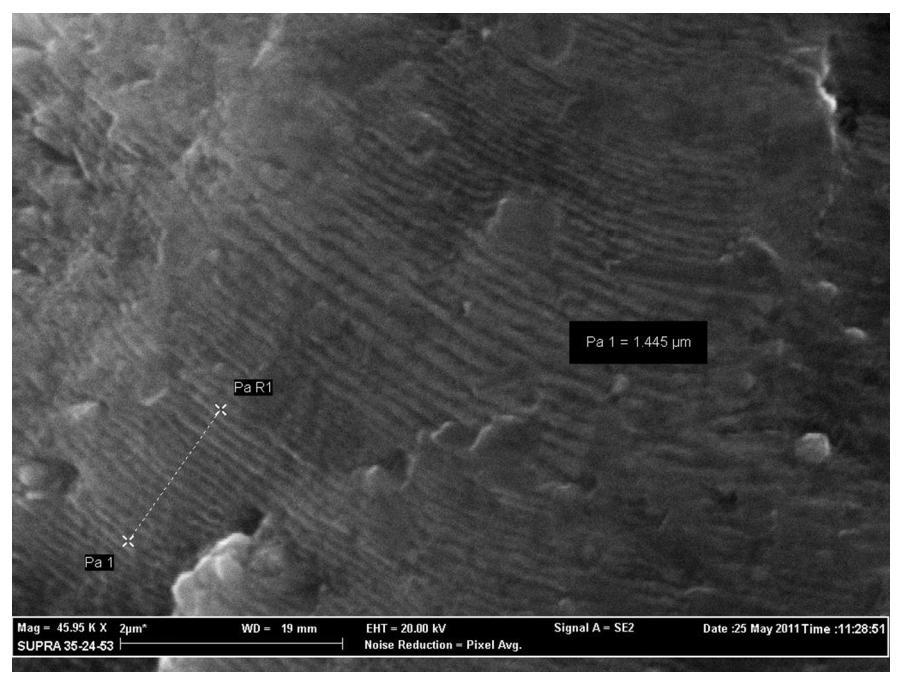
FIGURE 5.24

Fatigue striations in Area 1.

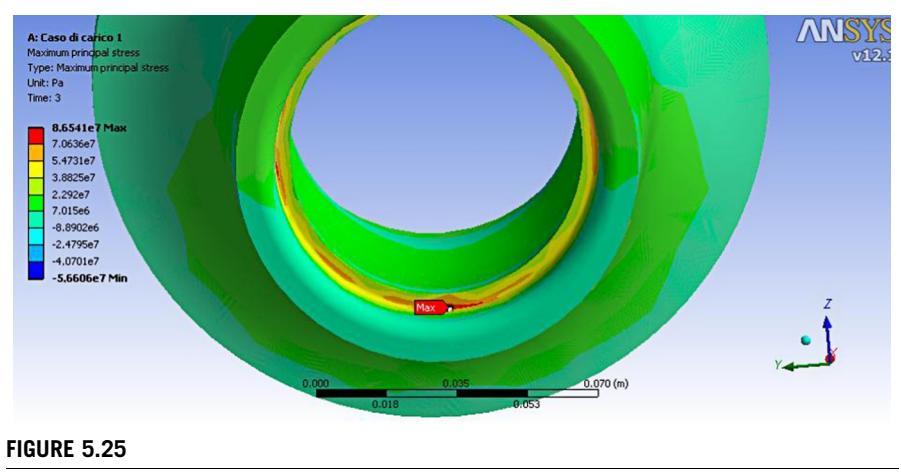
Stress at the fatigue initiation point.

airplane weight on the wheels due to the in-service operations would have led to about 300 MPa at the initiation site (Figure 5.25). This stress level would be higher than the AA2014-T6 fatigue limit, 125 MPa. Therefore, FEA demonstrated how the misalignment of the bearing cup led to the fatigue initiation.

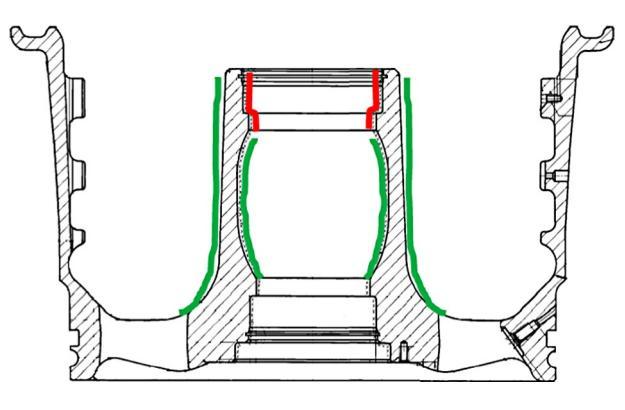
The main wheels are monitored for structural integrity by eddy current inspections performed only on the external surface (dashed line in Figure 5.26) but they cannot be performed under the bearing zone (line in Figure 5.26). However, no fault was

Eddy currents inspections: accessible area (dashed green line) and not accessible area (dashed red line).

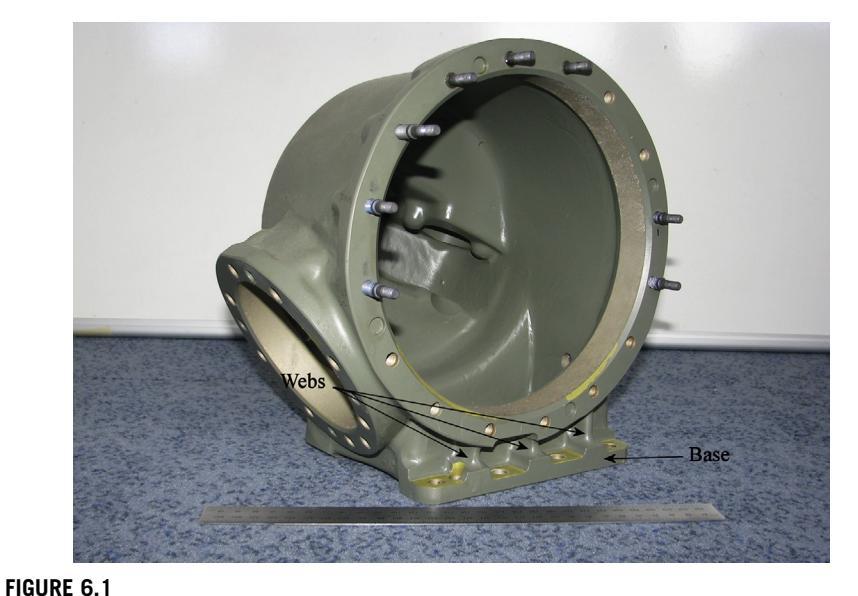
Image showing the port and forward faces of a TRGB center housing.

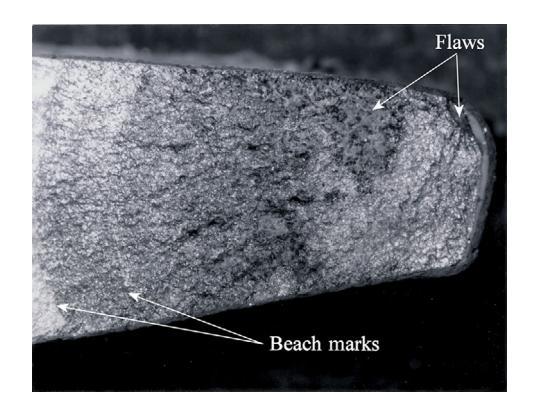
FIGURE 6.2

The crack was located on the port face of the center housing on the central web between the gearbox base and the attachment flange for the output housing. Examination of the fracture surfaces revealed river markings emanating from a small surface breaking casting flaw on the "nose" of the web, beach markings were also visible, see Figure 6.2. It was evident from these features that the crack was due to fatigue and that the crack had initiated at the casting flaw. It had then propagated through the web intersecting a number of other casting flaws. In particular, one very large flaw measuring ≈ 2 mm in diameter was only a few millimeters away.

Image showing one of the fracture surfaces of the fatigue crack in the Port Central Web of the ZE41A housing in Failure Investigation 1.

The fatigue crack was measured to be 11 mm long and it encompassed the full thickness of the web. The flaw at the origin was approximately 0.9 mm long and 0.3 mm deep.

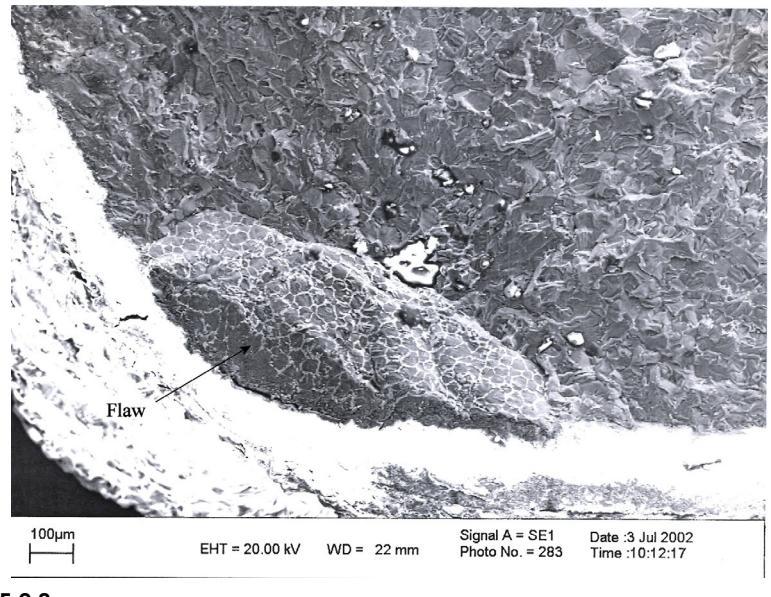
FIGURE 6.3

SEM image showing the casting defect in the origin region of the ZE41A housing web fatigue crack evident during Failure Investigation 1.

SEM examination of the fracture surface revealed that the crack origin region exhibited a relatively smooth "as cast" surface with a visible grain structure; see Figure 6.3. This was interpreted as a very small cold shut at the casting surface, possibly resulting from the presence of an entrapped oxide film. Other flaws evident on the fracture surface were also examined and were found to be of a similar appearance to that at the origin.

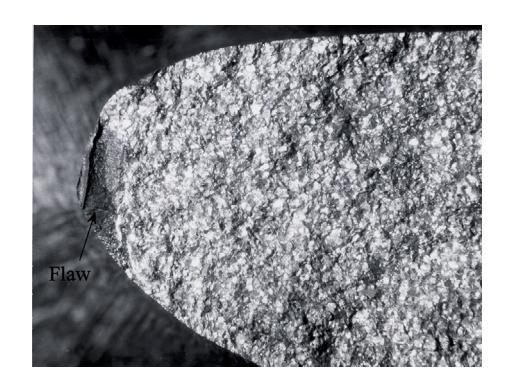
FIGURE 6.4

Visual examination revealed a crack in the port forward web. The section of material incorporating the crack was cut from the housing and the crack was broken open to reveal the fracture surfaces. The initial examination, undertaken using a WILD MAKROSKOP M420 binocular microscope, revealed a dull, dark-colored flaw at the nose of the web (see Figure 6.4) with the rest of the fracture surface exhibiting a reflective crystalline appearance.

Image showing one of the fracture surfaces of the crack in the port forward web of the WE43A housing examined in Failure Investigation 2.

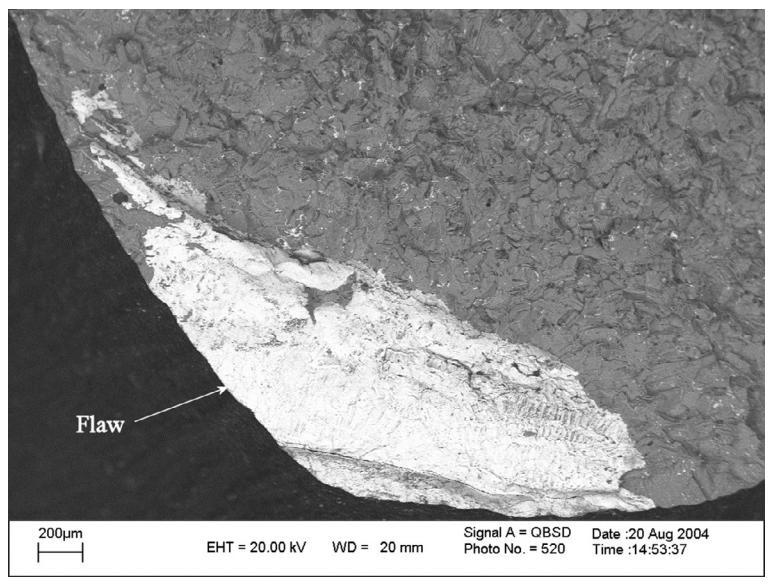
FIGURE 6.6

The defect at the nose of the web measured ≈ 3 mm in width and extended ≈ 1 mm below the surface (see Figure 6.6). Imaging utilizing the back-scattered electron (BSE) imaging mode to provide contrast based on atomic weight, revealed the defect to have a relatively smooth surface in relation to the rest of the fracture. It was also evident on both halves of the fracture. This imaging technique also indicated that the defect was rich in higher atomic number elements. This was confirmed using the attached Princeton Gamma Tech IMIX EDX analysis system which revealed the significant presence of yttrium and neodymium and the minor presence of magnesium.

SEM BSE image showing the casting defect at the origin of the web fatigue crack on the WE43A housing examined in Failure Investigation 2.

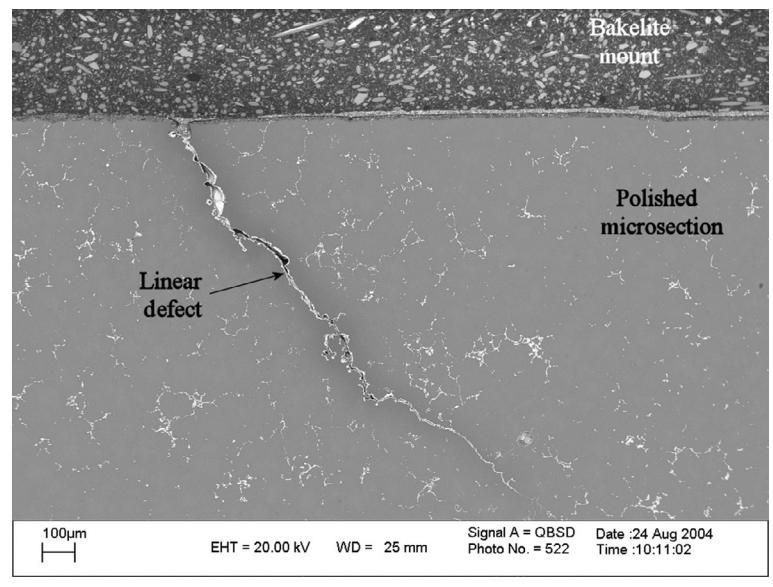
FIGURE 6.7

BSE imaging revealed that this feature was a "linear defect" measuring at least 1.5 mm in length and that the two surfaces of this had the appearance of a "skin" that was rich in higher atomic number elements; see Figure 6.7. EDX analysis revealed it to be rich in yttrium and neodymium, similar to the flaw at the crack origin. Figure 6.8 shows a region of this flaw where the "folds" in the yttrium-rich "skin" are clearly visible.

SEM BSE image showing the linear casting defect in the region adjacent to the cracked web on the WE43A housing examined in Failure Investigation 2.

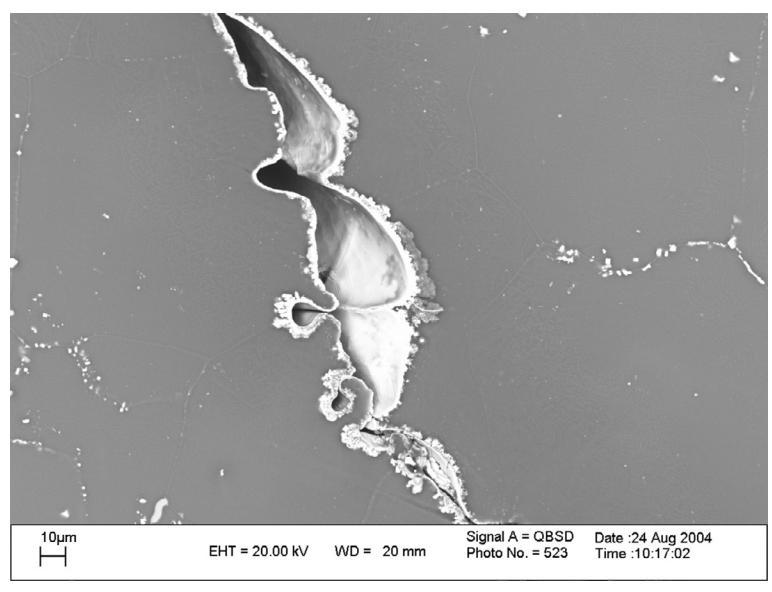
FIGURE 6.8

SEM BSE image showing a fold in the skin-like linear casting defect in the WE43A housing examined in Failure Investigation 2.

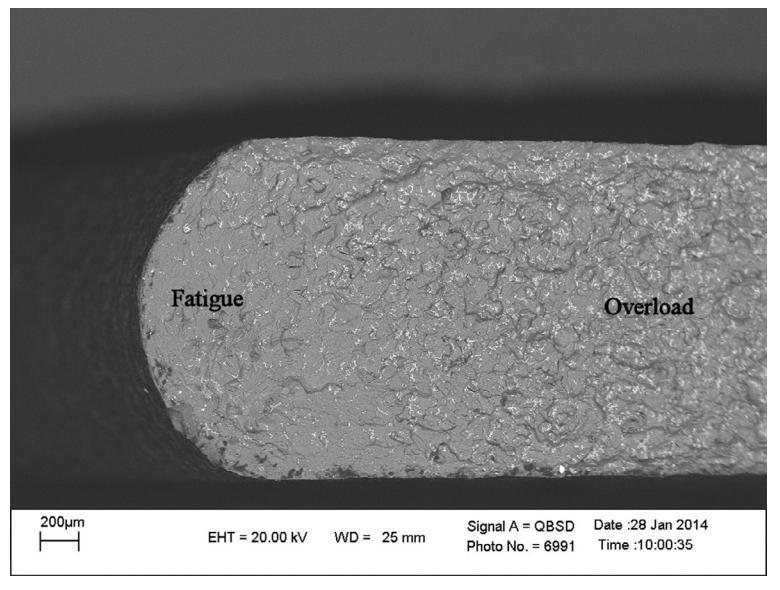
FIGURE 6.12

SEM BSE image of a fatigue specimen from the WE43A housing examined during Failure Investigation 3.
