Handbook of Materials Failure Analysis With Case Studies from the Aerospace and Automotive Industries Handbook of Materials Failure Analysis With Case Studies from the Aerospace and Automotive Industries

Abdel Salam Hamdy Makhlouf

Mahmood Aliofkhazraei

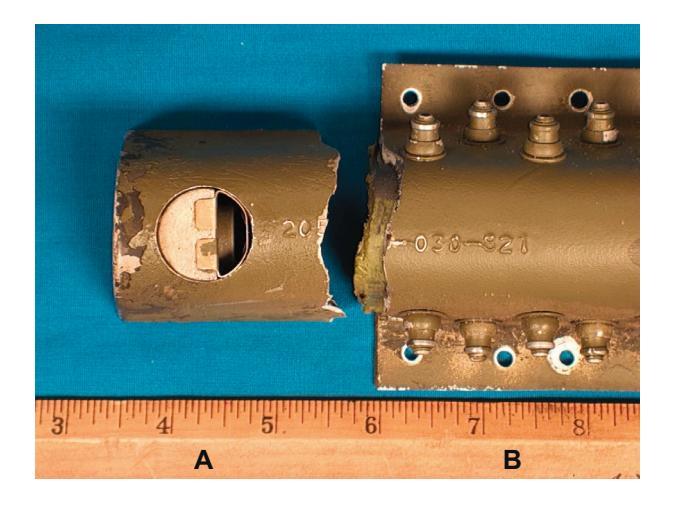
While a mechanic at Fort Rucker was securing the lower left-hand AFT engine cowling fastener to the forward left-hand upper tail boom of a utility helicopter, he discovered that the forward tail boom's bulkhead contained a 5-in. crack at the upper left-hand corner. Closer inspection revealed that the forward upper left-hand longeron had 2 in. broken off. It was determined that the bulkhead was cracked as a result of the longeron failure. It was estimated that the part accumulated 11,476 flight hours, while the actual aircraft had a total of 16,720 flight hours. Figure 7.1 shows the two broken pieces of the longeron, in the as-received condition. The part is fabricated from a 2014 aluminum alloy extrusion. For identification purposes throughout the context of this case study, the fracture half which became detached from the remaining assembly will be referred to as fracture half "A," while the other fracture half will be identified as fracture half "B." It is important to note that the same features and analytical results were obtained for both fracture halves but most of the results presented will be that of fracture half A. Figure 7.2 is a lowmagnification fractograph of fracture half A, which clearly revealed evidence of fatigue beachmarks emanating from one end of the "U"-shaped part, as identified by the arrow. The beachmarks, which are fractographic features left behind as a result of an advancing crack front subjected to cyclic loading conditions [5], occurred

The two broken pieces of the longeron, in the as-received condition.

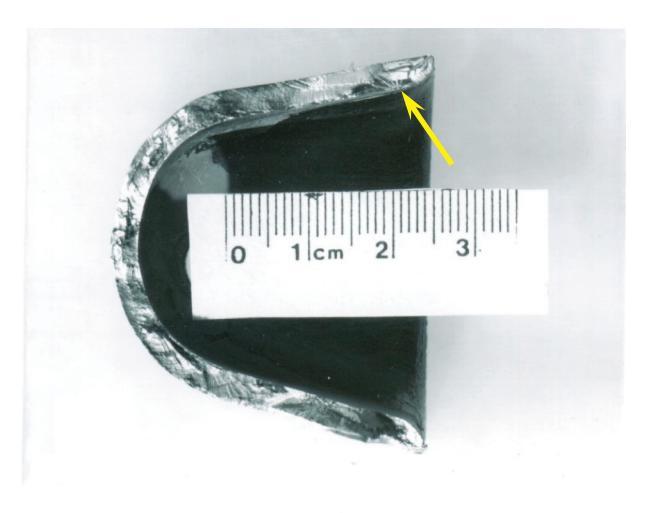
FIGURE 7.2

Low-magnification fractograph of fracture half A. Arrow denotes crack origin and beachmarks formed over approximately 80% of the entire fracture surface.

over approximately 80% of the entire fracture surface. The fracture surface itself contained dark deposits and contaminates at various locations. These regions usually suggest an older region of fracture, when compared to other areas which exhibit a more lustrous appearance; however, such was not the case for this fracture, since the origin was relatively clean. Figure 7.3 is an enlargement of the crack origin of

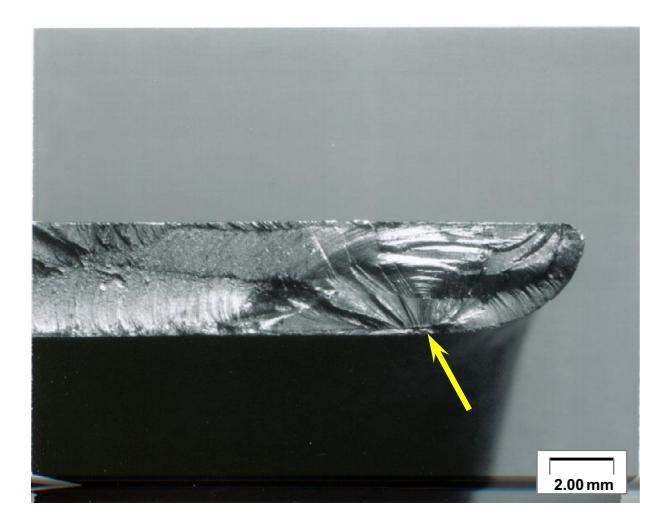
Enlargement of fracture origin of section A. Note the radial lines converging to a single area identifying the crack initiation site and the many finely spaced beach marks propagating outward from the fracture origin (arrow).

fracture half A. Note the radial lines converging to a single area identifying the crack initiation site and the many finely spaced beach marks propagating outward from the fracture origin. Closer examination of the crack initiation site revealed an anomaly that did not contain any discernible crack arrest markings or other features normally associated with a fracture surface. This area is shown in Figure 7.4 which represents fracture half A and that of fracture half B is depicted in Figure 7.5. In conjunction with this finding, several other surface anomalies were found below the crack origin, running parallel to the fracture (Figure 7.6). These defects were found to be cracks and still contained paint over and within them, substantiating the fact that they were the result of manufacturing (Figure 7.7). The hardness of the component was measured using the Rockwell B Scale (HRB). The part was sectioned such that the hardness could be measured along perpendicular planes (transverse and longitudinal to the extrusion direction). Specification SAE-AMS-QQ-A-367 [6] listed a minimum hardness requirement of 125 Brinell, which correlates to a minimum of 78 HRB using standard conversion charts. There was no significant variation between the 10 readings measured in both directions, and each set of readings conformed to the minimum hardness requirement. The average hardness value obtained in the transverse direction was 80.6 HRB, while that in the longitudinal direction was 80.0 HRB. The electrical conductivity of this component was measured using a DETEK analyzer. Because the process is sensitive to changes in composition and thermal condition [7], electrical conductivity can be used as a qualitative method for determining whether the prior tempering operation was performed adequately for aluminum alloys. The conductivity requirement is 35.0-41.5% International

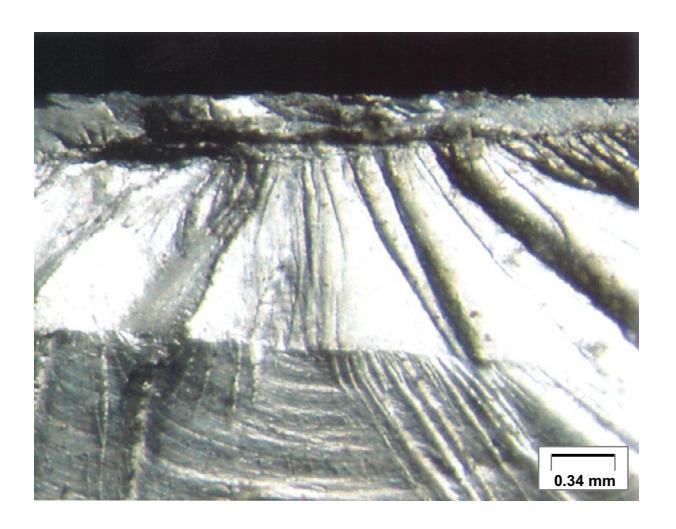
Closer examination of the crack initiation site of fracture half A revealed an anomaly that did not contain any discernable crack arrest markings or other features normally associated with a fracture surface.

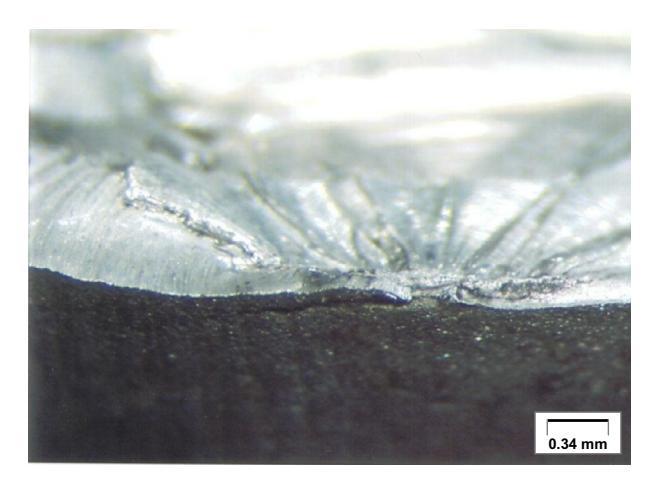
FIGURE 7.5

Closer examination of the crack initiation site of fracture half B revealed an anomaly that did not contain any discernable crack arrest markings or other features normally associated with a fracture surface.

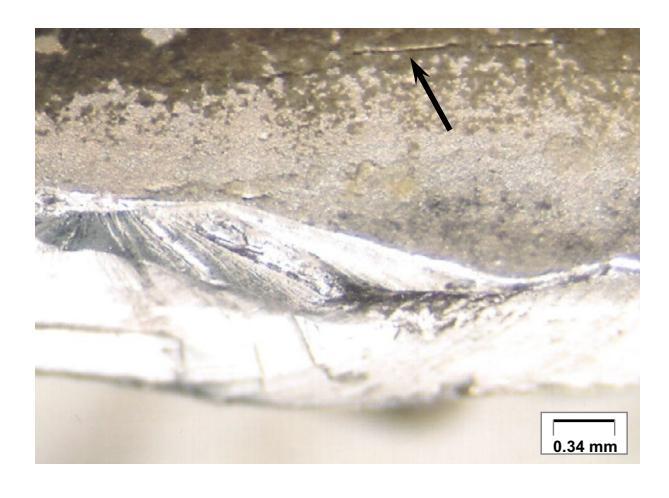
Surface anomalies found below the crack origin, running parallel to the fracture.

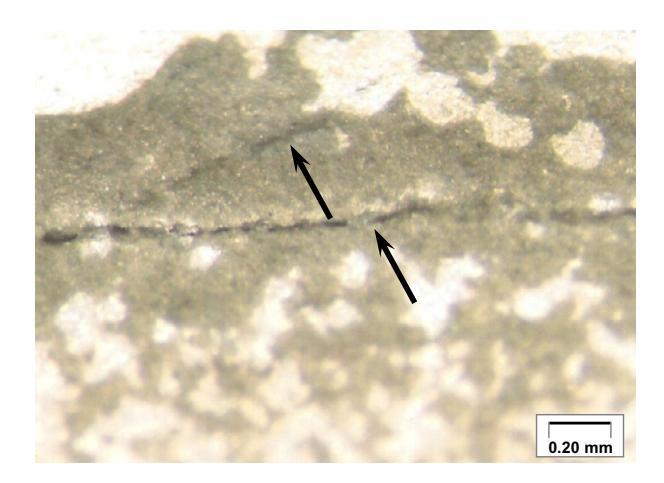
The defects (arrows) noted in Figure 7.6 extended into the surface of the material and contained paint in some areas, substantiating they were the result of manufacturing.

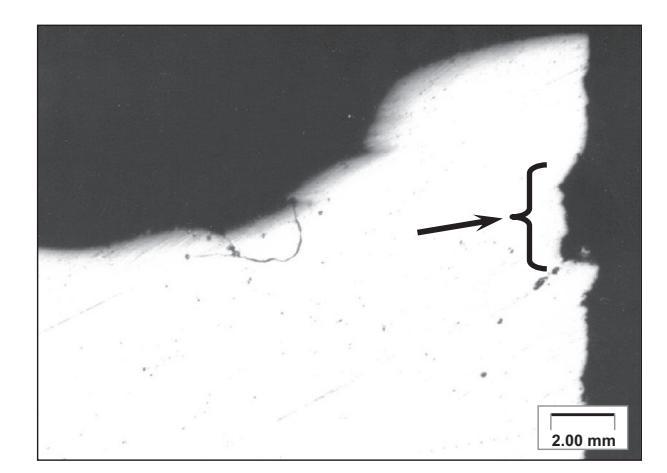
FIGURE 7.8

A cross-section taken through the crack origin in the as-polished condition. Note the recessed area identified by the arrow, which is the anamoly observed previously in Figure 7.5. The width of the defect was approximately 0.004 in.

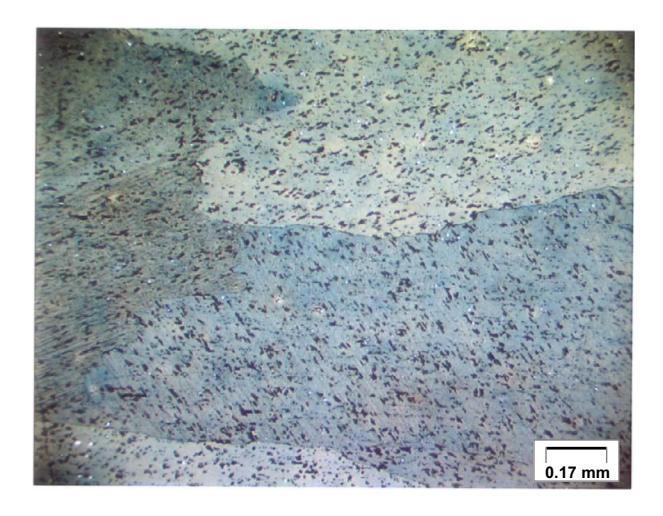
A cross-section through the center of the "U" was etched with Keller's reagent to reveal the microstructural features of the material. The material was typical of a T6 temper and did not contain any other inherent material defects. Magnification: $60 \times$.

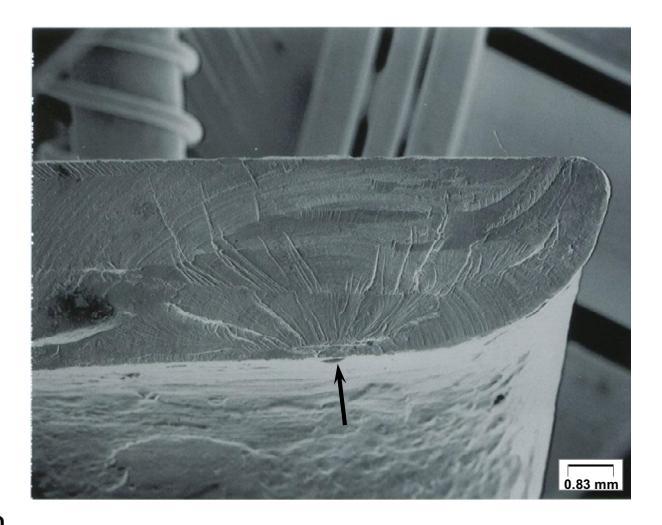
FIGURE 7.10

SEM fractograph of fracture half A. Note that the radial lines converge to a small area on the lower edge of the fracture surface as oriented in the fractograph (arrow). This area was located on the concave (inside) surface of the longeron. Beachmarks emanate from this region outward toward the opposite side and to the left of the fractograph continuing across approximately 80% of the entire fracture surface. The fracture morphology was irreconcilable at the point of crack initiation and what appeared to be an oxide was present.

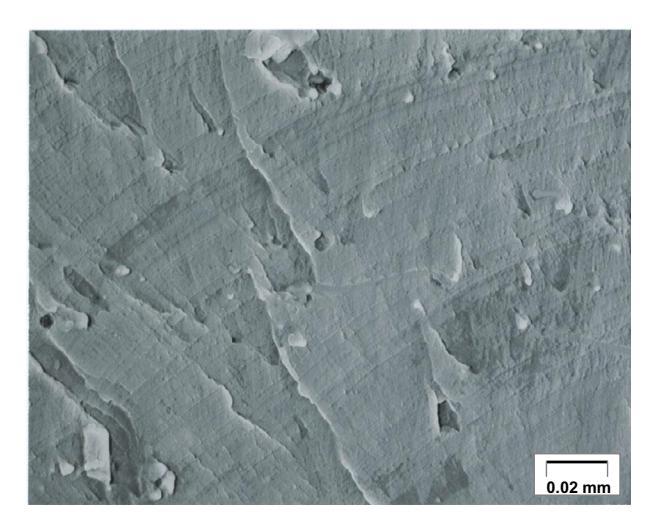
SEM fractograph of fracture half A showing that the fatigue striations predominate over most of the fracture surface confirming that crack propagation was the result of cyclic loading. The striation spacing varied as did the morphology within the fatigue region.

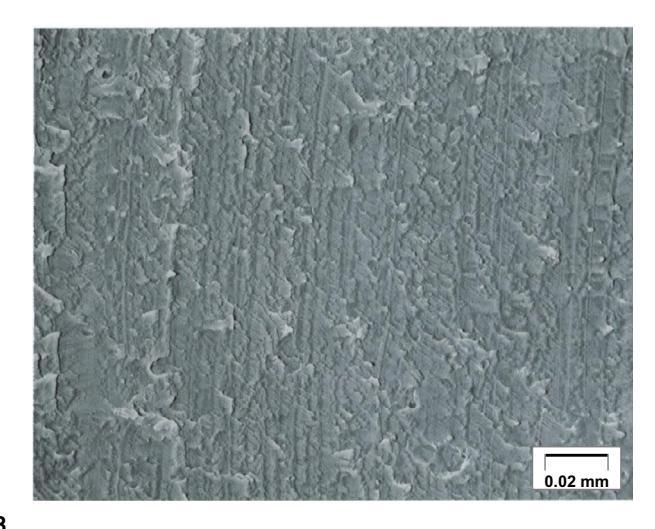
FIGURE 7.13

SEM fractograph of fracture half A showing distinct regions of transgranular fracture.

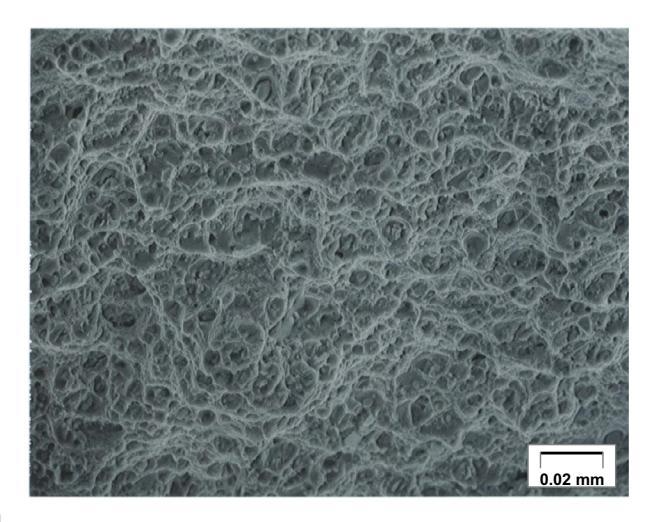
FIGURE 7.14

adjacent areas toward the outer edges of the advancing crack front, often consisted of a dimpled morphology (Figure 7.14). The final fracture region at the opposite end of the "U"-shaped part also contained a predominately dimpled morphology, indicative of overload conditions (Figure 7.14). The dimpled structure within the fatigue region most likely occurred as a result of the strength variation of the forging. The outer edges being more compressed would be stronger than the less deformed regions

SEM fractograph of fracture half A showing areas adjacent to those shown in Figure 7.13, toward the outer edges of the advancing crack front, that often consisted of a dimpled morphology. The final fracture region at the opposite end of the "U" shaped part also contained a predominately dimpled morphology, indicative of overload conditions.

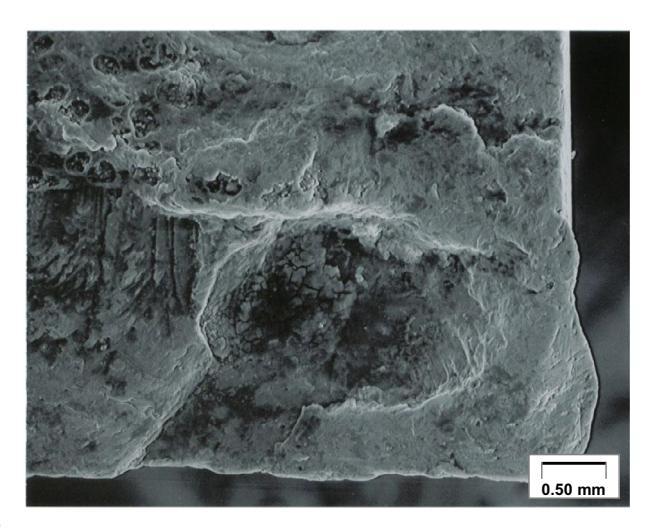
in the center. Figure 7.15 is an enlargement of a cross-section taken through the crack origin of fracture half B, which was not mounted in epoxy resin. The fracture morphology was irreconcilable at the point of crack initiation and what appeared to be an oxide was present, as distinguished by the featureless amorphous structure. Figure 7.16 represents the same area at higher magnification. Energy dispersive

An enlargement of an unmounted cross-section taken through the crack origin of fracture half B. The fracture morphology was irreconcilable at the point of crack initiation and what appeared to be an oxide was present.

The crack initiation site contained an irreconcilable fracture morphology that was covered with what appeared to be a discontinuous heavy oxide layer. EDS analysis revealed the presence of a large oxygen concentration as compared to the remaining fracture surface. The chemical composition of a polished section of the material was also used for comparative purposes and contained a very small oxygen peak. Therefore, it was reasonable to deduce that the layer in question was rich in oxygen. In addition, the thickness of the oxide layer, as well as the physical shape of the area encompassed by it, suggested that it formed by an alternative means other than atmospheric corrosion or fretting. The remaining fracture surface contained the effects of atmospheric corrosion in the form of dark oxide product which was clearly distinguishable from the oxide contained at the crack origin. Fretting would have produced minute, dark oxide particles, and which would have been caused by some type of mechanical action, but this was not observed. The alleged oxide layer and its morphology were consistent with that of a forming defect, such as a lap. Further evidence substantiating this claim was the other laps found on the concave surface of the part during stereoscopic examination (Figures 7.6 and 7.7). A series of these cracks were located adjacent to the crack origin and extended parallel to the fracture. Such a defect would have provided a suitable site for fatigue crack initiation and propagation.

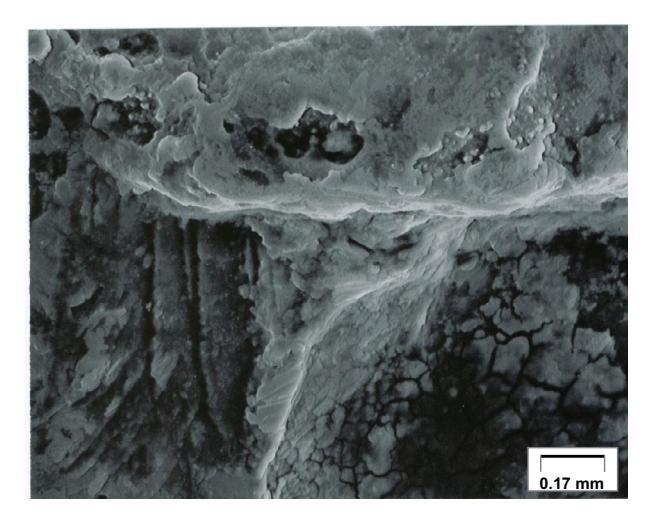
FIGURE 7.16

Photograph of the same area shown in Figure 7.15 at higher magnification. Energy dispersive spectroscopy (EDS) was performed to compare the chemical composition of the alleged oxide product with that of the polished cut surface and also with other areas of the fracture away from the origin.

spectroscopy (EDS) was performed to compare the chemical composition of the alleged oxide product with that of the polished cut surface and also with other areas of the fracture away from the origin. The results support the presence of an oxide as evidenced by high oxygen peaks associated with the oxide, as compared to that of the other areas of the fracture surface and the polished section, which contained little or no oxygen.

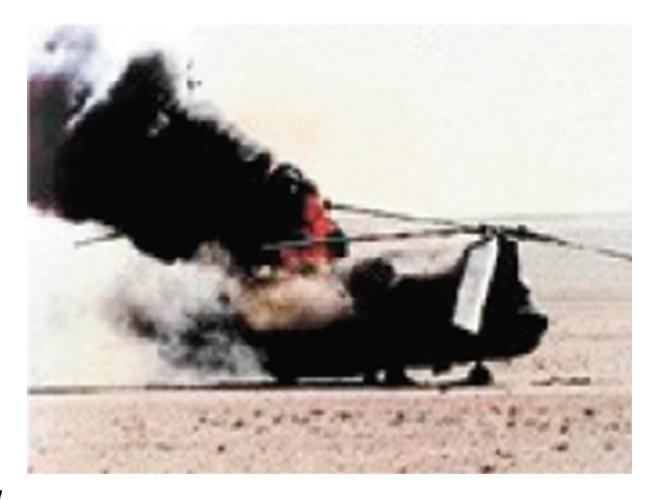
A metallurgical investigation of a CH-47D Chinook spiral bevel gear that had catastrophically failed leading to a controlled crash of the aircraft at Ft. Meade, MD was performed after the part was recovered from the crash site (Figure 7.17). The component was fabricated from VASCO X2M carburized steel and it failed due to a fatigue crack, which originated from grinding cracks. The failed component was double carburized. The grinding cracks formed from a microstructure that contained excessive carbides and was the result of an unauthorized grinding operation of the chamfer adjacent to the damping ring groove [10]. This grinding operation was performed in order to meet dimensional requirements and was the final step of the manufacturing process. This sequence was outside the approved specification because a subsequent nital etch inspection was required after any grinding operation to detect thermal damage. In addition, the part would also be required to be stress relieved and subsequently shot peened. The excessive carbides were formed during the carburization heat treatment and were the result of too high a carbon potential. Optical and electron microscopy of the case and core microstructures were performed and the grinding burns were characterized. Figure 7.18 shows an example of the carbide distribution as a result of a low-carbon potential treatment, associated with a certain gear manufacturer, while Figure 7.19 shows that of a high-carbon potential treatment associated with defective gears. Note the difference in carbide distribution between the two. Figure 7.20 shows the ground surface of a defective gear. There is evidence of a rehardening burn (lightly etched surface layer) as well as retempering burn (darker etching layer below the rehardening zone). This region is shown at higher magnification in Figure 7.21. Metallographic examination, combined with microhardness testing, revealed a deeper than acceptable case in the

Catastrophic failure of the CH-47 spiral bevel gear.

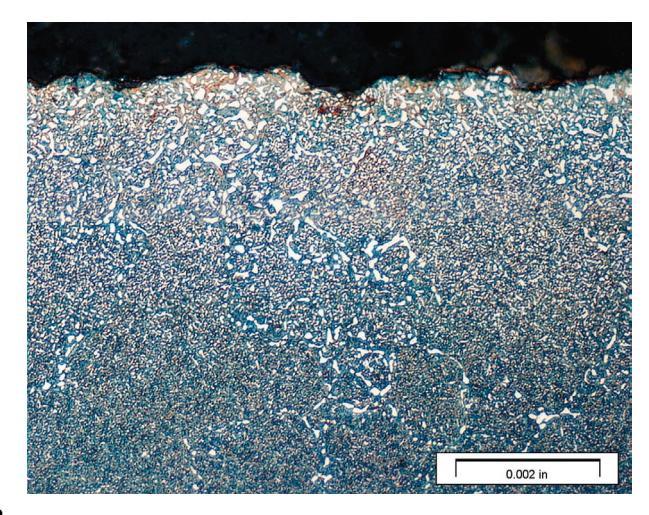
FIGURE 7.18

Typical carbide distribution within the case of a gear heat treated with a high-carbon potential (1.2%). Magnification: $500 \times$.

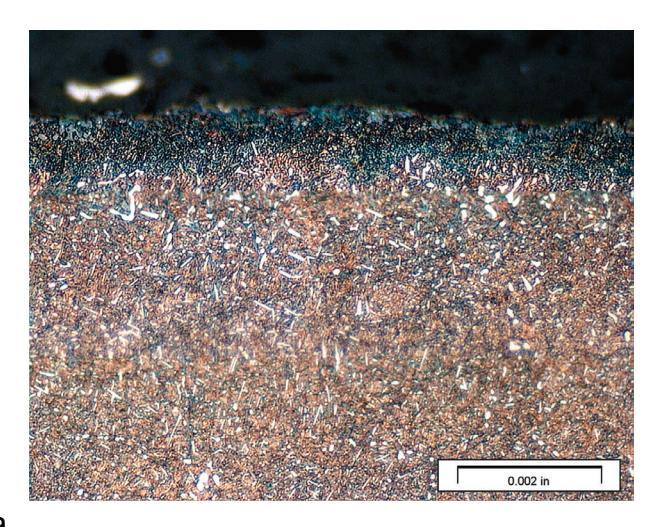
FIGURE 7.19

Typical carbide distribution within the case of a gear heat treated with a low-carbon potential (0.9%). Magnification $500 \times$.

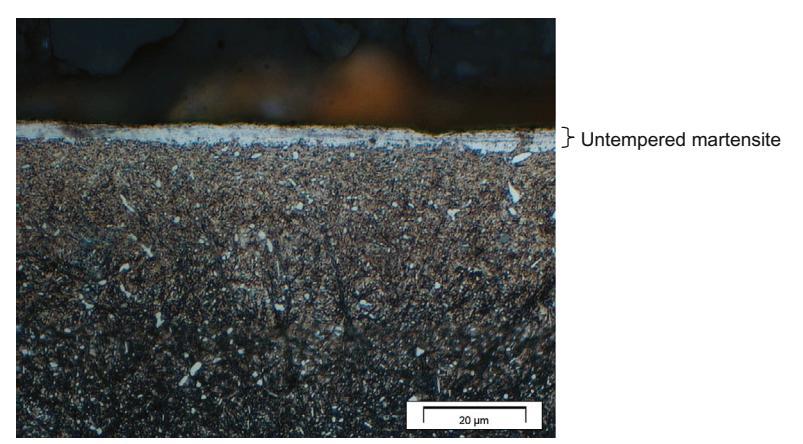
FIGURE 7.21

The rehardening burn shown in Figure 7.12 at higher magnification Note the layer of untempered martensite at the surface. Magnification $1000 \times$.

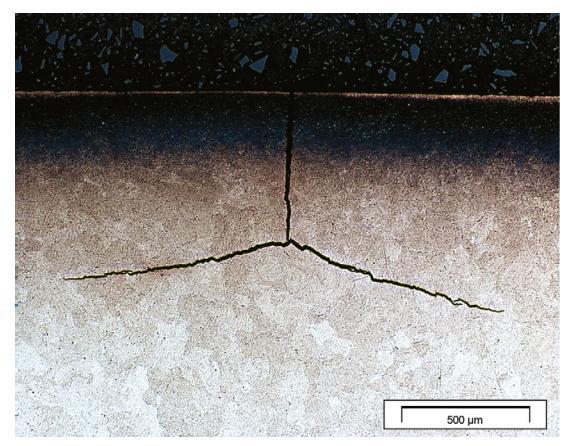
FIGURE 7.22

damping ring groove region (origin location). It was later learned that this region was mistakenly subject to a double carburization during processing. A grinding crack was also examined as shown in Figure 7.22. The shape of the crack suggests separation of the case and core. The core structure (Figure 7.23) consisted of a duplex structure of free ferrite and tempered martensite.

A grinding crack indicative of defective gears. Crack branching appears to suggest case/core separation. Magnification $50 \times$.

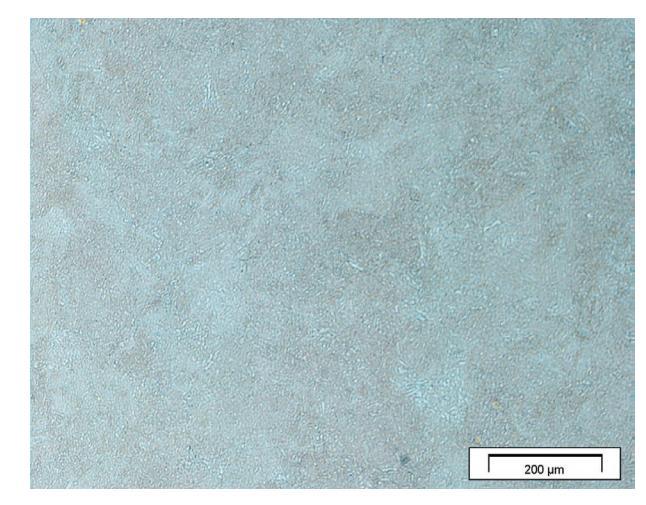
Typical core microstructure of the carburized gears. Magnification 100 ×.

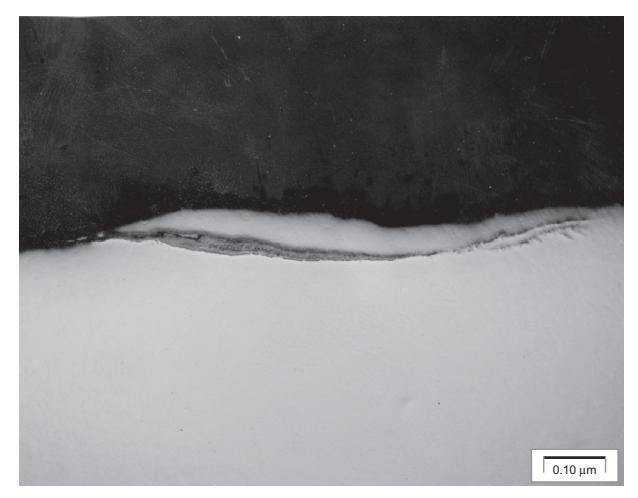
SEM of dark oxide at crack origin $1000 \times$.

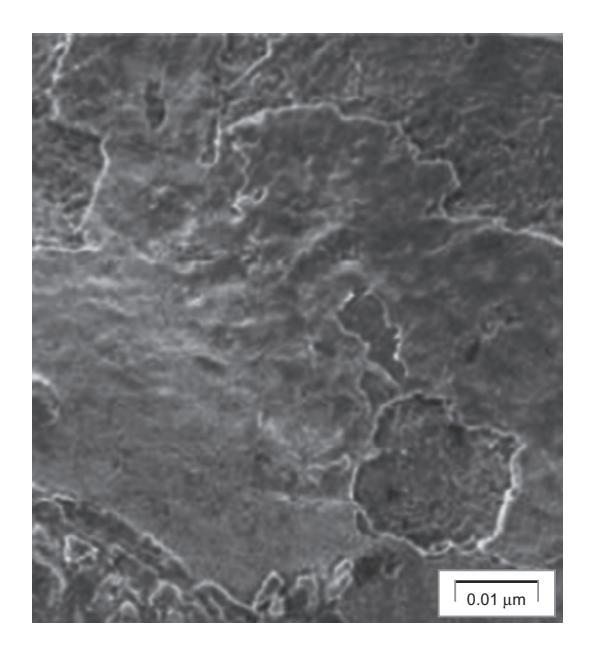
FIGURE 7.26

SEM of dark oxide at crack origin $1000 \times$.

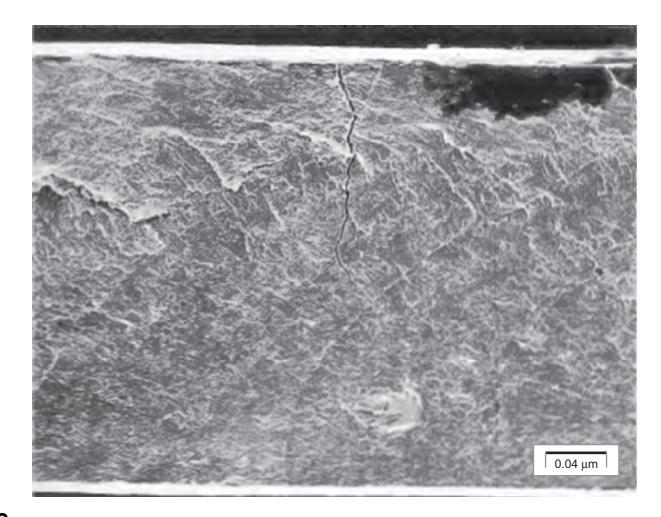
Secondary cracking noted on a strap pack laminate.

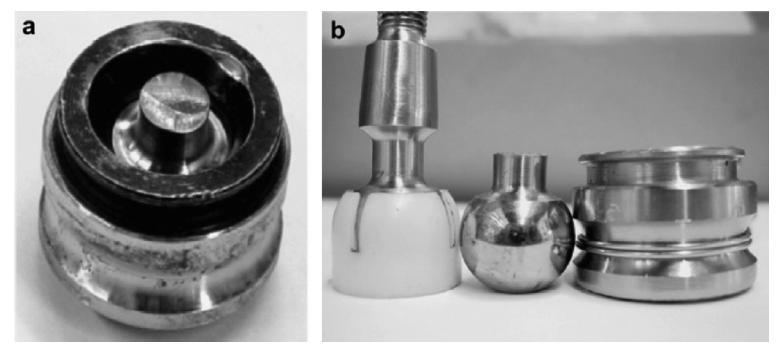
FIGURE 8.3

This case describes the analysis and investigation of the causes of the sudden failure of a MacPherson strut suspension system ball joint. The axis of the ball joint element showed a complete fracture, which occurred midway between the top and bottom section changes of the element, as shown in Figure 8.3.

Ball joint element. (a) Failed ball joint in the cage. (b) Failed and new ball joints out of the cage [8].

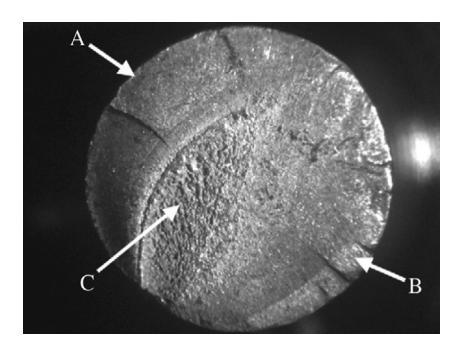
FIGURE 8.4

Figure 8.4 shows a macroscopic image of the fractured surface of the ball joint obtained by optical microscopy. Three different characteristic zones of the fracture are identified in the figure as Zones A through C. Zones A and B indicate opposed zones where the crack growth started. These zones showed a smooth and curved appearance or beach marks. These zones are a clear indication of fatigue failure of the material. Furthermore, in Zones A and B can be appreciated fracture features pointing toward the center of the fracture. These ratchet marks are typical of fracture on elements subjected to high-stress concentrations. Zone C on the other hand shows a rough surface, indicating the final fracture zone of the element; this zone occupying approximately one quarter of the cross-section of the element.

Fracture surface of the failed ball joint [8].

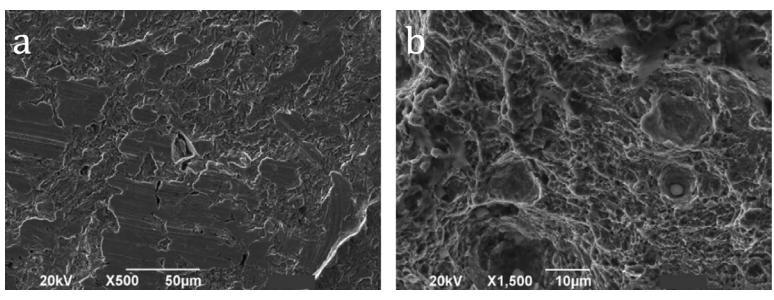
FIGURE 8.5

Figure 8.5 shows the fracture zones of the element, where the smooth surface and the beach marks characteristics of fatigue crack propagation can be appreciated, corresponding to Zone A (Figure 8.5a). On the other hand, Figure 8.5b shows Zone C, where the micro-voids characteristic of final ductile fracture of the element can be appreciated.

SEM micrographs of fracture surface. (a) Zone A and (b) Zone C. [8].

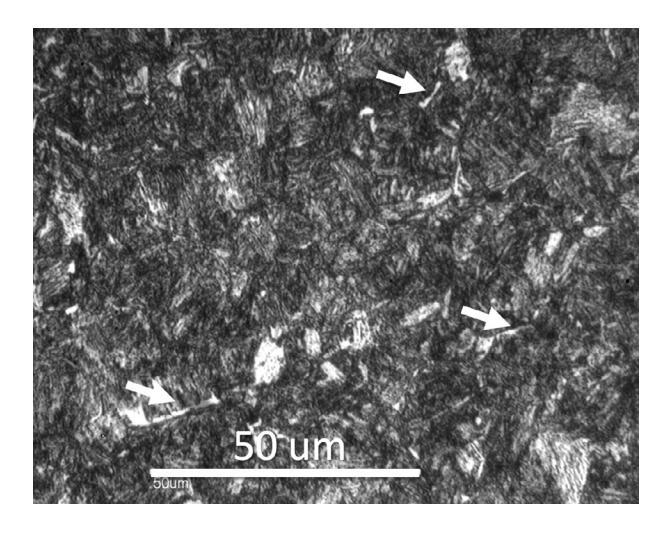
According to chemical composition analysis by OES, the ball joint was manufactured using AISI-SAE 5140 steel. Figure 8.6 shows the microstructure of the ball joint element. This micrograph shows a microstructure formed mainly by tempered martensite with acicular grains of ferrite on the grain boundaries (white grains indicated by arrows).

The presence of tempered martensite indicates that the material suffered a heat treatment of quenching and tempering. Despite of the beneficial effect of increasing material toughness of ferrite in low-carbon steels [25–27], it has been found that acicular ferrite can decrease the fracture toughness and mechanical strength of heat treated steels when it appears on tempered martensite grain boundaries [28,29], as in the present case. The presence of acicular ferrite on grain boundaries can also induce a

Microstructure of the material. Etched with Nital 2% [8].

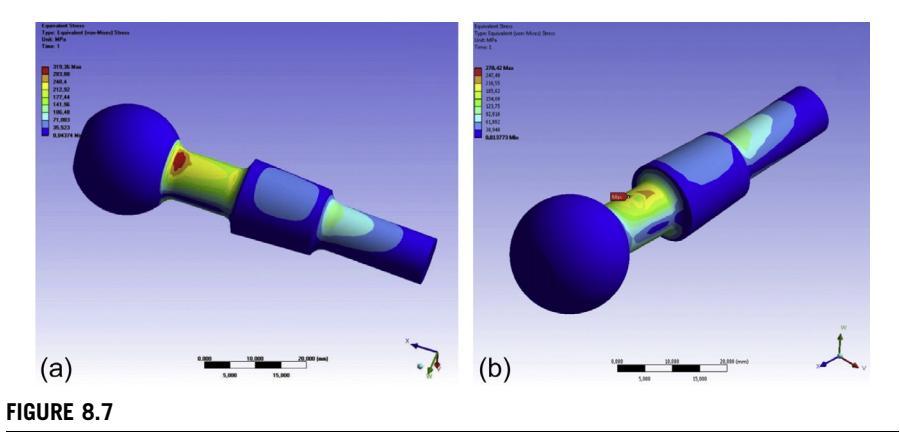
Equivalent Von Mises stress distribution of the ball joint. (a) Without contact support and (b) with contact support [8].

The analysis and calculations of maximum stresses were performed both with and without the contact support patch, in order to highlight the places of higher stresses in the element. The contact support between the axis of the element and its cage was modeled as frictionless because the failed element surfaces did not show any indications of fretting or wear suggesting friction between them. Figure 8.7a shows the stress distribution on the ball joint element without the contact support patch in place. In this case, the maximum stress was found on the section change between the ball and the axis. This stress reached a maximum value of 319 MPa approximately. On the other hand, Figure 8.7b shows the stress distribution on the element including the contact support patch. In this case, the maximum stress was found on the contact region between the axis of the element and its cage. This stress reached a maximum value of 278 MPa approximately, which is lower than the bulk fatigue endurance limit of this steel under normalized conditions, which reaches to a value of 416 MPa [31]. However, this stress is close to the endurance limit found using Murakami's Equation (8.1) for the acicular ferrite present in the grain boundaries of the material. Also note that the place where this stress is reached corresponds to the place where the fracture occurred in the ball joint element (see Figure 8.3). The smooth beach marks accompanied by ratchet marks and a small final fracture zone (one quarter of the cross-section of the element) confirm that the element suffered high-stress low-cycles fatigue conditions initiated at the acicular ferrite on the grain boundaries, followed by fatigue crack growth.

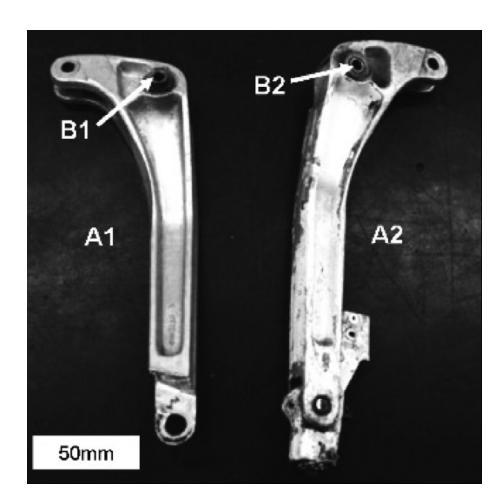
FIGURE 8.9

Figure 8.9 shows the two linkages as received for analysis after the accident. Linkage A1 shows fracture of the bottom clevis, with bolt B1 fractured at one end. Linkage A2 on the other hand, was received with clevis bolt B2 fractured at both ends.

Landing gear left and right locking linkages A1 and A2, respectively. Also shown is the location of the respective failed bolts B1 and B2 [22].

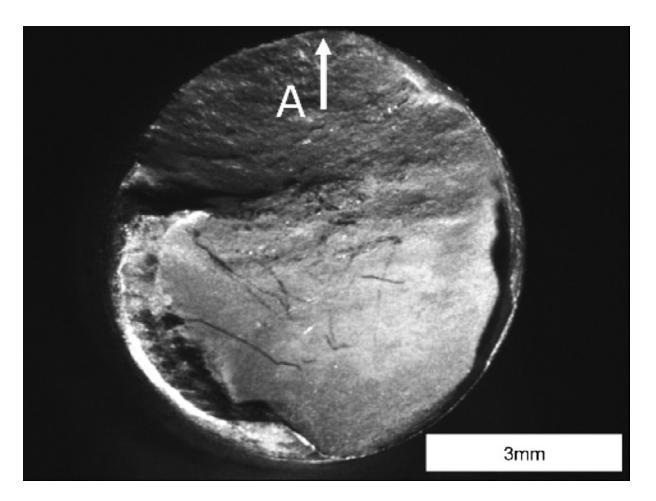
Stereographic examination of the fractured surface of bolt B1 reveals a typical mode II or shear loading fracture, with the arrow indicating the zone where the fracture began (Figure 8.10).

Stereoscopic micrograph of the fractured surface of bolt B1. The arrow points toward the fracture initiation [22].

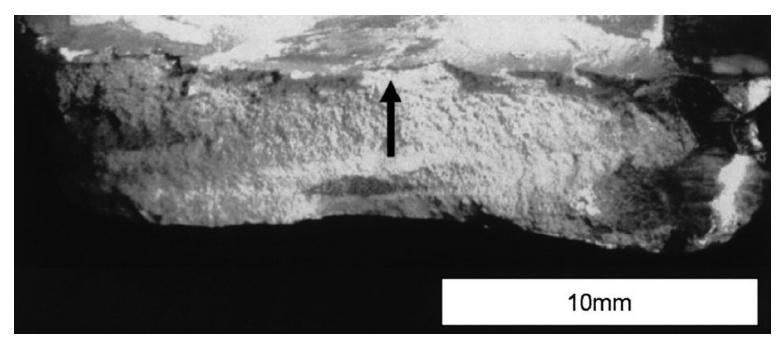
FIGURE 8.11

Figure 8.11 shows the fracture surface of the failed clevis of linkage A1. The fracture surface indicates crack-opening mode-I loading failure, initiating the crack at the internal surface of the element as indicated by the arrow.
178 CHAPTER 8 Suspension and landing gear failures

Stereoscopic micrograph of the fractured surface of the clevis of linkage A1. The arrow points toward the fracture initiation [22].

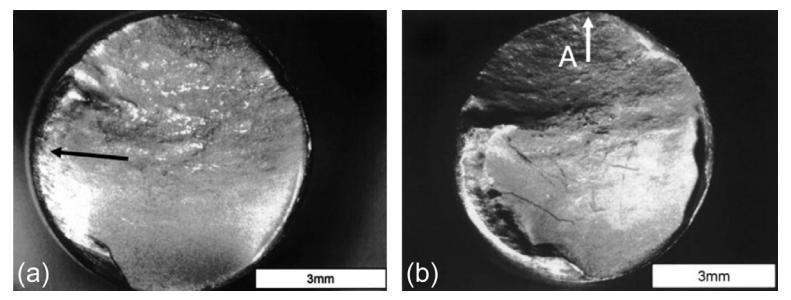
Figure 8.12a shows the fractured surface of the left-hand side tip of bolt B2. This surface displays similar characteristics to the fracture surface shown in Figure 8.10 for bolt B1, with shear fracture mode prevailing, also accompanied by bending of the left-hand side tip of the bolt. Figure 8.12b, on the other hand shows the fracture surface of the right-hand side of bolt B2. This surface exhibits different characteristics when compared with the respective fractured surfaces of the bolts analyzed previously, with a less rough appearance in Zone A (see Figure 8.12b). This zone also displays what appear to be fatigue beach marks, which along with the straight

Fracture surface of bolt B2. (a) Left-hand side and (b) right-hand side [22].

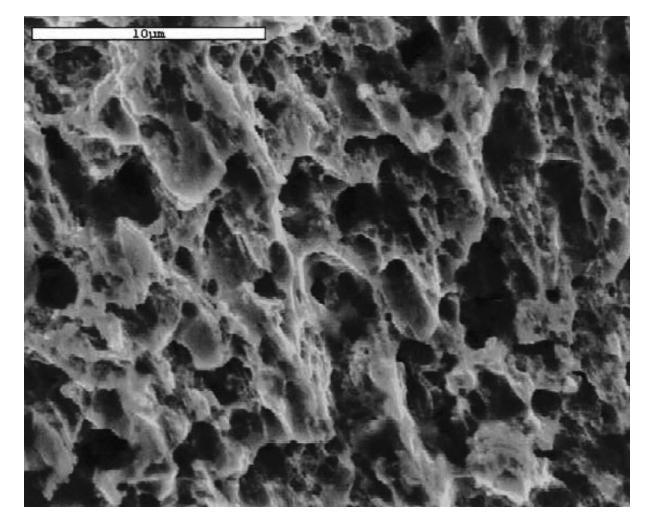
SEM micrography of Zone A in Figure 8.12, showing ductile shear fracture [22].

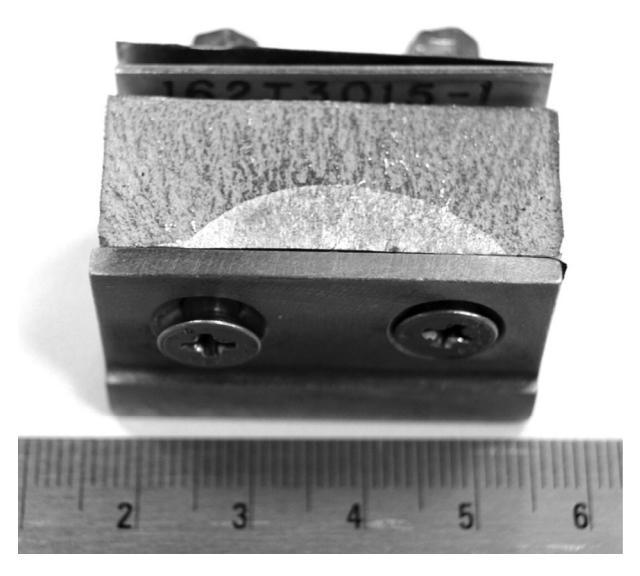
Failed AFT lock-link with support plate in place.

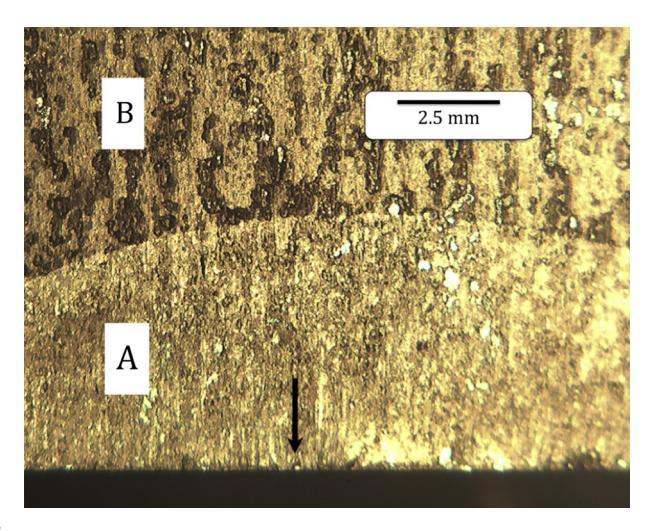
Figure 8.16 shows the fracture surface of the landing gear, appreciated by optical microscopy. This fracture shows two distinctive zones, one clear and semi-circular zone denoted as Zone A, and a darker zone, denoted as Zone B. The fracture began at

Fracture surface of the AFT lock-link.

the lower part of Figure 8.16, as indicated by the arrow. This zone coincides with the placement of the support plate of the element.

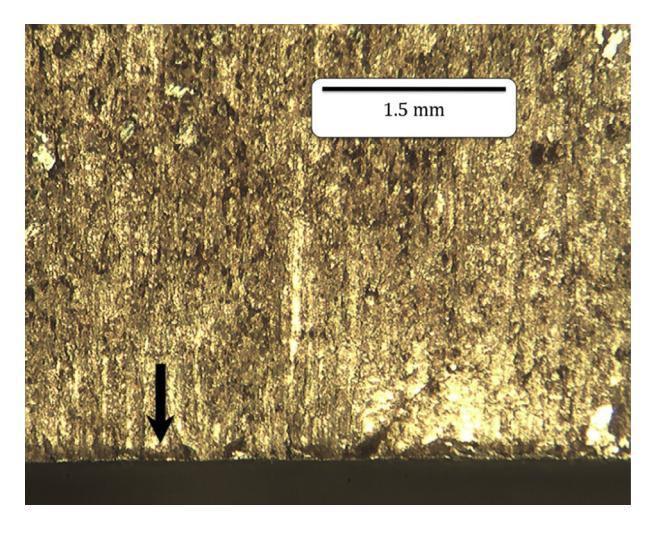
Figure 8.17 shows Zone A; here the ratched marks can be appreciated, indicating high stresses in the contact area of the support plate.

Fracture surface of the AFT lock-link, Zone A.

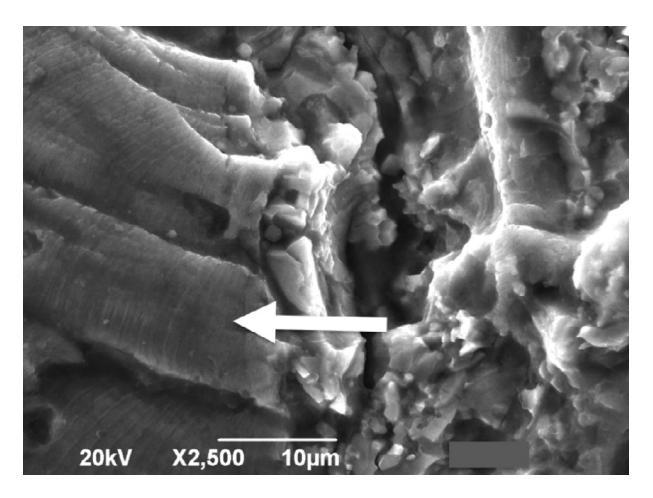
SEM fracture surface of the AFT lock-link at Zone A. The arrow indicates fatigue-growing marks.

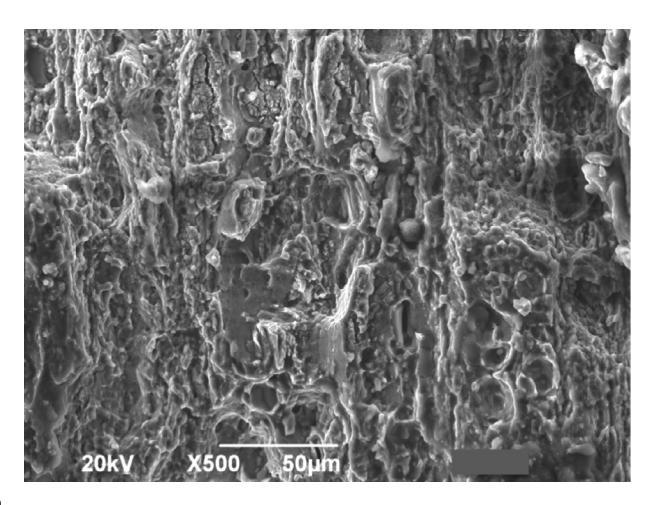
FIGURE 8.19

SEM fracture surface of the AFT lock-link at Zone B.

Figure 8.19 shows the fracture surface of the element on Zone B. Here, the surface is characteristic of ductile fracture with vertically aligned precipitates.

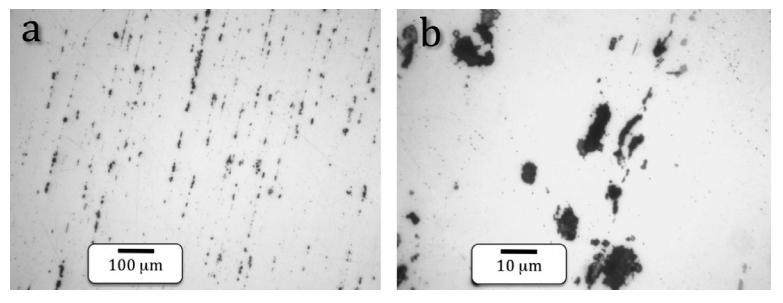
Figure 8.20 shows a metallographic specimen etched with nitric acid (25%) in a zone near to the fracture. Here, the aligned FeAl_3 (dark gray) and MgZn₂ precipitates (black) inside an aluminum-rich matrix can be seen.

Microstructure of the AFT lock-link showing aligned precipitation of $MgZn_2$ and $FeAl_3$. (a) low magnification and (b) high magnification.

The failure of the AFT lock-link was due to the appearance of aligned precipitates and inclusions. These were present in the microstructure of the material in high quantity, which after cyclic loading started fatigue cracks near to the contact region against the steel support plate, leading to the final fracture of the element. In order to reduce or even avoid the appearance of this kind of failures, it is recommended to perform appropriate heat treatments to the material in order to avoid the formation of precipitates, which can cause fatigue crack initiation. It is also important to avoid the presence of contaminant elements like iron on the aluminum alloy. Iron creates FeAl₃ precipitates, which reduces considerably the fracture toughness of the material.

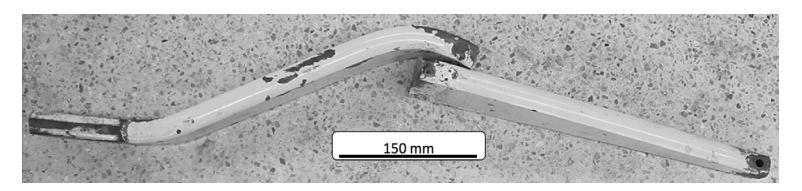
FIGURE 8.22 Failed cantilever spring.

A rear cantilever spring landing gear of a fumigation aircraft (Figure 8.21) failed during a landing procedure under normal conditions. The failed cantilever spring was manufactured using an AISI 4340 steel and failed at the same place of support to the aircraft main structure, as shown in Figure 8.22.

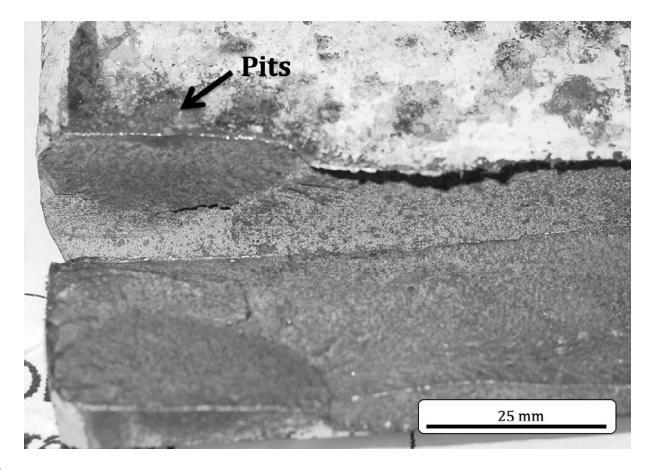
Figure 8.23 shows the two fracture surfaces of the cantilever spring. Here, the corroded surface on top of the cantilever with pits near the fracture surface can be appreciated.

Top view cantilever spring fracture surfaces.

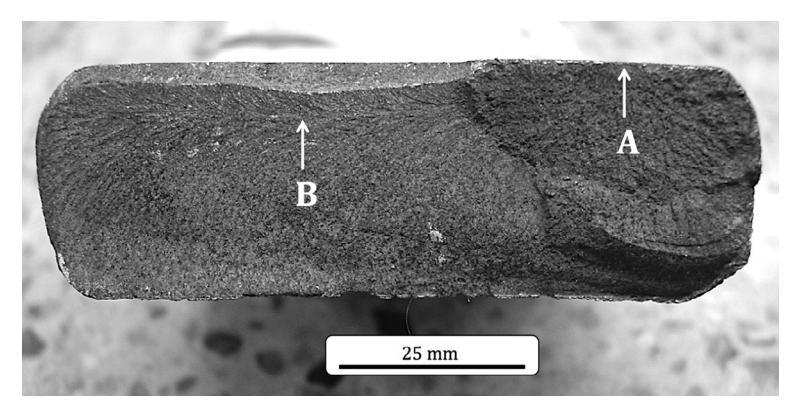
Figure 8.24 shows the fracture surface of the spring. Here, the fracture shows two characteristic zones, denoted as A and B. Zone A is where the crack started, and the arrow points toward the point where the crack started to grow, which corresponds to a pit cavity. Zone B, on the other hand is the region of the element, which supported the loads at the final stages of crack growth of the element, as indicated by the river lines.

Fracture surface of the cantilever spring.

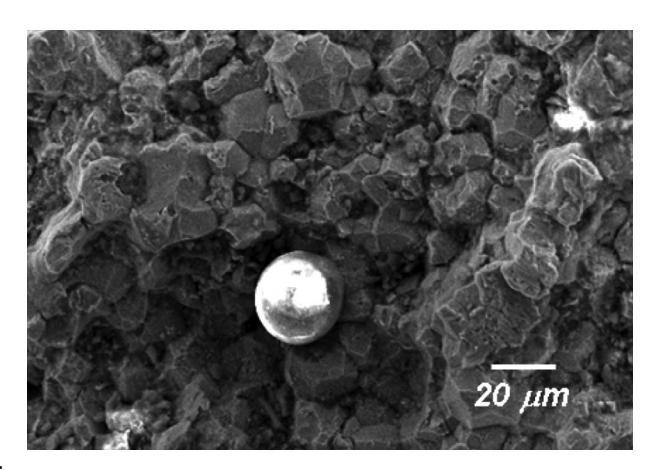
FIGURE 8.25

Figure 8.25 shows a SEM micrograph of the fracture Zone A, close to the starting point of fracture. This fractograph ruled out any possibility of associating this failure

SEM micrograph of fracture Zone A.

to fatigue. The fracture is completely intergranular, which is an indication of stress corrosion-induced cracking.

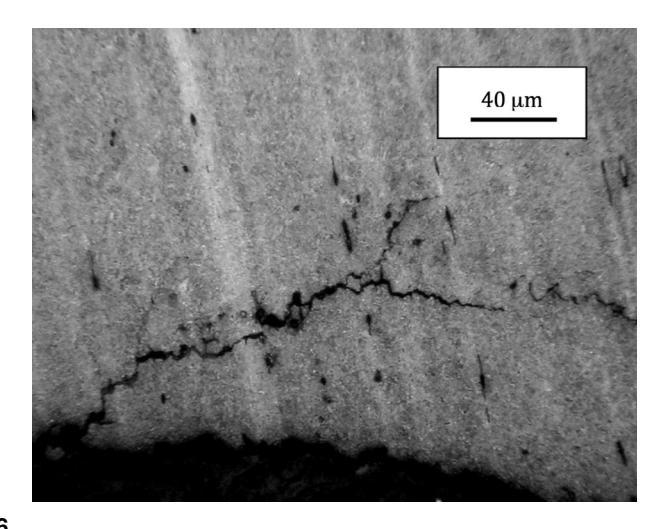
FIGURE 8.26

Figure 8.26 shows one intergranular corrosion crack growing from a pit on the surface of the cantilever spring. These kinds of cracks were found consistently in different zones near the surface and the fracture zone of the element.

It can be concluded that the failure of the cantilever spring was caused by a defective protective coating in order to prevent surface corrosion. The corrosion pits created intergranular corrosion of the material that further grew cracks due to cyclic loadings during take offs and landings of the aircraft.

Intergranular crack growing from the element surface on Zone A.

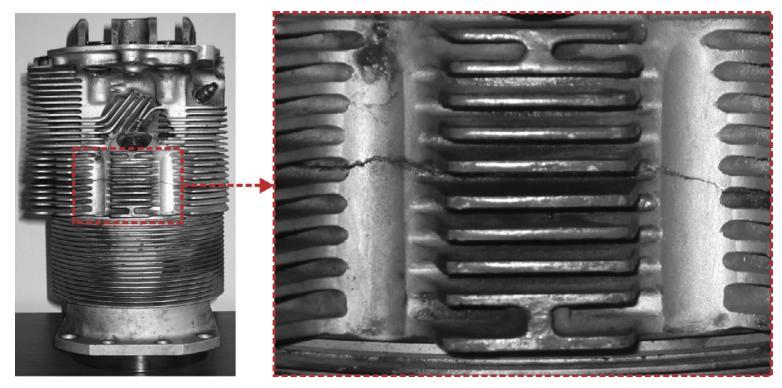
The damaged cylinder assemblies, photographed in the as-received condition, are shown in Figure 9.4 and 9.5. As seen from the aforementioned figures, both CHs had cracked between the fifth and the sixth cooling fins. The clearly visible crack

Cylinder assembly photographed in the as-received condition with close-up view of the crack in the CH I (Failure Case I).

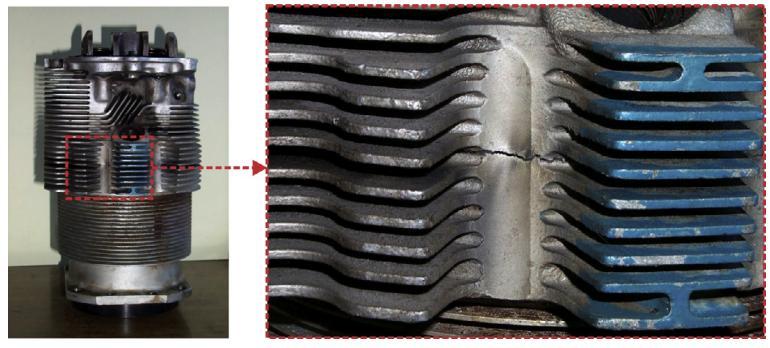
FIGURE 9.5

Cylinder assembly photographed in the as-received condition with close-up view of the crack in the CH II (Failure Case II).

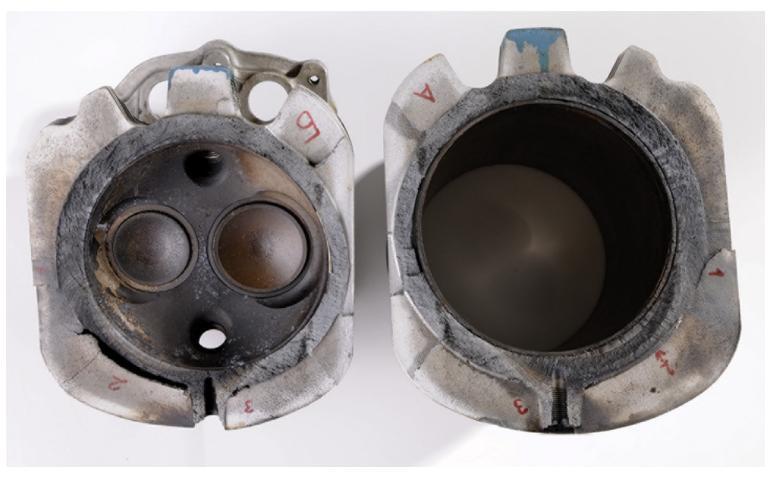
FIGURE 9.7

The initial visual inspection of the mating fracture surfaces of the CH I (Figure 9.7), using the unaided human eye, indicated the presence of five different morphologies, marked as A, B, C, D, and E in Figure 9.8. The sector A, located on the exhaust side of the CH I, showed a flat and smooth surface. Features characteristic of fatigue fracture can be clearly distinguished. These are ratchet marks, which represent steps between fatigue crack regions propagated from different origins (the larger of them

Mating fracture surfaces of the CH I obtained after the crack was mechanically opened.
