Handbook of Materials Failure Analysis With Case Studies from the Aerospace and Automotive Industries Handbook of Materials Failure Analysis With Case Studies from the Aerospace and Automotive Industries

Abdel Salam Hamdy Makhlouf

Mahmood Aliofkhazraei

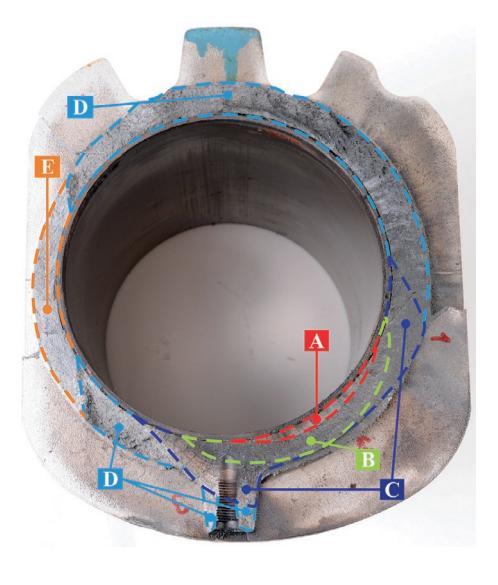
The initial visual inspection of the mating fracture surfaces of the CH I (Figure 9.7), using the unaided human eye, indicated the presence of five different morphologies, marked as A, B, C, D, and E in Figure 9.8. The sector A, located on the exhaust side of the CH I, showed a flat and smooth surface. Features characteristic of fatigue fracture can be clearly distinguished. These are ratchet marks, which represent steps between fatigue crack regions propagated from different origins (the larger of them

Macrograph showing characteristic morphologies on the fracture surface of CH I.

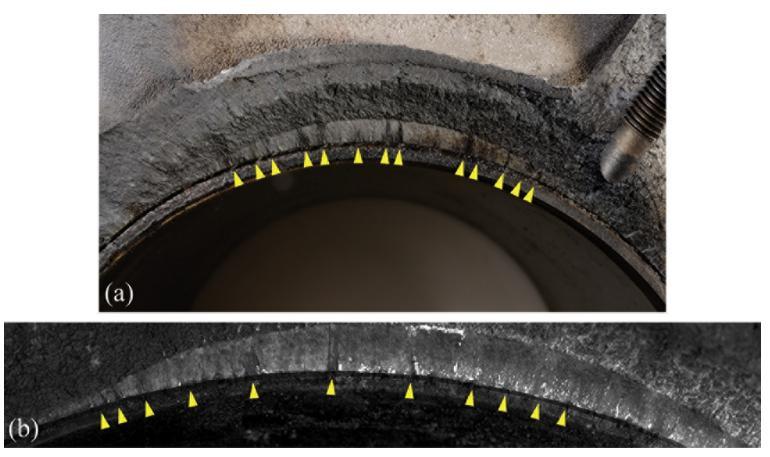
FIGURE 9.9

are marked with arrowheads in Figure 9.9a). The additional examination of fracture surface of the sector A under stereomicroscope confirmed that the fatigue crack initiated from different origins located on the inner edge of the CH I (Figure 9.9b). The fatigue crack had propagated slowly over this sector. The sector A has an obvious thumb-nail-shaped boundary with the sector B. The main macroscopic feature of the slant fracture surface of the sector B (Figure 9.10a), approximately 45° to the CH I axis, is a rough and dull texture, which suggests ductile fracture under mostly

(a) View of the sector A of the fracture surface depicting ratchet marks (arrowheads) and (b) stereomacrograph showing the sector A of the fracture surface with multiple ratchet marks along the inner edge of the CH I (arrowheads).

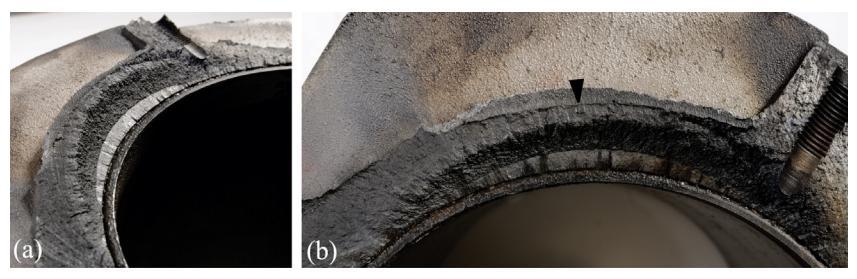
tensile loads. Moreover, a narrow rim of overstress fracture extends around almost the entire outer circumference of the slant fracture. However, in this stage of fracture life, the crack depth reached the outside surface of the CH I (arrowhead in Figure 9.10b). The sector C of the fracture surface revealed the presence of macroscopic crack beach marks (arrest lines), which suggest that the crack propagated in a fatigue mode (Figure 9.11). The sector D represents the fracture surface of unstable fracture with a rough, dull, and coarse grainy morphology, where the overload was the main fracture mechanism. This final overstress fracture of the CH I wall occurred when the crack had reached a critical size. The sector E covers about 20% of cross-section of the CH I. Actually, this sector is area of mechanically forced open fracture characterized by the bright appearance resulting from the reflective qualities of cleaved crystals. In addition, the visual inspection disclosed a varying degree of exposure of the fracture surface of the CH I, except sector E, was significantly contaminated by these gases. No evidence of macroscopic plastic deformations was found on the fracture surface.

(a) Macrograph showing the slant fracture surface of the sector B and (b) place where the crack depth reached the outside surface of the CH I (arrowhead).

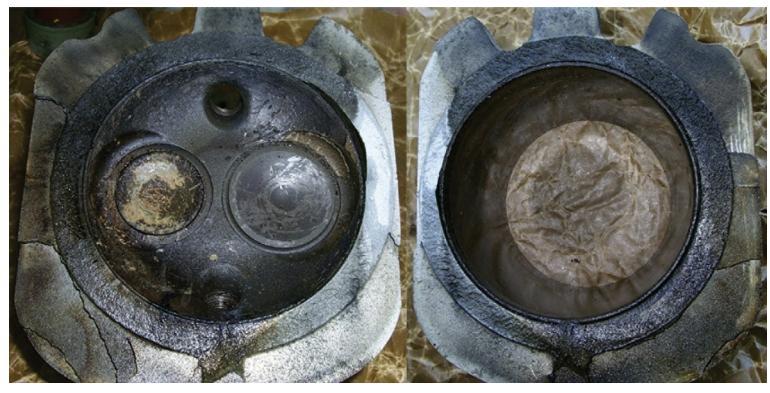
FIGURE 9.12

Three distinct areas of apparent morphologies were noticed on the mating fracture surfaces (Figure 9.12) of the CH II (marked as A, B, and C in Figure 9.13). A rather smooth and flat surface of the sector A, with clearly visible beach and ratchet marks (Figures 9.14 and 9.15), undoubtedly evidenced that the fatigue was involved. This sector extends about a quarter of the CH II circumference and appears to cross the

Mating fracture surfaces of the CH II obtained after the crack was mechanically opened.

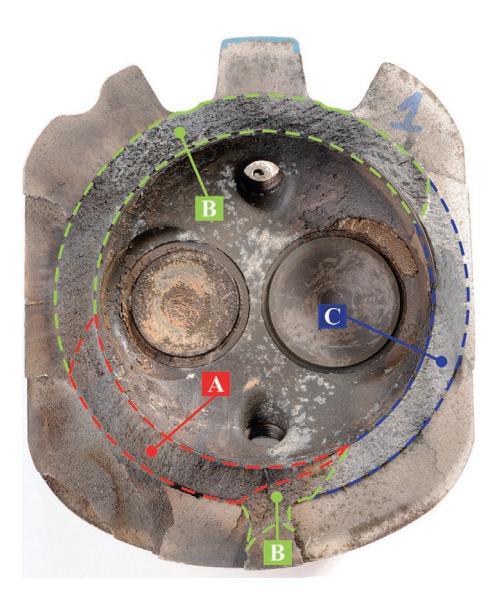
FIGURE 9.13

entire thickness of the CH II wall in the middle. By tracing back the beach marks, the fracture origin area was also found to be at the internal surface of the CH II. The fracture surface of unstable fracture, sector B, exhibited a rough, dull with coarse grainy morphology, which is common for an overstress fracture mode. This final overstress fracture of the CH II wall occurred when the total area of the crack had reached a critical size. The sector C of fracture surface, obtained after the crack was mechanically opened, was characterized by the bright appearance due to reflective qualities of cleaved crystals and represented about 25% of the CH II cross-section. Similar to the Failure Case I, areas of apparent fatigue and overstress fracture (sectors A and B) were also significantly contaminated by combustion gases. No evidence of macroscopic plastic deformations was found.

Macrograph showing characteristic morphologies on the fracture surface of CH II.

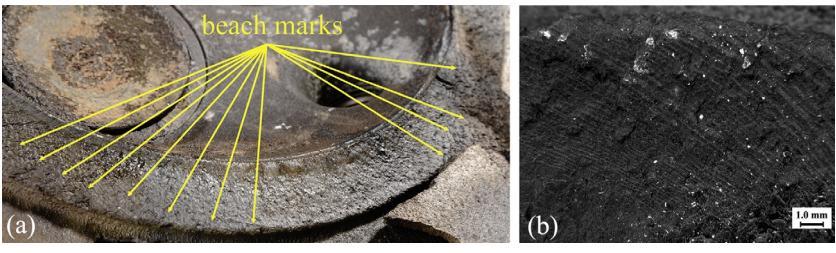
FIGURE 9.14

(a) Macrograph showing beach marks in the sector A of the fracture surface of CH II and (b) stereomacrograph of beach marks in the sector A.

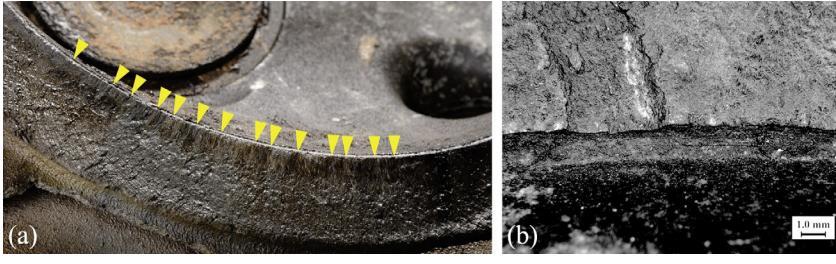
FIGURE 9.15

(a) Macrograph showing ratchet marks in the sector A of the fracture surface of CH II (arrowheads) and (b) stereomacrograph of ratchet marks in the sector A.

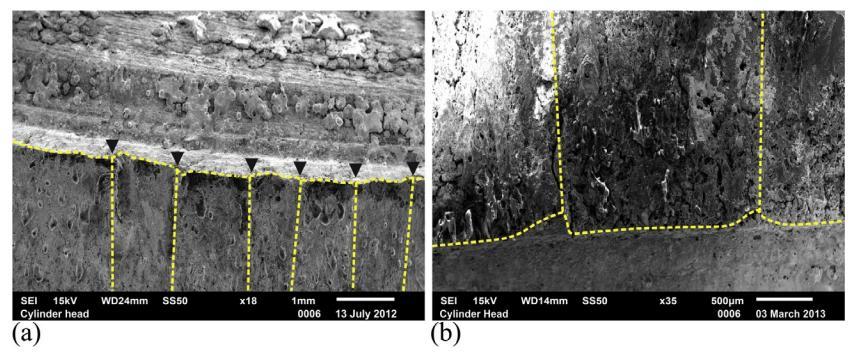
FIGURE 9.16

of deposits, the SEM examination of the most interesting areas of the fracture surfaces (sector A on fracture surfaces of the CH I and the CH II) revealed the fine ratchet marks along the entire fracture nucleation region on the both CHs inner surfaces (Figure 9.16a). In addition, this confirmed the macroscopic observation about the existence of multiple fatigue fracture origin sites (Figure 9.16b).

(a) Fatigue fracture surface of the sector A of CH I shows evidence of fine ratchet marks (arrowheads) and (b) one of the multiple fatigue origin sites on the inner surface of the sector A of CH II.

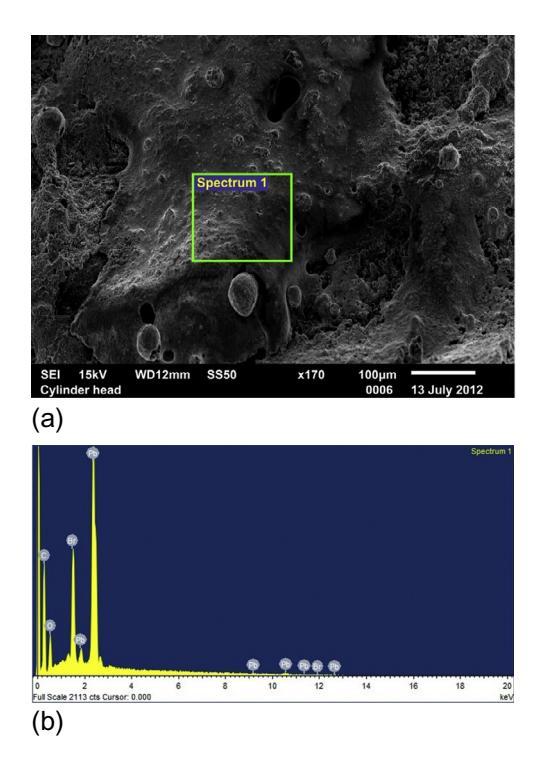
As mentioned in the previous section of the chapter, the mating fracture surfaces of the both CHs, CH I and CH II, were covered by large amounts of deposits (except the areas of mechanically forced opened fractures), which were impossible to remove using nondestructive methods. Therefore, the SEM examination did not provide detailed information about mechanisms leading to failures. Regardless of the presence

(a) Fatigue fracture surface of the sector A of CH I covered by deposits and (b) EDS spectrum from deposit (region marked in (a)).

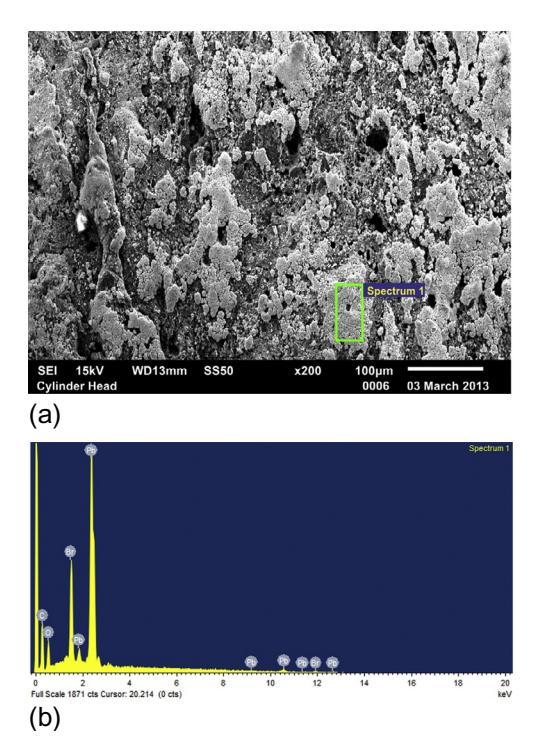
FIGURE 9.18

(a) Fatigue fracture surface of the sector A of CH II covered by deposits and (b) EDS spectrum from deposit (region marked in (a)).

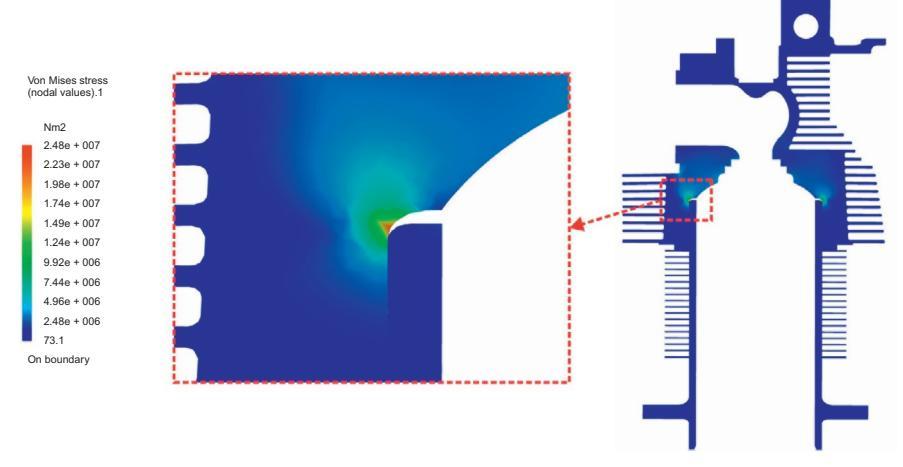
FIGURE 9.24

The stress distribution of the cylinder assembly was obtained according to the Von Mises stress criterion. The FE analysis confirmed that the crack origins were located at the most stressed area of the cylinder assembly (i.e., on the inner flange fillet of the exhaust side of the CH). The stress maximum value is 24.8 MPa, which is less than yield strength of 242.0 aluminum-casting alloy. However, this stress in combination with high concentration of shrinkage pores can lead the crack to initiate. The node where stress reaches the maximum value, Figures 9.24 and 9.25, corresponds to the central portion of sector A, Figures 9.8 and 9.13.

Stress distribution on the longitudinal section of the FE model through the node with maximum stress value.

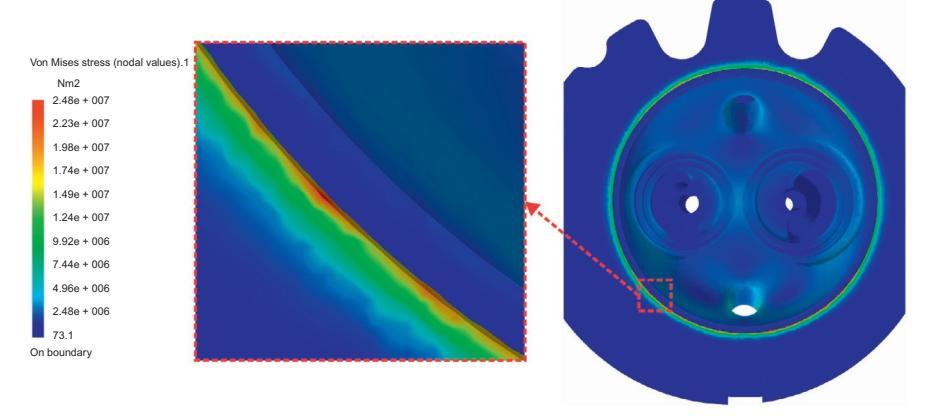
FIGURE 9.25

Stress distribution on the cross-section of the FE model through the node with maximum stress value.

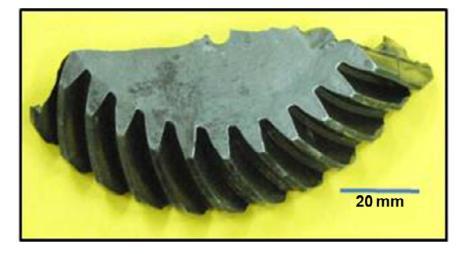
FIGURE 10.1

An abrupt failure of an engine bevel pinion was reported during test runs. Prior to the failure, the component completed approximately 1300 h of testing. Strip examination after the event revealed that a portion of the spiral bevel pinion of engine gear box was fractured (Figure 10.1) and ejected out of the test setup. This caused secondary damages to the front cover plate of the test assembly. The balance portion of the bevel pinion remained positioned in the pinion housing (Figure 10.2). However, the rotation of the bevel pinion was arrested. The engine pinion housing was sheared into two halves (Figure 10.3). Top end splines of the vertical quill shaft (mating with engine bevel pinion) were found completely worn out and the bottom splines (mating with engine gear box bevel pinion) were intact (Figure 10.4).

Fractured spiral bevel pinion piece found outside the test setup after failure.

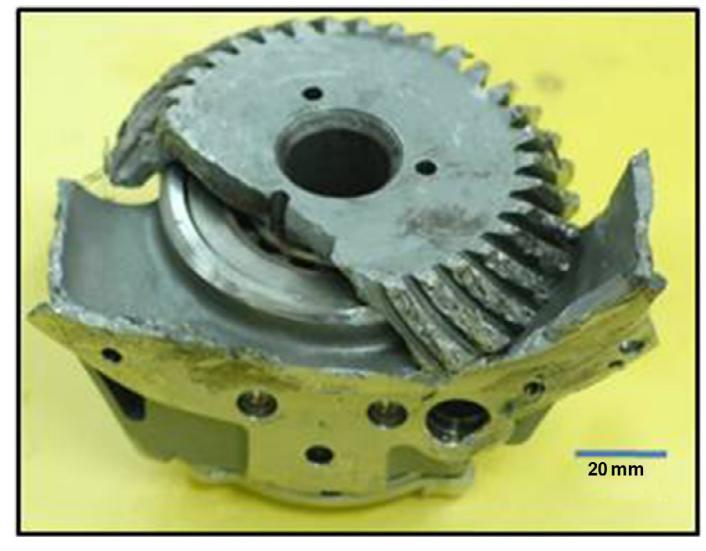
FIGURE 10.2 Fractured bevel pinion in the housing.

The pinion housing was found to have fractured into two pieces (Figure 10.2). The top portion of the pinion housing was deformed. The edges of the fractured piece revealed evidence of shearing (Figure 10.11) indicating that failure of the pinion was secondary in nature.

The bottom portion of the pinion housing was still holding a portion of the bevel pinion after the failure (Figure 10.2). Extensive damages (impact and abrasion marks) were noticed on this part as well (Figure 10.12).

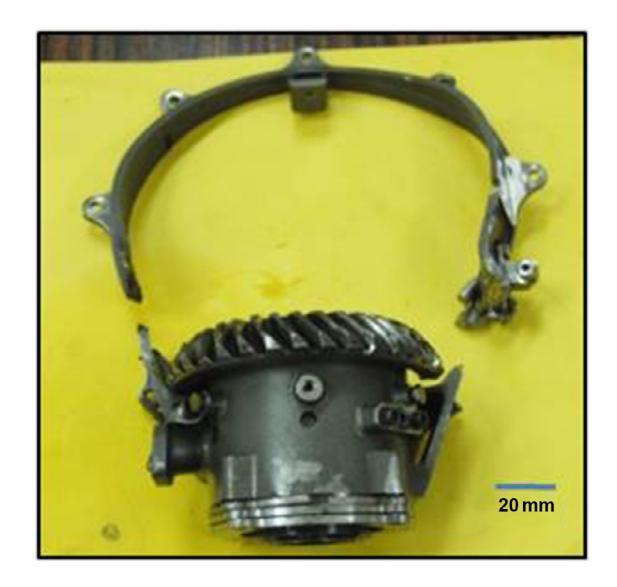
Photograph of the pinion housing after the failure.

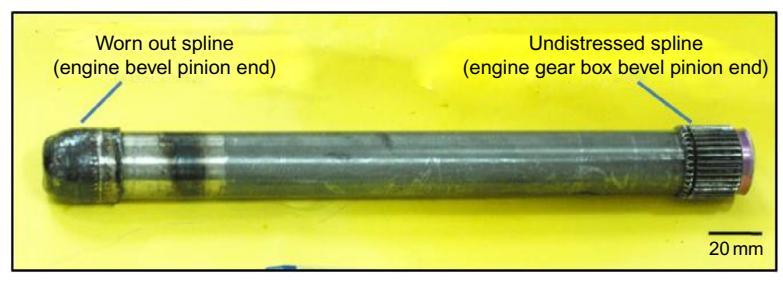
FIGURE 10.4

Photograph of the vertical quill shaft showing worn out splines and bluish tint on the shaft.

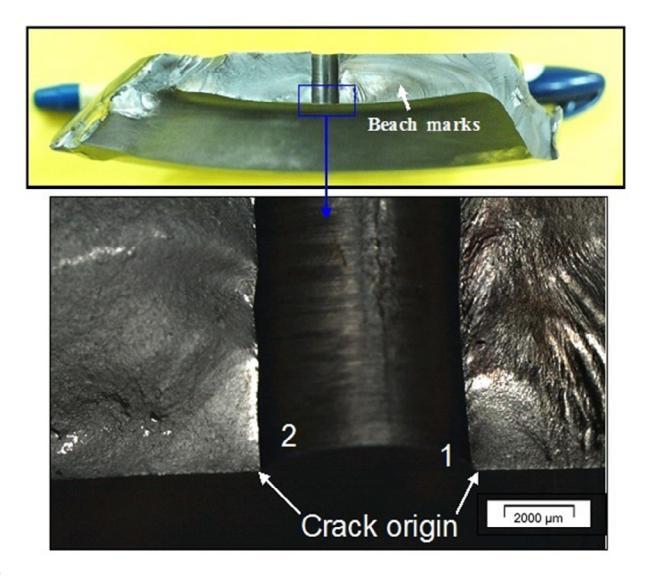
FIGURE 10.5

The fractured piece of the bevel pinion was observed visually and under stereobinocular microscope (Figure 10.5). The fractured surface revealed the presence of "clam shell marks" or "beach marks" indicating that the bevel pinion has failed in a progressive mode (i.e., fatigue). Tracing back the orientation of the beach marks, the crack origin was found to be at the bottom surface of the gear wheel where an extraction hole was present. It may be noted here that one crack front was at the right side of the extraction hole which was found to propagate almost the entire length up

Fractured surface of the failed bevel pinion showing beach marks and fatigue crack origin.

to the gear teeth (with crack origin at location 1 as shown in Figure 10.5). One more crack front was present at the left side of the extraction hole (crack origin region indicated as 2 in Figure 10.5). In this case, the fatigue crack was found to propagate a short distance (approximately 15-20% of the fractured surface). The remaining area was found to have fractured by overload. A third crack front was identified at the gear teeth region; i.e., at the extreme end of the first crack front (Figure 10.6). The crack propagation area for this crack front was also relatively smaller than the first crack front. Considering the fact that fatigue crack propagation region was higher for the first crack front than the third crack front, it appeared most probable that the crack front "1" had originated first and then propagated. As it reached the gear teeth root region, the high-stress concentration at this region had resulted in the third fatigue crack origin.

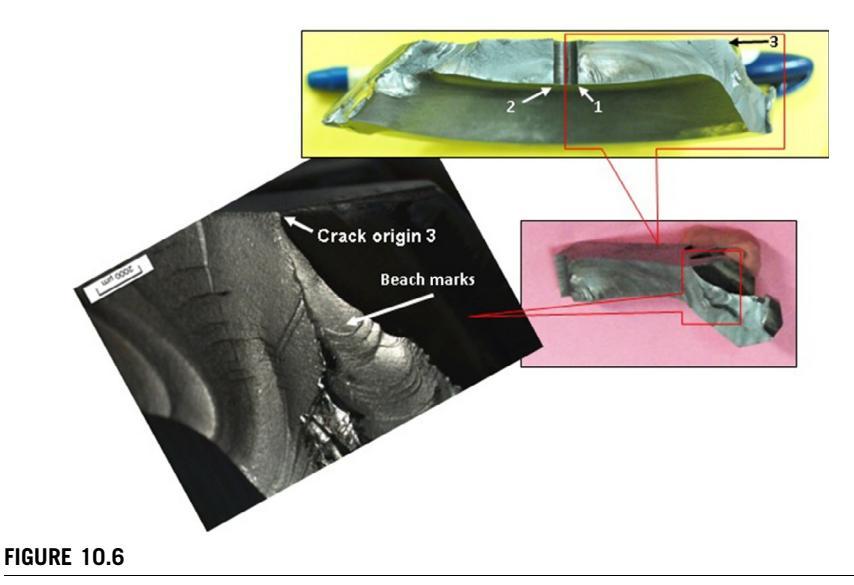
Fatigue crack at the gear teeth root region.

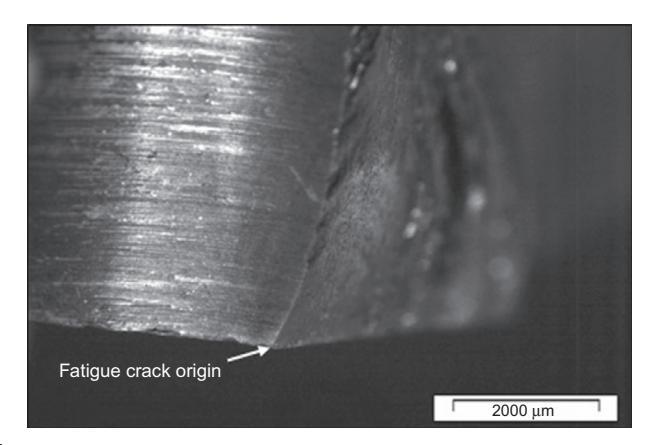
FIGURE 10.7

The extraction hole was studied further to ascertain if any abnormalities were present which might have caused the fatigue crack initiation. The extraction hole surface at the fatigue crack origin region was free from any distress (Figure 10.7).

Condition of the extraction hole at the fatigue crack origin 1.

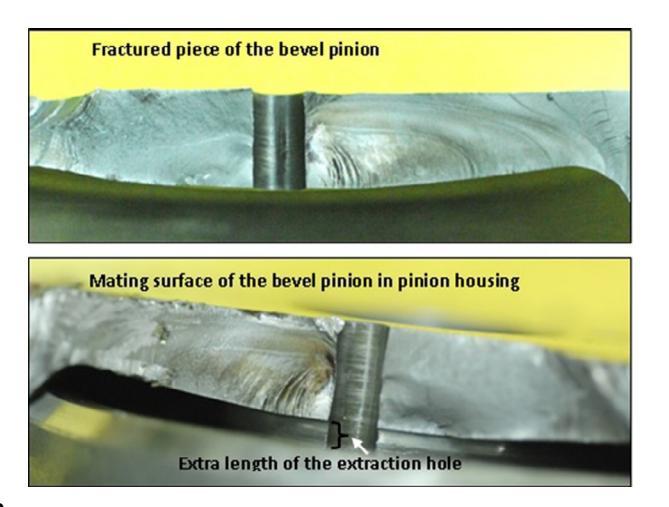
FIGURE 10.8

When the mating surface of the fractured bevel pinion was observed, it was noticed that the extraction hole continued further in length (Figure 10.8). This resulted in an "L"-shaped geometry at the gear shaft-gear wheel junction (Figure 10.9). It must be noted here that the fatigue crack origins at both sides of the extraction hole were located at the corner of this "L" shape. A photograph of the bottom surface of the bevel pinion at the other extraction hole is presented in Figure 10.9. The edges of the holes were found to be very sharp.

Mating fractured surfaces of the bevel pinion showing more length at one side of the extraction hole.

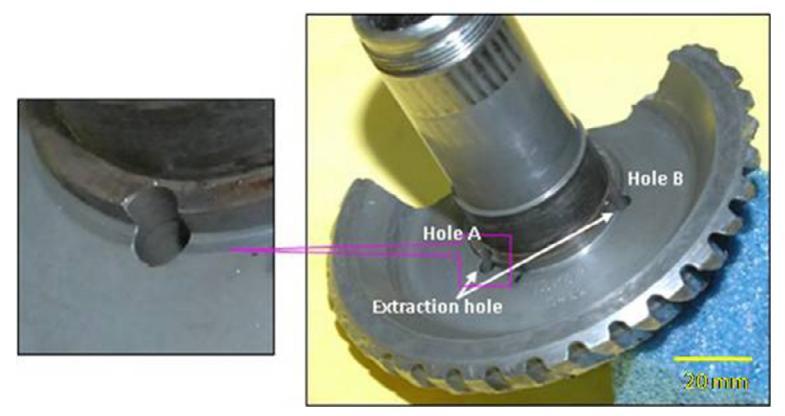
FIGURE 10.9

Extraction hole geometry at the bottom of bevel pinion (gear shaft-gear wheel junction).

checked for presence of any abnormalities under stereo-binocular microscope. Both of them exhibited the presence of cracking around the gear shaft extending from both the corners of the "L"-shaped contour of the hole (Figures 10.9 and 10.10). Hole "A" revealed the existence of multiple cracks from the edge. This observation was later reconfirmed by magnetic particle inspection (MPI). Sharp machining marks were also observed near hole "A."

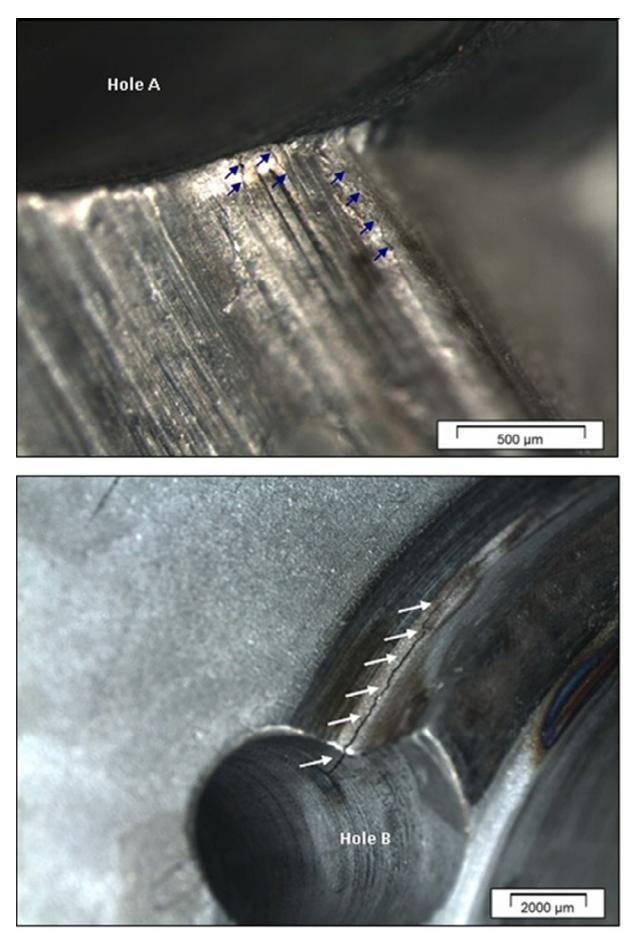
FIGURE 10.10

Crack (indicated by arrows) at edges of the extraction hole of the bevel pinion.

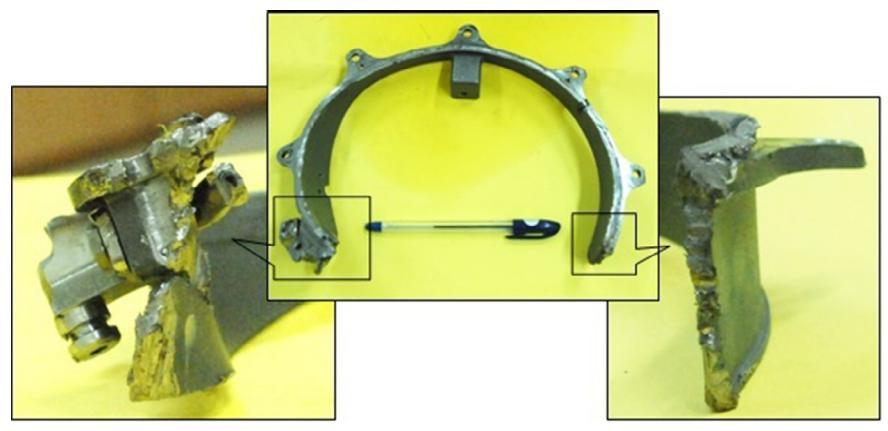
FIGURE 10.11 Top portion of pinion housing after failure.

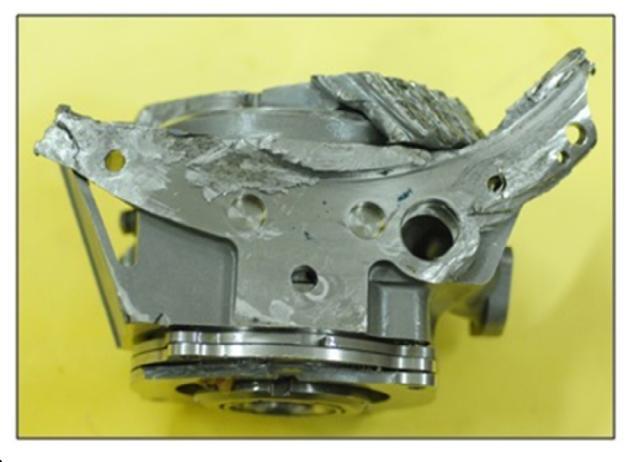
Secondary damages on the pinion housing.

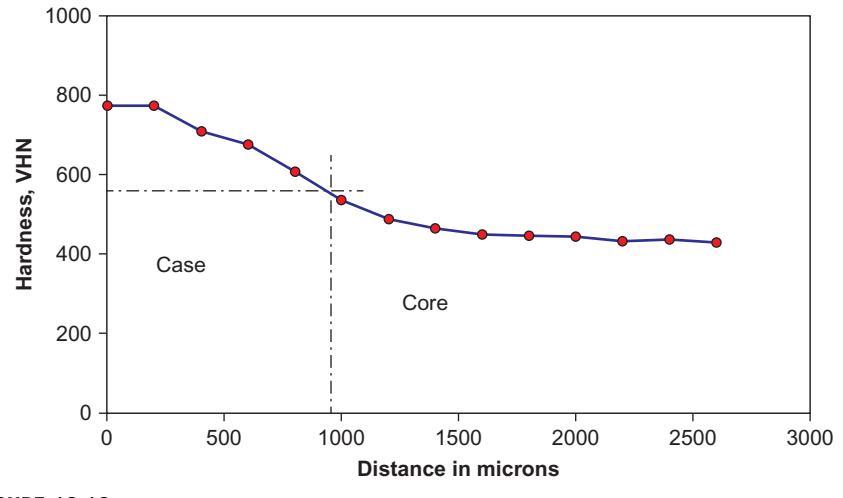
A suitable sample was cut from the gear and prepared metallographically for a microhardness measurement. The case hardness on the flank region of the gear teeth was 62-63Rc, where as core hardness was 42-44Rc. Case depth was found to be around 0.9 mm (Figure 10.13) and meeting the specification requirement. Core hardness indicated that the material was in hardened and tempered condition. Optical microstructure also revealed the presence of a tempered martensitic structure at the core (Figure 10.14).

Microhardness profile at one of the gear teeth flank region.

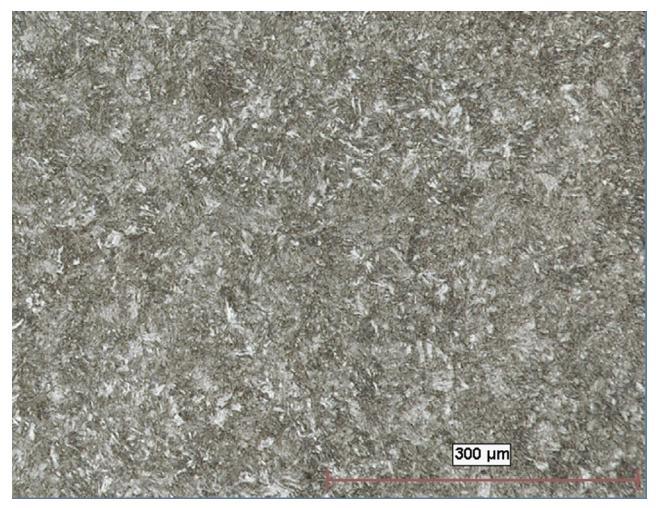
FIGURE 10.14

Microstructure of the gear material at core revealing tempered martensitic structure.

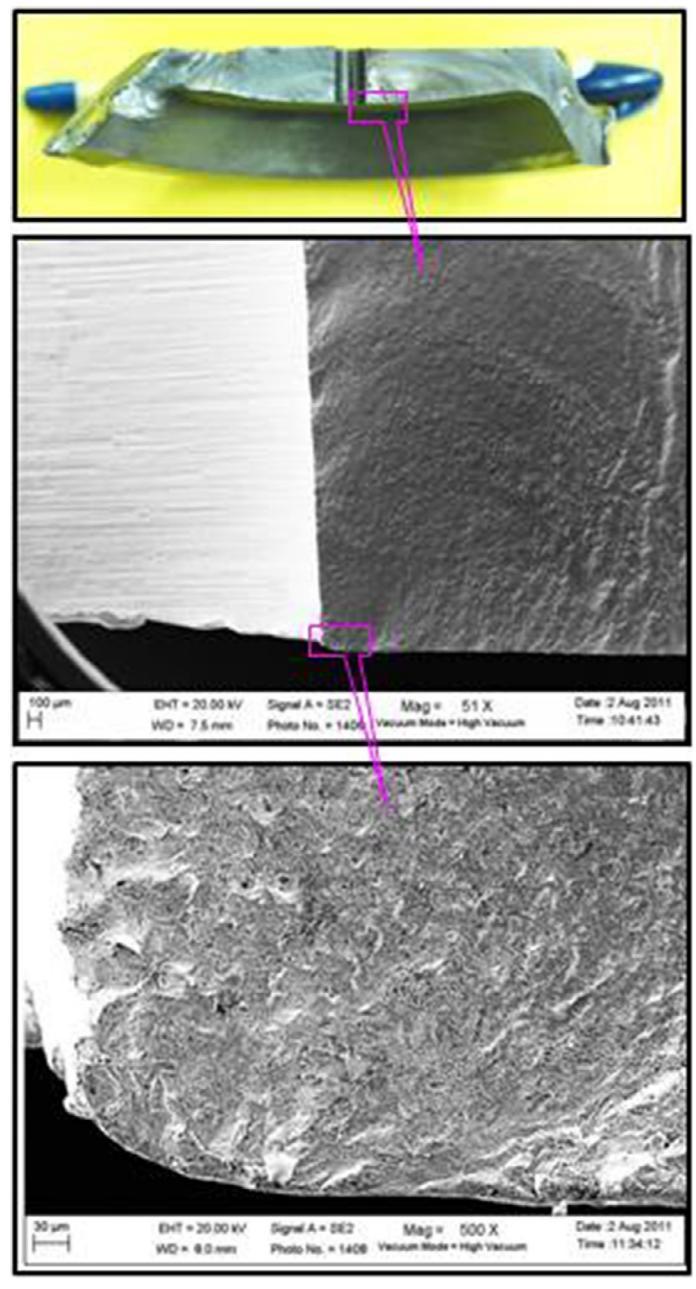
crack front "1" (Figure 10.5) under SEM is presented in Figure 10.15. Semiquantitative composition analysis using energy-dispersive spectrum (EDS) at the crack origin region also confirmed that the composition was conforming to the low-alloy case-carburizing grade steel (Table 10.1).

Crack origin "1" under scanning electron microscope.

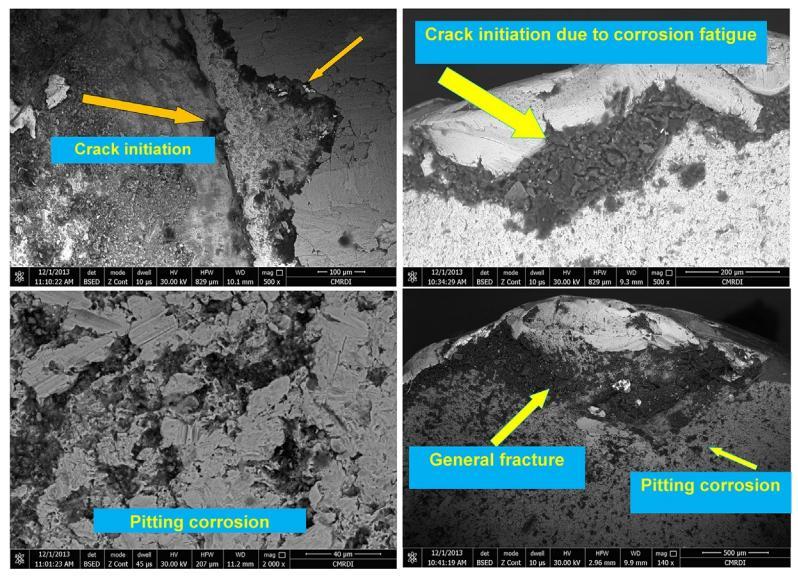
FIGURE 11.3 SEM analysis of the bolts showing well-defined pitting corrosion and fracture.

deposits. SEM analysis of the bolts specimen showed well-defined pitting attackand transgranular fracture which point to the occurrence of corrosion and severe vibration. The cracks initiation and fracture have also been evidenced (Figure 11.3). SEM-EDS analysis revealed formation of pitting corrosion which can be attributed to the presence of high chloride and sulfur content as explained in Section 3.3.

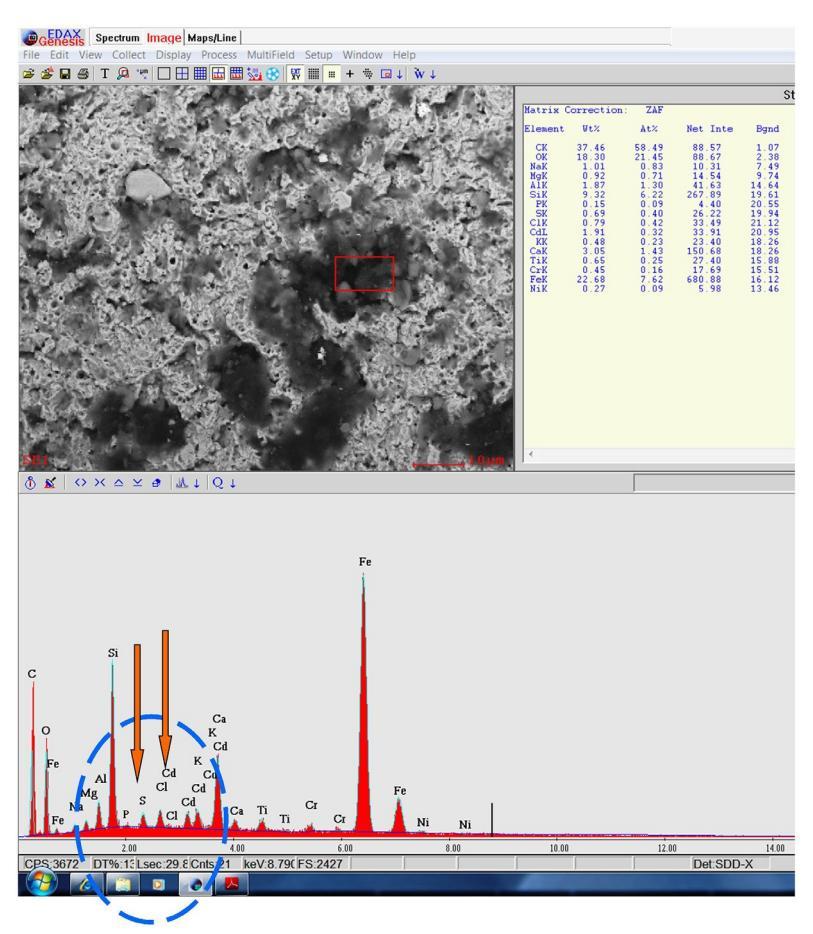
FIGURE 11.4

The microprobe analysis of the deposits (dark color) formed at the pitting corrosion areas was performed using EDS. EDS provides specific information on the chemical composition of the deposits, which can be correlated with data on media contamination and the chemical composition of the bolts material. The analysis of deposits formed at the bolts specimen revealed presence of corrosive sodium chloride and sulfur at the pitting zones (Figures 11.4–11.6). Chloride and sulfur are well-known reasons for occurrence of pitting corrosion on steel substrates.

Surface analysis using EDS of the deposits formed over the pitting zone.

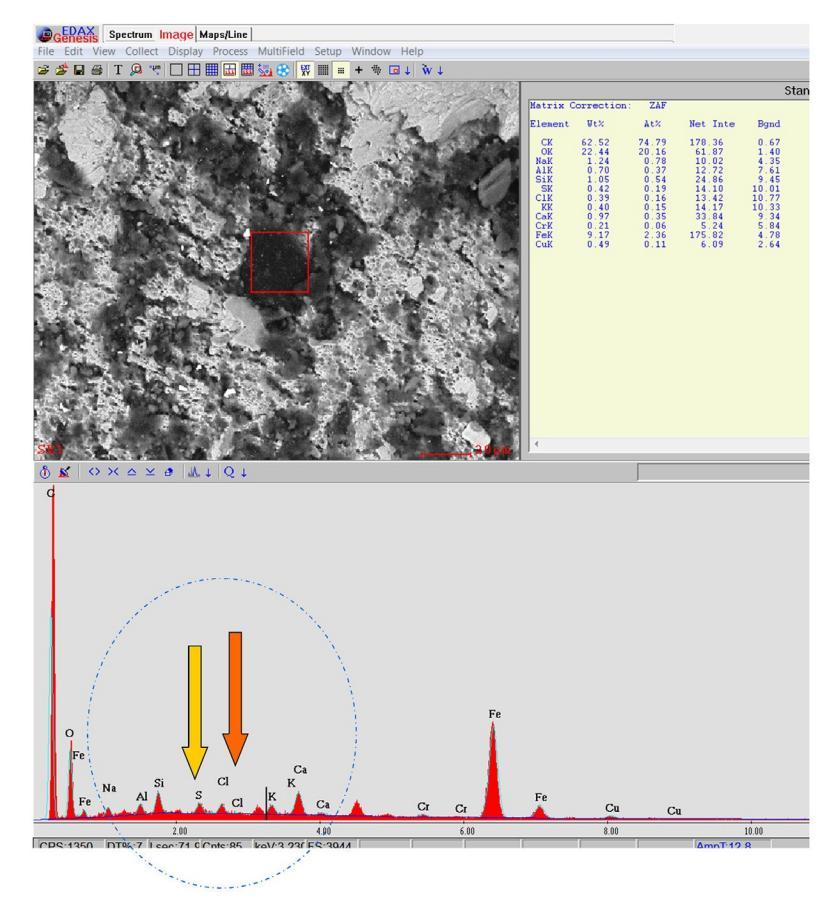
FIGURE 11.5

Surface analysis using EDS of the deposits formed over the pitting zones.

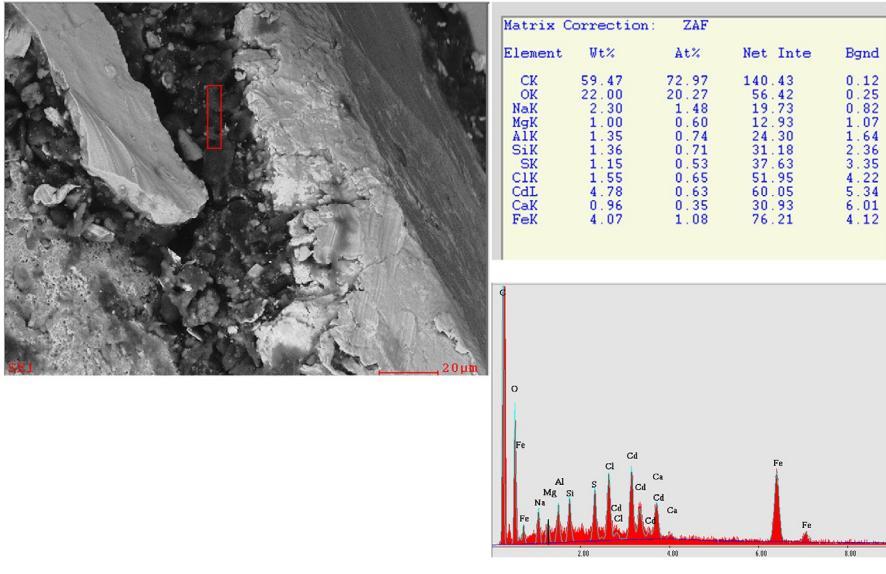
FIGURE 11.6

Surface analysis using EDS of corrosion fatigue crack initiation zones.

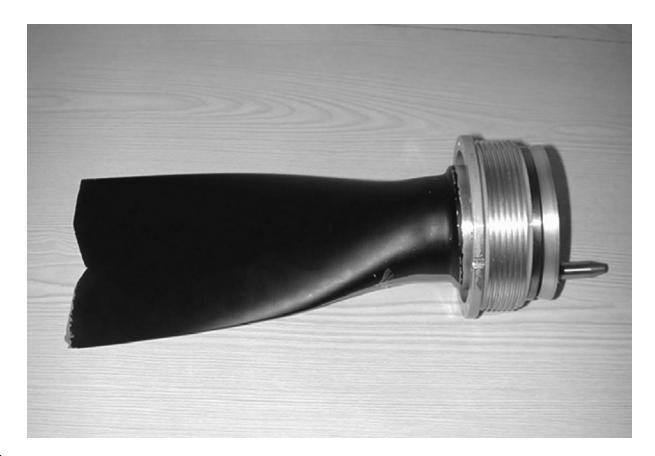
FIGURE 13.3

The fracture line separated the blade into two pieces. The upper piece was lost during the accident and the lower piece stayed connected to the propeller hub. Fracture was located at one third of the total length from the blade root as seen in Figure 13.3. There were many deformation points on the blade surface as given in Figure 13.4. The deformed areas provided the intense clue that the failure was induced by foreign object damage.

Broken propeller blade.

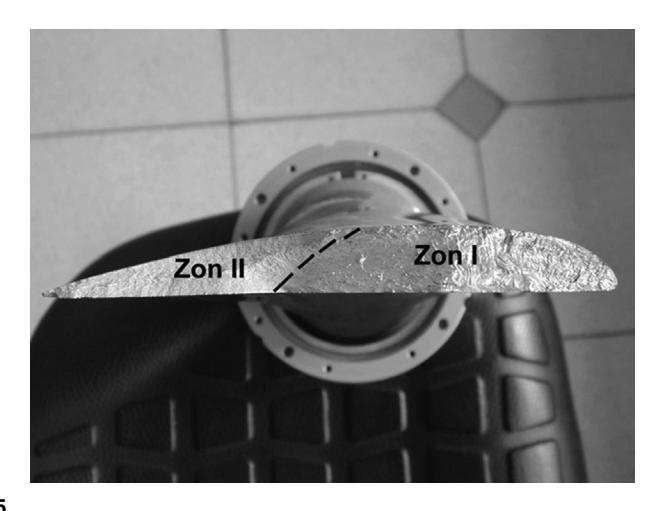
FIGURE 13.5

Crack surface had two different planes which were tagged by Zone-I and Zone-II as given in Figure 13.5. Zone-I was at the leading edge side and perpendicular to the XZ plane, whereas Zone-II was at the trailing edge side and had about 45° angle to the XZ plane as seen in Figure 13.6. The surface characteristics of these two planes were relatively different. Zone-I had brighter surface due to its smooth surface, whereas Zone-II had dull surface resulting from roughness making the light less reflected.

Zone-I and Zone-II on the crack surface of the propeller blade.

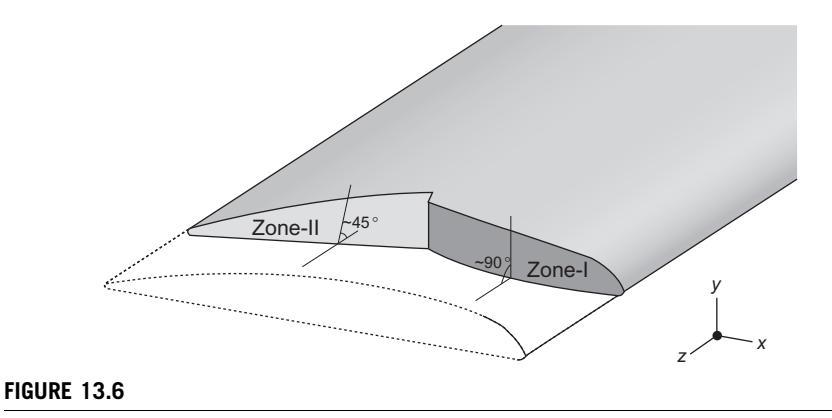
Characteristics of the crack surface.

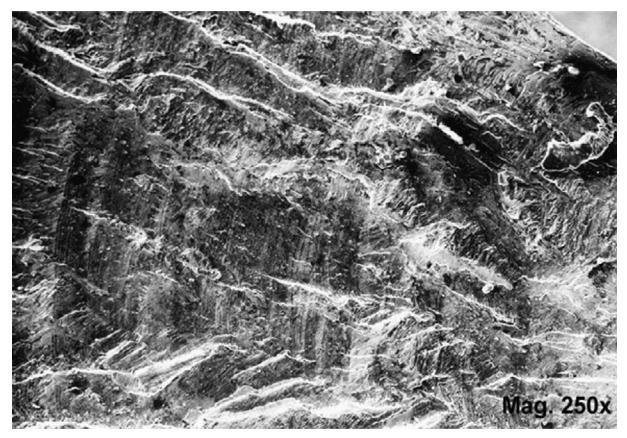
Examination of the Zone-I showed that the fatigue striations were obvious under the microscope as seen in Figure 13.7. These striations were in the semi-elliptical circles form and result of the cyclic loadings. The striation circles overspread from a center point, which was the starting point of crack propagation, located at the lower surface of the blade. Generally, cracks launch from a surface flaw rather than in-body flaws and cyclic loadings accelerate the crack growth process. These flaws can be scratches, notches, burrs, or dents where the local stresses are prone to increase. Geometrically, these kinds of discontinuities cause notch effect by the effect of increased local stresses and facilitate the microcrack formations. Once a crack starts off, it moves on until failure of the structure. In addition to this, since the discontinuities are formed as a result of an impact, strain hardening takes place on the impact areas. Locally strain-hardened areas increase the hardness of the material and initialize brittle crack propagations easily [12].

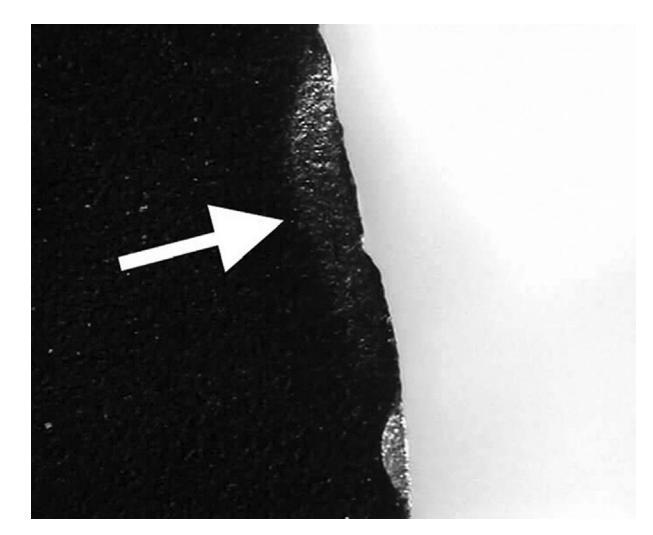
FIGURE 13.8

In the broken propeller blade case, the starting point of the crack was a dent on the lower surface as shown in Figure 13.8. The dent size was explained by a depth of 140 μ m and a width of 3060 μ m.

Crack propagation point.

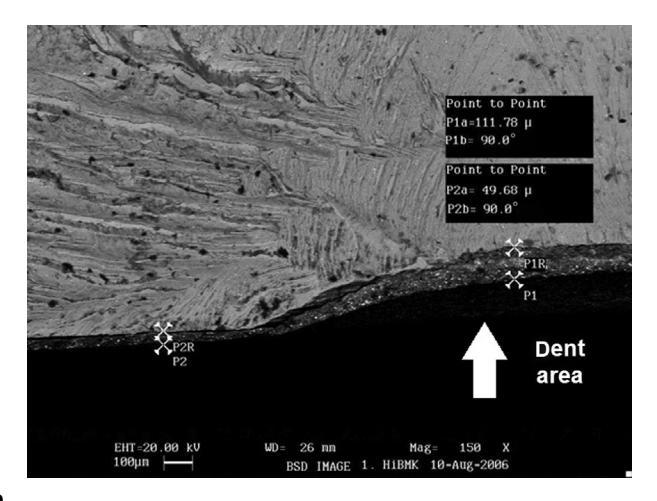
FIGURE 13.9

After discovering the crack propagation source, investigation was focused on this point to reveal the root cause. The findings were weird that the dent was covered by paint. Figure 13.9 shows the SEM image of the paint layer on the dent area.

Maintenance reports showed that the propeller was inspected 50 flight hours before the accident. In the inspection process, blade paint was removed from the part surface and then inspection was performed against the surface problems. However, there was no defect detection in the maintenance reports. If the dent had been formed before the last inspection, residual paint should have been on the crack surface. Because after the inspection, the blade was painted again therefore, the microcracks on the dent area must have included paint debris. On the contrary, microcracks were such tiny that the paint could not penetrate into despite the capillary effect [13].

SEM image of dent area.

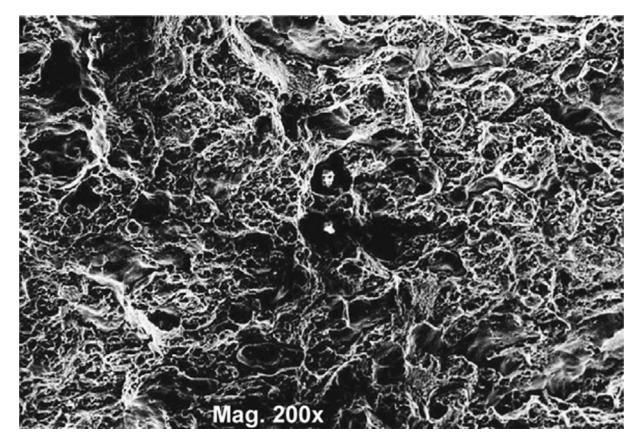
FIGURE 13.10

SEM image of the propeller blade Zone-II.

In the examination of Zone-II, the crack surface had dimpled appearance as seen in Figure 13.10. This kind of crack surface including little holes indicated a ductile-type fracture under monotonic loadings [4].

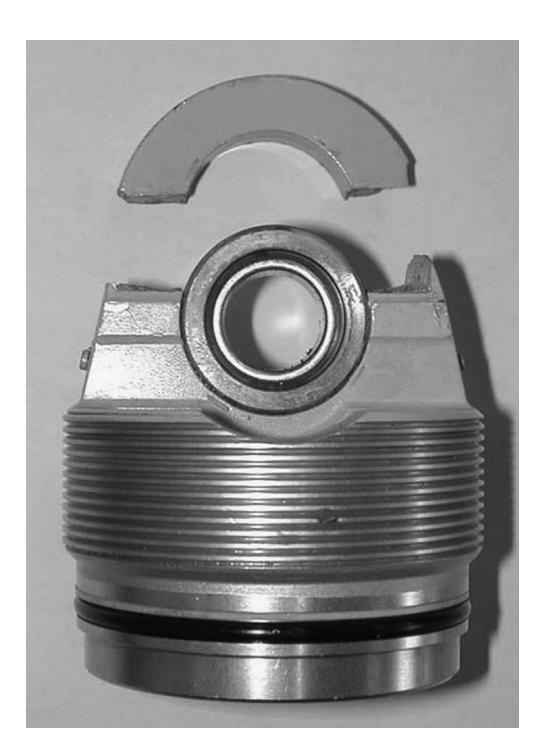
FIGURE 13.13

In this case study, one of the flaps lost the mobility during the flight. Fortunately, the aircraft could make the landing safely and the investigation procedure was carried out to find the root cause of the problem. First inspection revealed that the cap section of the actuator rod was broken. The rod had a ball bearing inside the hole drilled on the cap section and the failure occurred near along the diameter of the hole. Figure 13.13 shows the failed section of the actuator rod.

Macroscopic examination showed that the cap section of the rod was broken clearly and that there were no evidence of dent, scratch, or deformation neck in the vicinity of the crack. General condition of the rod was good out of the crack zone. There was no evidence of dirt explaining corrosion on the crack surface. Corrosion on the parts can cause fatigue damages particularly in contact surfaces (e.g., surface between hole and ball bearing). Therefore, avoiding of contact fatigue is very important for the structural reliability. Corrosion fatigue is formed by the combined effect of cyclic stress and corrosive environment in the structure. This term should not be confused with stress corrosion crack. In corrosion fatigue, corrosion decreases the strength of the material and

Failed section of the actuator rod.

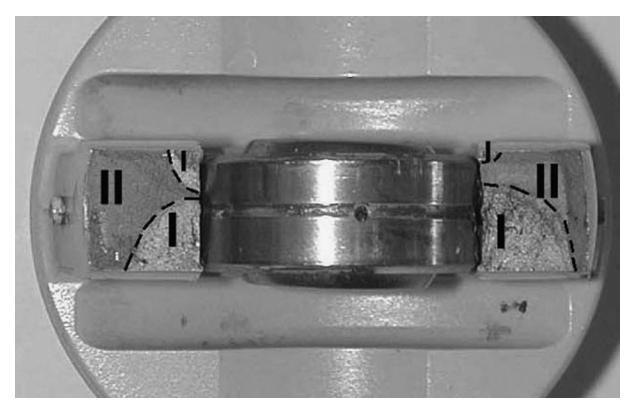
FIGURE 13.14

At the beginning of the investigation, the crack surface was divided into two regions due to different surface characteristics. The smooth regions with shiny appearance were labeled by Zone-I and the dull regions were labeled by Zone-II as seen in Figure 13.14.

Zone-I and Zone-II on the crack surface of the actuator rod.

Loading characteristic was also understood from the investigation that the cap section of the rod was subjected to double bending in the service. There were four crack initiation sites on the fracture surface. Furthermore, as seen in Figure 13.14, the fatigue areas (Zone-I) were wider at the bottom side than at the upper side of the fracture surface that unsymmetrical bending acted on the component.

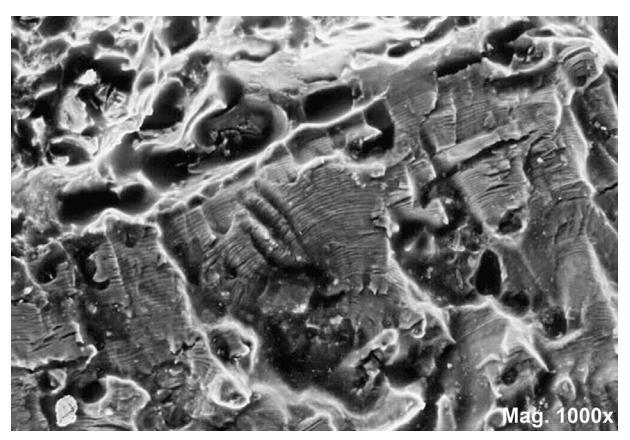
FIGURE 13.15

In the microscopic examination, stereo microscope and SEM images were employed. The images were evaluated and for Zone-I, it was stated that there were fine fatigue striations which were stemmed from cyclic loading as seen in Figure 13.15. Propagation points of the striations indicated that V-shaped dents around the hole had started the crack growth (Figure 13.16). The V-shaped dents were formed at the junction of the hole and the ball bearing to fix the bearing secure inside the hole.

SEM image of the actuator rod Zone-I.

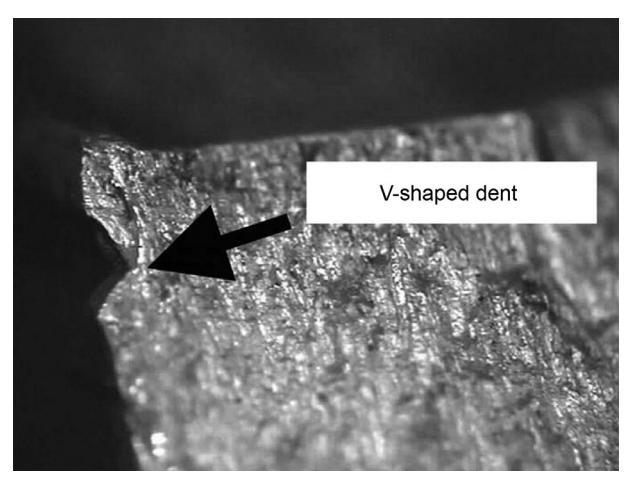
FIGURE 13.16

V-shaped dent as crack propagation point.

According to the investigation results, fatigue crack initiation was stemmed from the V-shaped dents which were design errors to constraint the ball bearing in the hole. Microcracks nucleated in the sharp root of the dents and propagated by the effect of cyclic loadings in the part. Finally, the cross-sectional area was so reduced that the rod cap ruptured.

The problem source was found as the V-shaped dent which accumulated the stress and expedited the crack growth. The V-shaped dent was a design error, which was performed by squeezing operation in assembly stage, and must have replaced by a safe method. Figure 13.18 shows a recommended forming method with larger root radius to distribute the stress accumulation while constraining the ball bearing inside the hole. Additionally, locations of the squeezing operation were very important in terms of failure since the maximum stresses affect certain sections of the rod cap. Locations of the V-shaped dents are given by circles and the recommended locations where the stresses are less during the service conditions are given by lines in Figure 13.19.

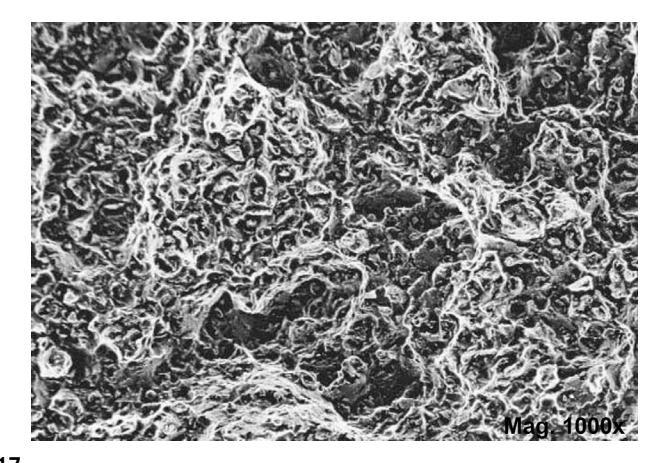
FIGURE 13.17 SEM image of the actuator rod Zone-II.

In the Zone-II examinations, the failure was explained as a typical ductile fracture. SEM images showed that the Zone-II had rough surfaces including equiaxial dimples as shown in Figure 13.17. These surface characteristics explained that the component was subjected to uniaxial tensile loading rather than shear loading. Because, ductile materials develop microvoids inside the body and since the loading

acts perpendicular to the fracture surface, the microvoids are elongated in the normal direction of the fracture surface. Fracture line intersects the microvoids and they are seen as spherical dimples under the microscope. However, in the shear loadings, dimples are seen in elliptical or C-shaped form because of the horizontal elongation of the microvoids with respect to the fracture surface.
