Handbook of Materials Failure Analysis With Case Studies from the Aerospace and Automotive Industries Handbook of Materials Failure Analysis With Case Studies from the Aerospace and Automotive Industries

Abdel Salam Hamdy Makhlouf

Mahmood Aliofkhazraei

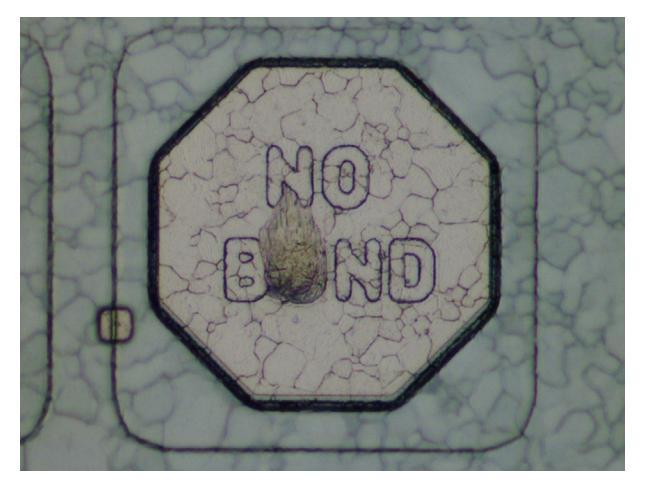
FIGURE 15.14

The devices in this case are dies from wafers used for higher level component construction. The dies are tested using probes which make contact with the die pad surfaces (Figures 15.14 and 15.15). Test failures reached 100% for some wafers and extensive failure analyses were initiated. SEM/EDS was chosen as the initial investigatory technique. Both the pad surfaces and the test probe tips were thusly characterized (Figure 15.16).

Probe mark on die after test failure.

The root cause in this case was determined to be implantation of etchant gas atoms into the aluminum pads. Fluorine in particular catalyzed the formation of electrically insulating aluminum corrosion products. These built up over time on the test probe tips leading to the observed failures. The questionable wafers were quarantined and the test probes replaced. These measures proved to mitigate the failures.

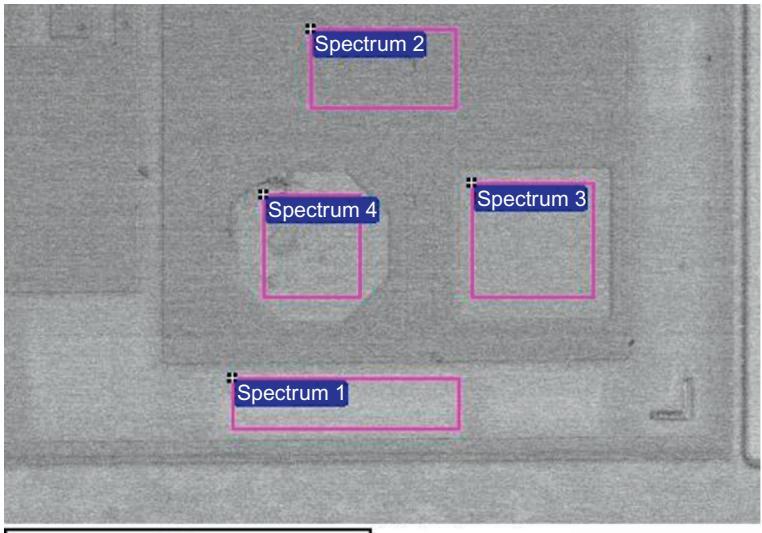
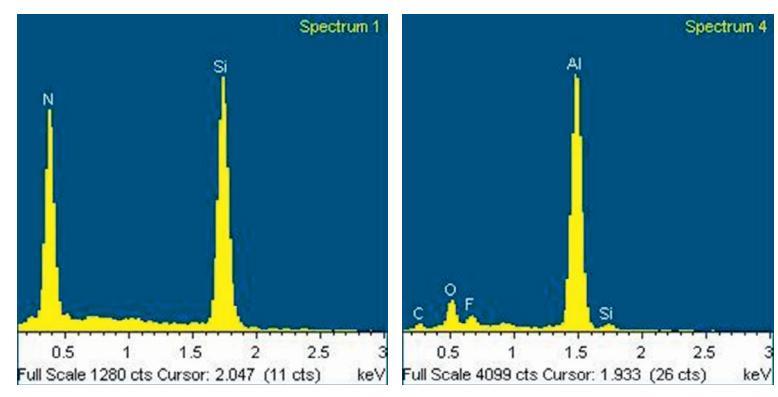
FIGURE 15.16

Spectrum 1 displayed in Figure 15.16 is that of a noncontact surface of the die. It is consistent with the expected silicon nitride passivation. Spectrum 4 is of a contact surface. Of particular note is the detection of fluorine which was completely unexpected (C, Al, and Si were easily rationalized, while detection of O was troublesome). When the probe tips were analyzed (not shown), sulfur was detected in addition to fluorine. Neither fluorine nor sulfur was expected. At this stage, it was clear that contamination at electrical contact surfaces was the cause of the test failures.

EDS analyses were obtained by rastering the areas shown for spectra 1 - 4. Spectrum 1 is of a non-contact area and displays the expected elements Si and N of silicon nitride passivation. Spectrum 4 is of a contact area and the detection of carbon (C), oxygen (O), and fluorine (F) in addition to the aluminum metalization are indicative of the presence of contamination.

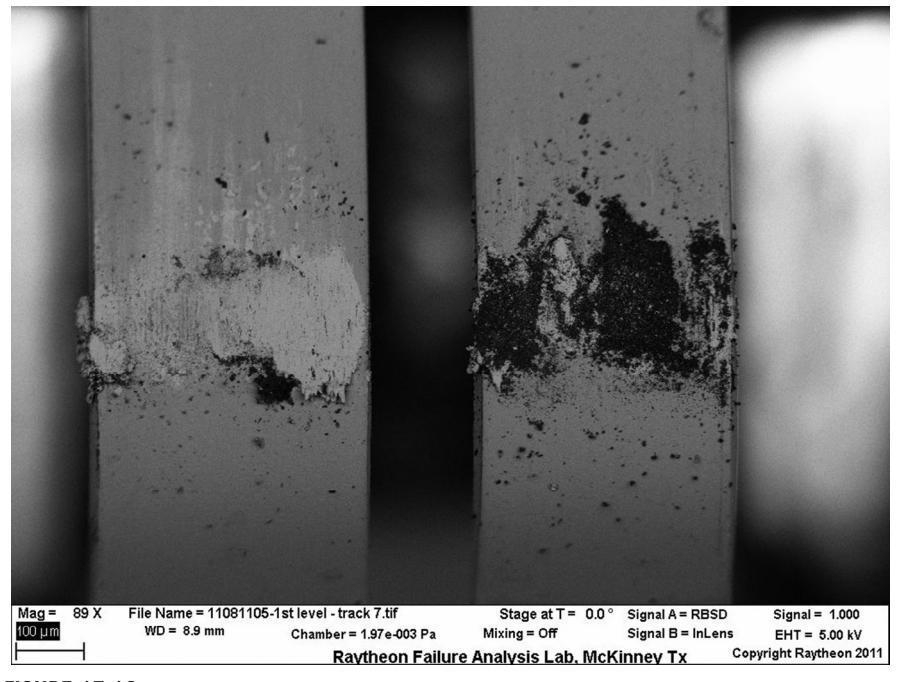
Displayed in Figure 15.18 is the condition of the brush contact surfaces as revealed by SEM imaging. The lighter colored areas, at the contacts interfaces (contact was made at a region in the middle of image), result from the presence of gold which was transferred from the platter contacts. The darker residues result from the presence of lower atomic weight elements such as silicon, oxygen, and carbon. Figure 15.19 was a typical EDS spectrum recorded from these areas.

SEM image of residues on brush surfaces.

Corrective actions included changing of the platter polymer to one that was not silica particle filled, removing silicone potting materials from the construction, and application of a different contact lubricant. These measures, along with others, lead to complete resolution of these failures.

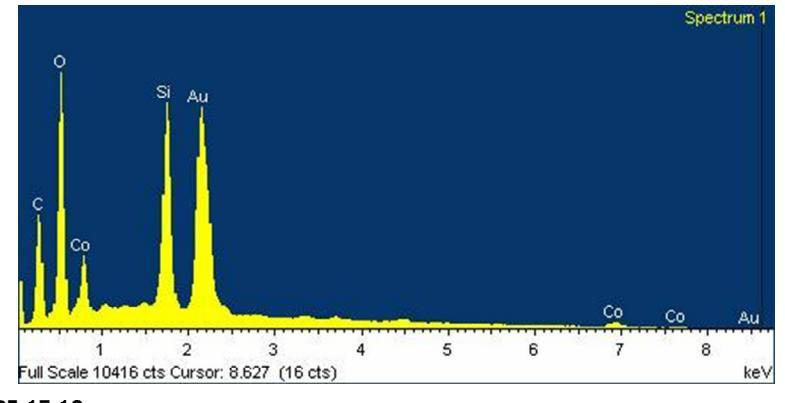
FIGURE 15.19

Typical EDS spectrum of residues on brush contacts.

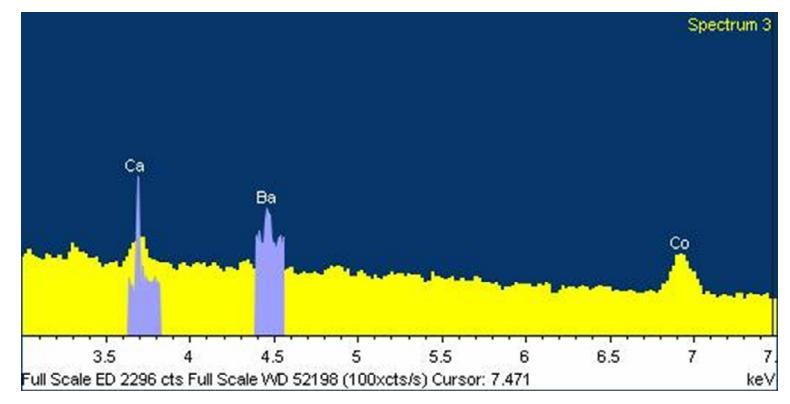
FIGURE 15.20

Figure 15.20 shows that barium and calcium were detected in the contact residues. This supported the supposition that grease additives contributed to the residue formation.

WDS spectrum showing the presence of calcium (Ca) and Barium (Ba) in the contact surface residues.

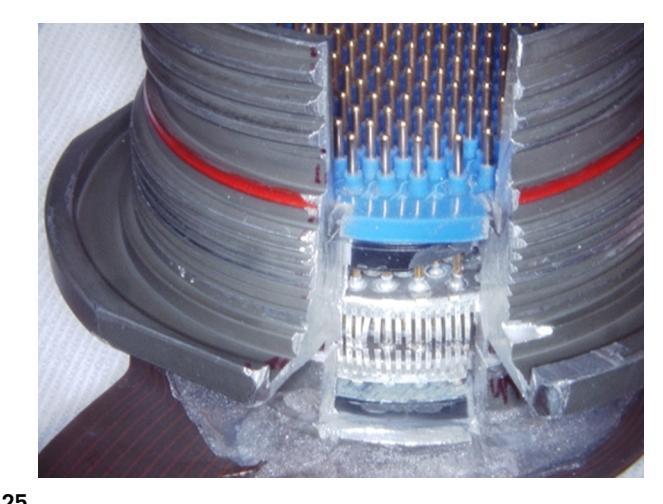
The connector displayed in Figure 15.25 has three distinct cavities internal to the construction. Additionally, a silver metal grounding ring encircles these cavities. Closer inspection revealed extreme corrosion and electromigration between the pins and from some pins to the case (Figures 15.26–15.28).

As shown, Figures 15.25 and 15.26, electromigration of lead from tin/lead solder as well as silver from the grounding frame was noted on the internal cavity surfaces of the connector. For such phenomena to occur, the connector must have had power applied while wet, or at least with significant humidity present [13]. Discussions with the customer revealed that the flex circuits and connectors had passed through an in-line cleaner system. This led to the belief that the ingress of cleaner chemicals, which cannot be washed out by the DI rinse phase, accounted for the failures. The saponifier, in particular, would accelerate these phenomena as it is both corrosive and an electrolyte. Chemical investigations started with the collection of Raman

FIGURE 15.25
Overall construction of connector after a section was removed.

The findings of in-line cleaner marker compounds, as revealed by analysis of the relevant mass spectra, verified that ingress into the connectors coupled with applied voltage lead to the reported failures (Figure 15.30). Remediation in this case involved purchasing screw caps from the supplier which were put over the tops of the connectors prior to exposure to in-line cleaning operations thusly eliminating cleaner intrusion.

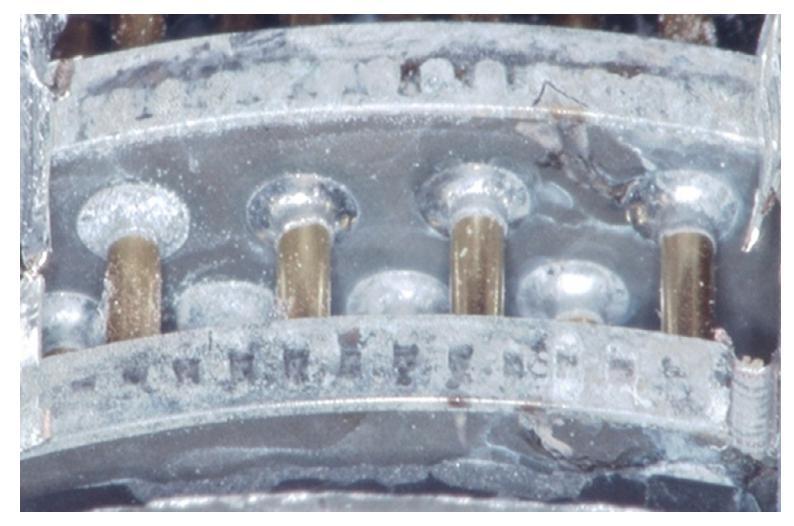
FIGURE 15.26

Note white corrosion residues.

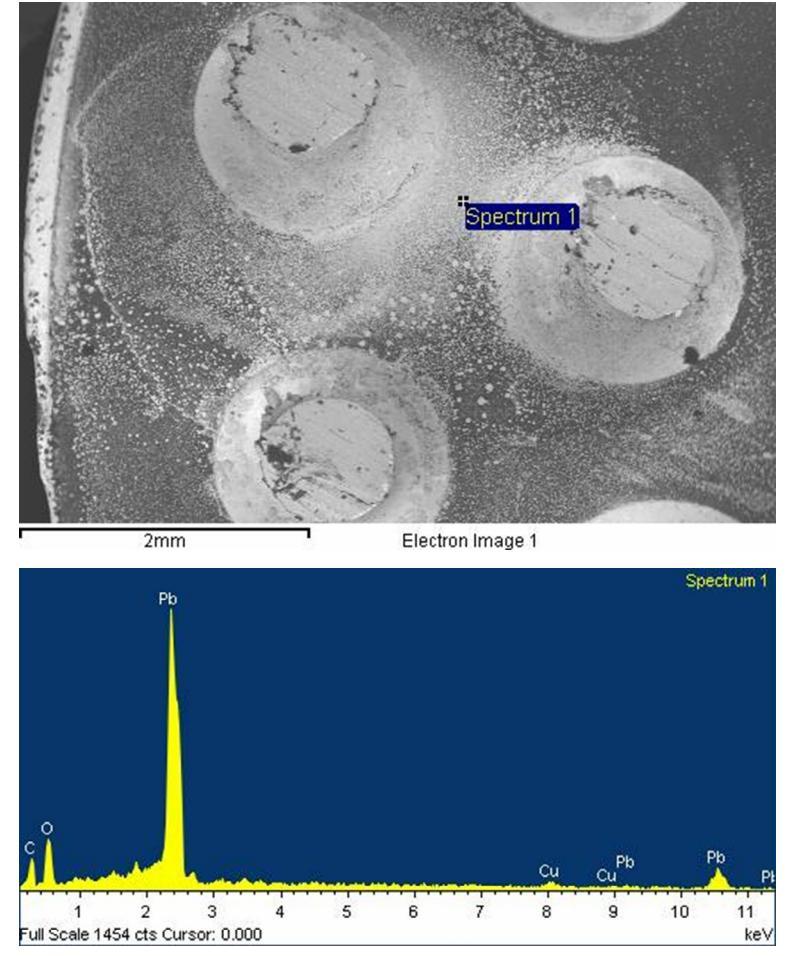
FIGURE 15.27

Spectrum 1, collected from the spot indicated in the image, shows that electromigration of lead occurred between pins.

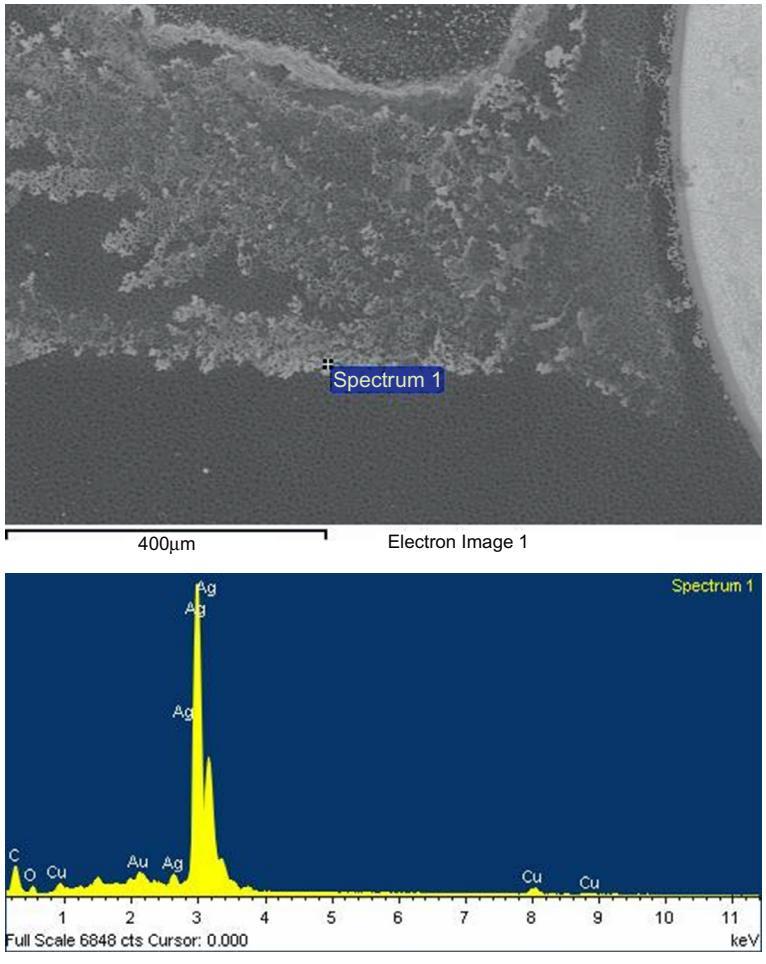
Spectrum 1, collected from the spot indicated in the image, shows that electromigration of silver occurred between a pin and the case.

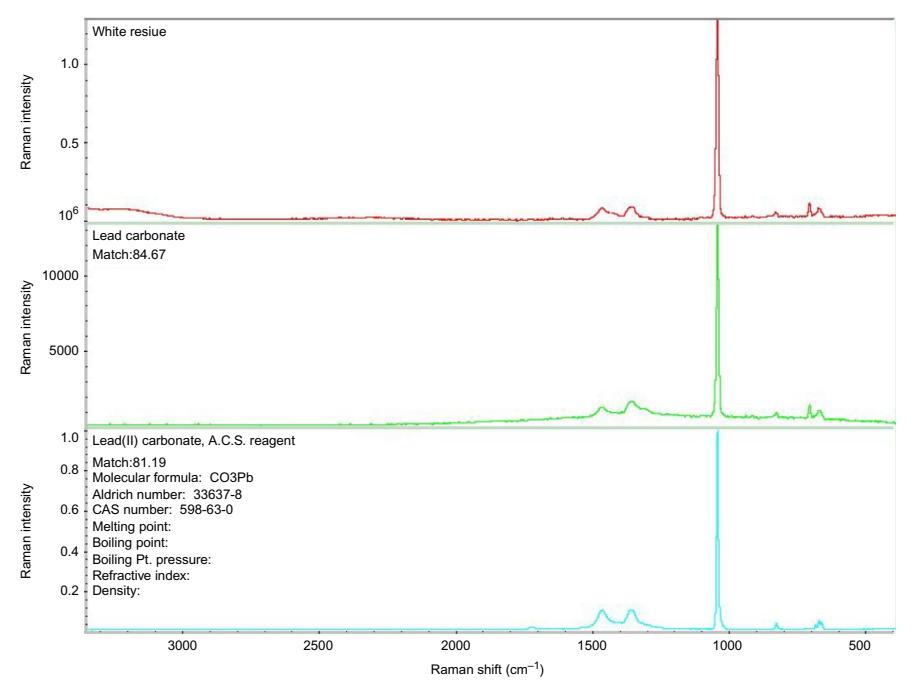
FIGURE 15.29

The Raman spectral data presented in Figure 15.29 indicate that the residue is largely composed of lead carbonate, an expected corrosion product. However, this does not yield insights into how the electromigration leading to corrosion occurred. To further test the assumption of in-line cleaner ingress, GC/MS methods were chosen.

Raman spectrum of white residue between pins (top) database matches to lead carbonate (bottom two spectra).

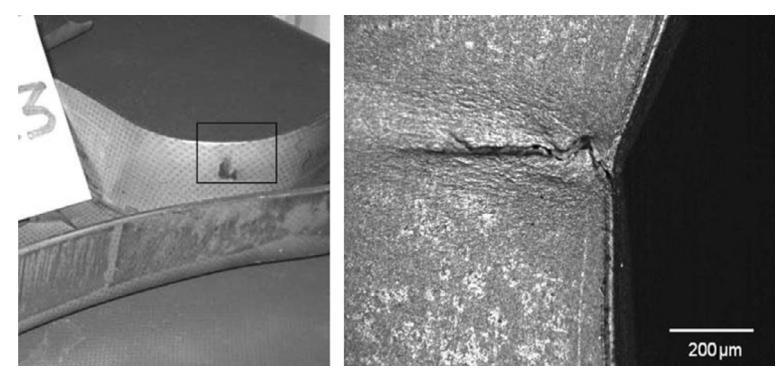
The issues pertaining to fatigue are the key limiting factor to the wider use of high-performance steels in demanding structural applications. The majority of steel components produced for service as automotive structures are primarily manufactured using the mechanical blanking process. This can produce a rough cut-edge which results in the formation of a fatigue crack initiation as shown in Figure 16.2.

Suspension arm with a mechanical cut-edge fatigue crack emanating from a point of high stress.

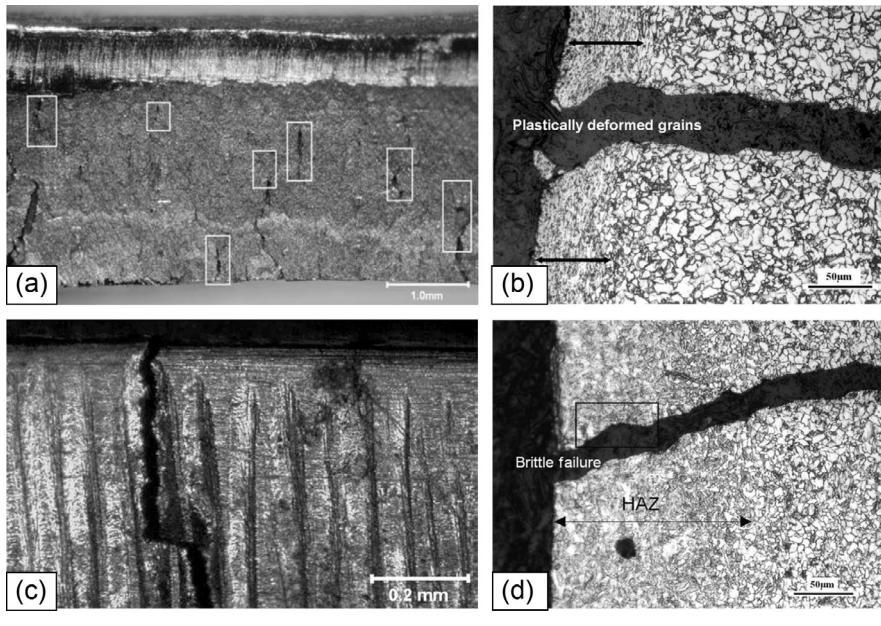
FIGURE 16.11

Micrograph of DP600 cut-edges with (a) the formation of multiple crack initiations from a mechanical cut-edge, (b) micrograph of a mechanical cut-edge fatigue crack initiation, (c) micrograph of the initiation of a laser cut-edge fatigue crack, and (d) micrograph of a fatigue crack initiating from the trough of a cut-edge.

At a load of 20 kN, mechanical cut-edge cracks were observed to initiate from notch features. This suggests that it is the cut-edge surface properties that are of critical importance particularly under HCF testing. These observations suggest the reason why mechanical cut-edges displayed a dramatic decrease in fatigue life.

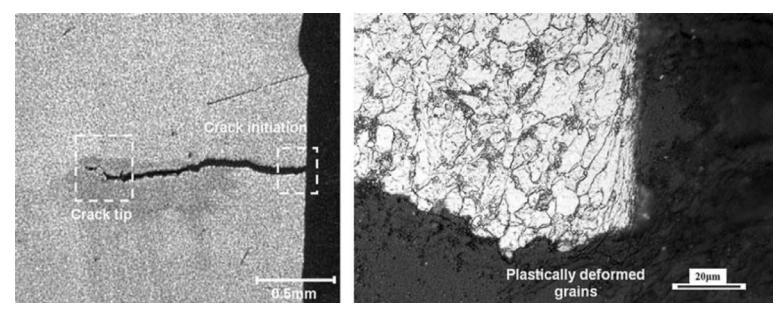
FIGURE 16.15

Smooth-edge region I crack propagation and the microstructure of the region around the crack initiation.

Plastically deformed grains in the near-edge region and the notch defects produced during the mechanical cutting process act as stress raisers and the starting point of a crack. Under the process of sinusoidal loading, the orientation properties of the crack were observed to change as shown in Figure 16.15. Over the 25.0-mm length, where the fatigue cracks are grown, it was clear to observe the region I and region II crack growth regimes.

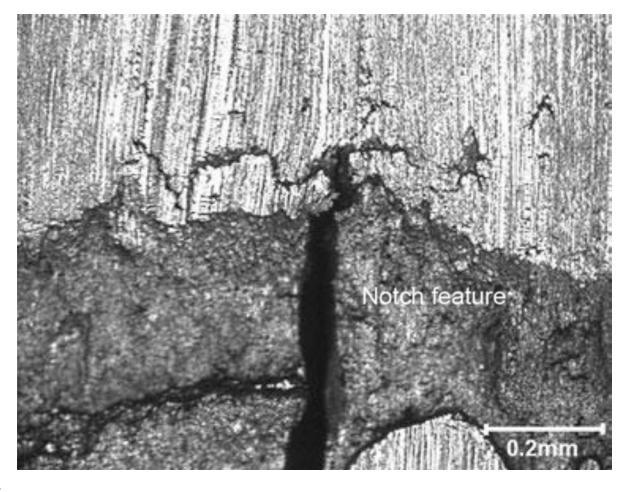
FIGURE 16.16

Surface of the fatigue crack initiation from a mechanical cut-edge notch.

However, the more the crack grew into region II growth, the more the inconsistent it became as shown by observations made of the crack tip behavior. Microstructural examination of the crack growth revealed the elongation of grains at the region where the crack initiated as shown in Figure 16.16. This indicates that under the process of sinusoidal loading there is a localized region of plastically deformed grains, which have been deformed before the formation of the region I crack growth.

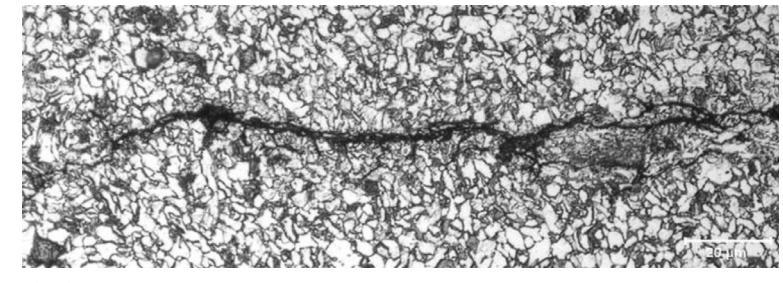
FIGURE 16.19

Shown in Figure 16.18 are the *E*-N and S-N lives to crack initiation, in which it can be seen that, under higher levels of strain, laser cut-edges display a reduced life relative to that of milled and mechanical cut-edges. Under lower strain levels, the effect of cut-edges is of less significance. A crack propagating through the microstructure of the steel is shown in Figure 16.19 in which the crack grew transgranularly through the microstructure forming daughter cracks running at 90° to the crack growth direction.

Fatigue crack propagating through the microstructure of DP600.

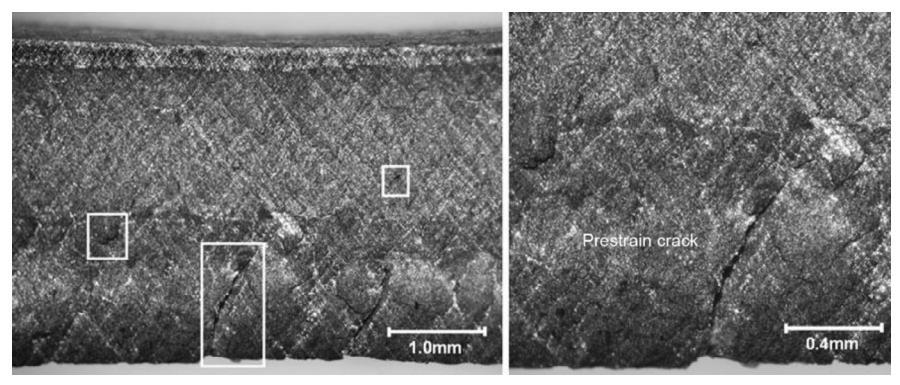
FIGURE 16.21

Micrograph of a mechanical cut-edge surface after an 8% prestrain has been applied.

of 5%, there is a large increase in fatigue life over mechanical cut-edges that have not been prestrained. At a prestrain of 8%, mechanical cut-edges as shown in Figure 16.21 display a number of prestrain-induced cracks at the rougher lower region of the mechanical cut-edge, and these features resulted in a large reduction in life over all cut-edge types. The influence of prestrain can have characteristically damaging effect on the fracture zone of mechanical cut-edge surfaces. The imperfections in the lower region of the fracture zone are where, under prestraining, cracks can open up into a larger rupture.

At a prestrain of 8%, there are a number of cracks that have formed toward the bottom of mechanical cut-edges and occurred when strain limits of the cut-edge were exceeded. Therefore, the size of the fractured zone is important in terms of understanding the fatigue performance, as it is the roughest region of a mechanical cut-edge and has the presence of tensile residual stresses. Rapid transformation of austenite to martensite at first is due to the nucleation sites introduced by the deformation. However, an excessive strain can retard the transformation, eventually bringing it to a halt as is the case at higher 8% level of strain. This mechanical stabilization process later is a characteristic feature of displacive transformations.

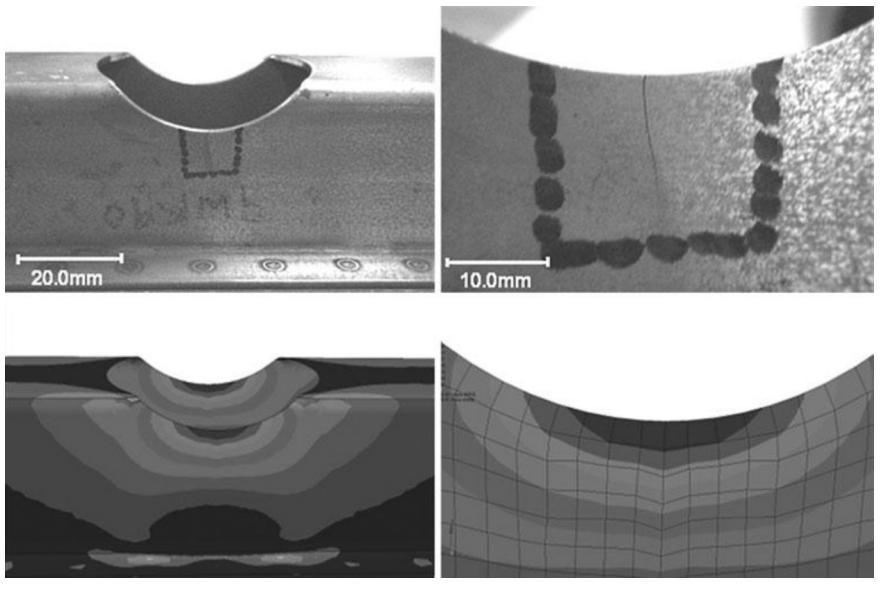
FIGURE 16.22

When comparing the three life prediction methods above, the method most appropriate for estimating fatigue lives of automotive chassis components with exposed cut-edges can be determined. To achieve this, results from the three different methods of life predictions using MSC.Fatigue are compared with the crack initiation lives from the laboratory tests, in which cracks initiated from the highest stress point at the apex of the cut-edge hole as shown in Figure 16.22.

The critical region on the structure showing the location of maximum stress from where a crack initiates.

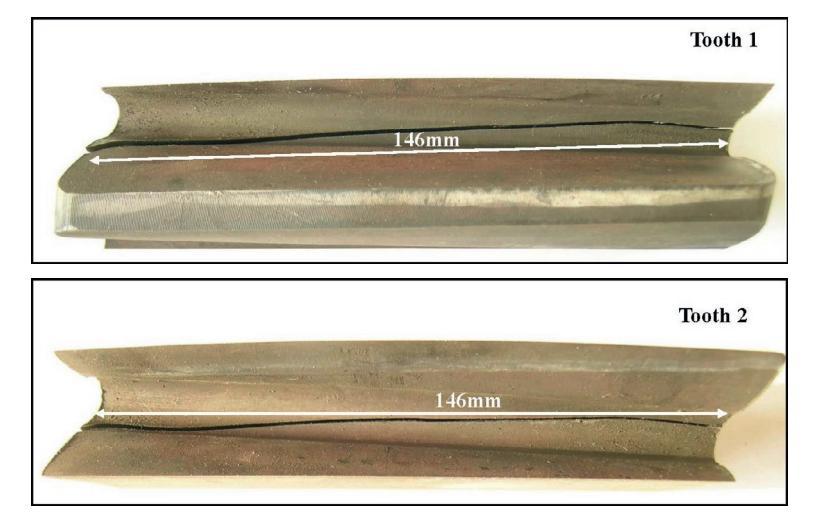
Two cracked gear-teeth are shown in Figure 17.1 as they were received. Visual inspection revealed that the cracks were situated at the groove root and were along the axial direction. The cracks were found throughout the entirety of the grooves and the axial length was about 146 mm. Fracture surfaces of two cracked teeth prepared by opening cracks showed similar fractographic features, as shown in Figure 17.2. Dark brown fracture surfaces and the presence of oxidation film on the fracture surfaces suggest that the fracture surfaces underwent a process of high-temperature oxidation after the cracking of the gear-teeth. No obvious plastic deformation was observed on the fracture surfaces. The fracture surfaces close to the groove showed opposite chevron crack propagation markings [1,2], as marked by dotted arrows in Figure 17.2. The chevron points toward the origin of the fracture. Hence, it can be determined that the crack origins were about 3.3-3.5 mm from the groove and

As-received cracked teeth.

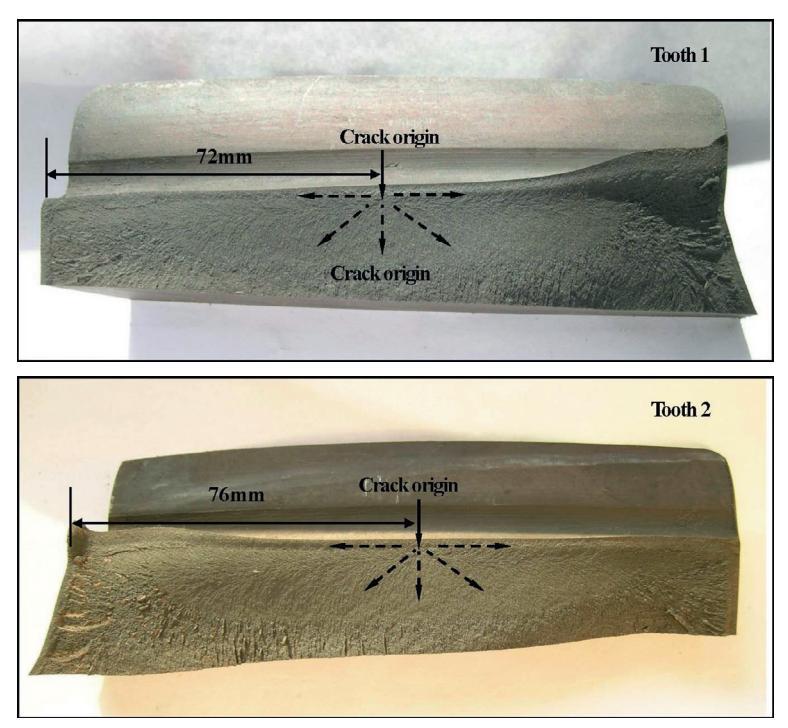
Macro-fracture surfaces.

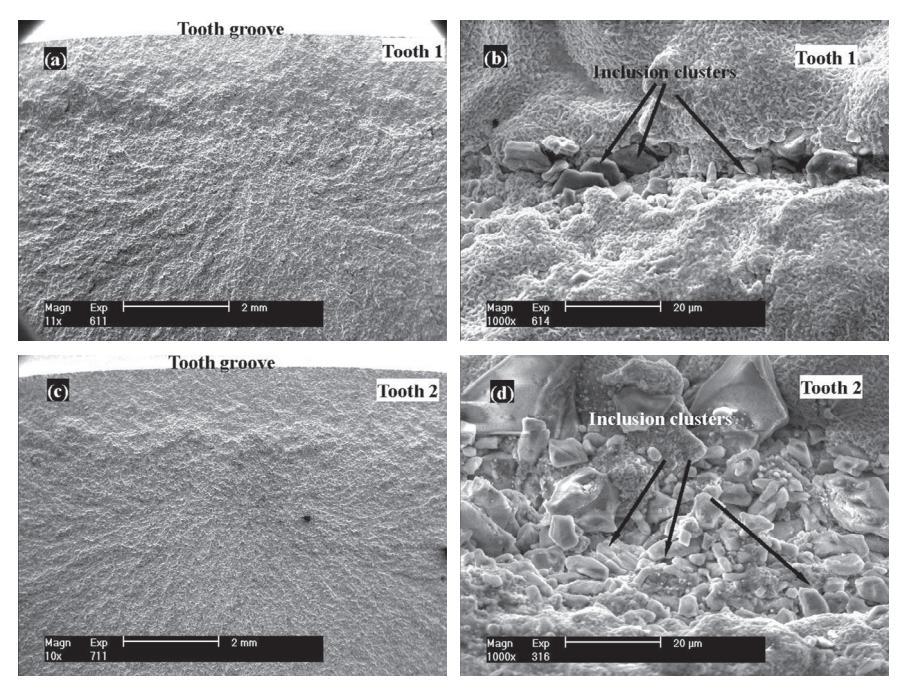
FIGURE 17.3

A discontinuous oxidation layer was found covering on the fracture surfaces, but the point-like feature in crack origins and radioactive crack propagation marks were clearly revealed by scanning electron microscope (SEM) (Figure 17.3a and c). After the fracture surfaces were cleaned repeatedly by supersonic vibration in acetone solution, large nonmetallic inclusion clusters containing numerous small particles of 5-30 μ m in diameter were found in multiple locations of the crack origin regions (Figure 17.3b and d). Based on the morphology and the present position of the particles, it can be deduced that the particles in the crack origins did not originate from the coverings on the fracture surfaces, but were from the raw material. Theses inclusions are of the type generally associated with ingot segregation patterns. Energy dispersive X-ray (EDX) analysis (Figure 17.4) indicated that the particles were mainly Al₂O₃ complex metallurgical inclusions.

SEM observation on fracture surfaces: (a,c) general view, (b, d) showing inclusion clusters in crack origins.

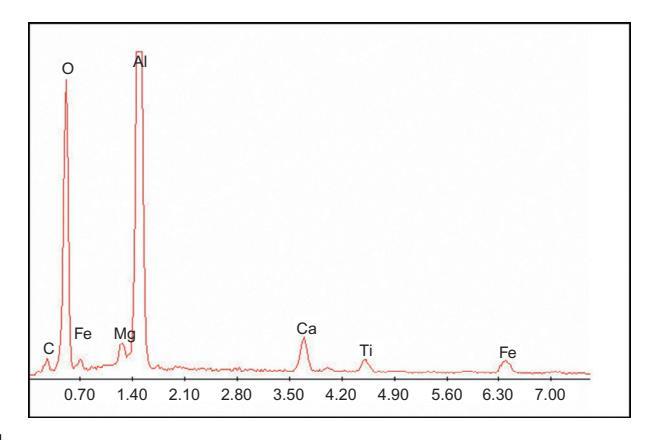
FIGURE 17.4

EDX spectrum taken from the inclusions in the crack origin (tooth 2).

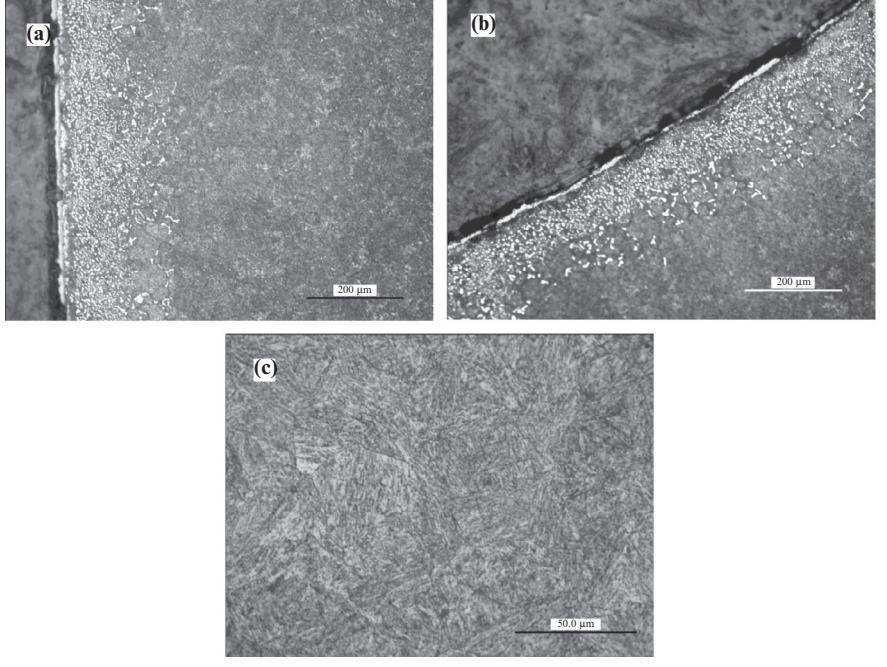
FIGURE 17.5

Microstructure of cracked tooth (tooth 1): (a) carburized layer (pitch region), (b) carburized layer (groove region), and (c) core.

carburized layer was composed of a fine acicular martensite, retained austenite, and both particle-like and discontinuous network-like carbides. The core was composed of low-carbon lath-martensite (Figure 17.5c). It should be mentioned that the presence of excessive carbides, especially network-like carbides in the case layer, may induce the brittle cracking of carburized tooth. However, fractographic investigation indicated that the cracking of teeth in this study was not related to the presence of carbides in the case layer. Additionally, the examination on the chemical composition of the failed gear materials showed that the two failed gears were fabricated from 20CrMnTi steel as specified.

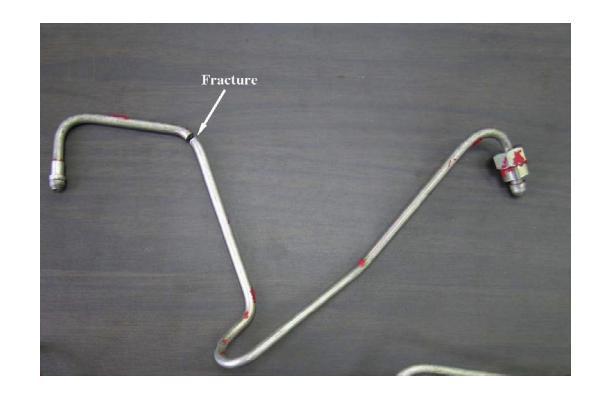
A high-pressure fuel injection pipe from a truck diesel engine was returned to the manufacturer because the pipe was broken into two sections after about 3650 km of service (see Figure 17.6). The fractured pipe was assembled on the second cylinder of 6-cylinder diesel engine. The pipe is made of No. 20 steel (C \leq 0.17, Si < 0.30, Mn: 0.40-0.70, P < 0.025, S < 0.025). The specified mechanical properties were as follows:

From Figure 17.6, it can be seen that the fracture occurred at a bending position. SEM observation of the fracture surface revealed the beach marks (Figure 17.7a) and the fatigue striations (Figure 17.7b) reflective of fatigue crack propagation. From the bowing direction of the beach marks, it can be determined that the fatigue crack

Cracked fuel injection pipe.

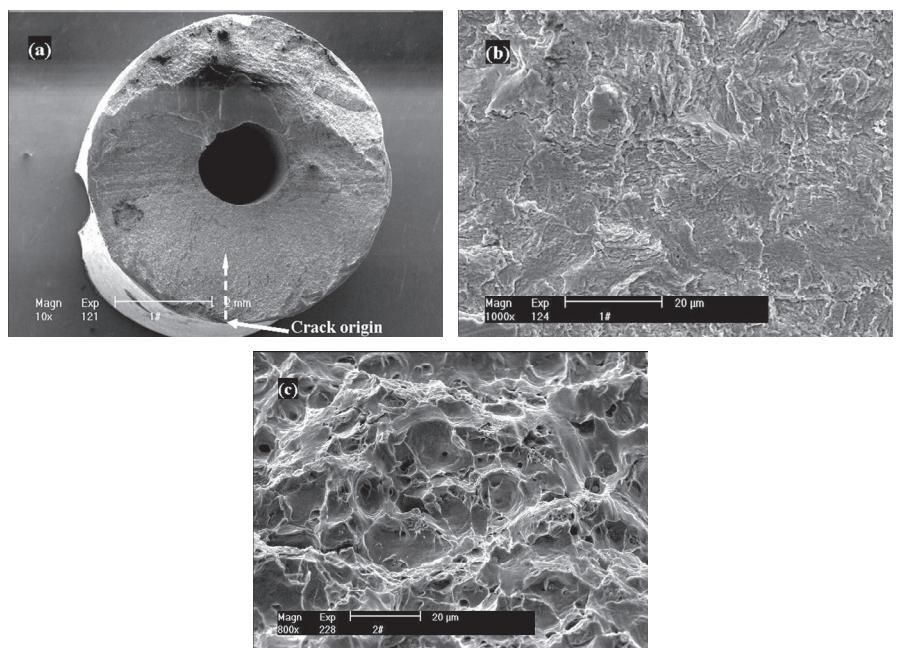
FIGURE 17.7

SEM observation on fracture surface of pipe: (a) general view; (b) crack propagation zone showing fatigue striations, and (c) final fracture zone showing dimples.

origin initiated from the concave side of bending fillet and propagated toward the convex side along the radial direction, as marked by dotted arrows in Figure 17.7a. It is suggested that the unidirectional bending fatigue is the dominant failure mechanism of pipe. The dimples are presented on the instantaneous fracture zone (Figure 17.7c). The final fracture area is about one-third of the whole fracture and the larger final fracture area suggests that the load which pipe bore was greater before fracturing.

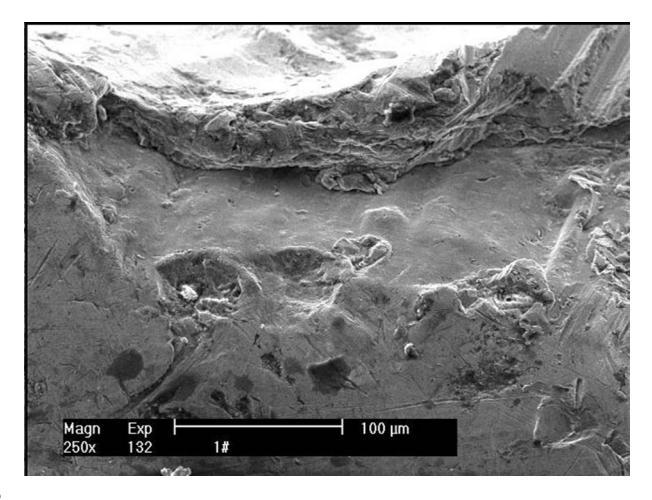
SEM observation on external wall of pipe in crack origin zone showing machining dent.

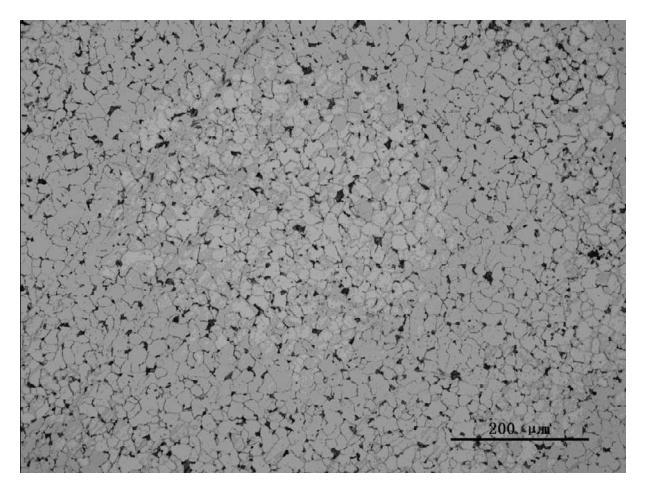
FIGURE 17.9

The microstructure of the radial section close to the crack origin was observed by optical microscope (OPM). The microstructure of the pipe was composed of ferrite and a small amount of pearlite (Figure 17.9) without the occurrence of decarburization on the surface of pipe wall, which is the normal microstructure of this grade of steel. Additionally, the chemical composition of pipe material corresponds to the specification.

Microstructure of cracked pipe material.

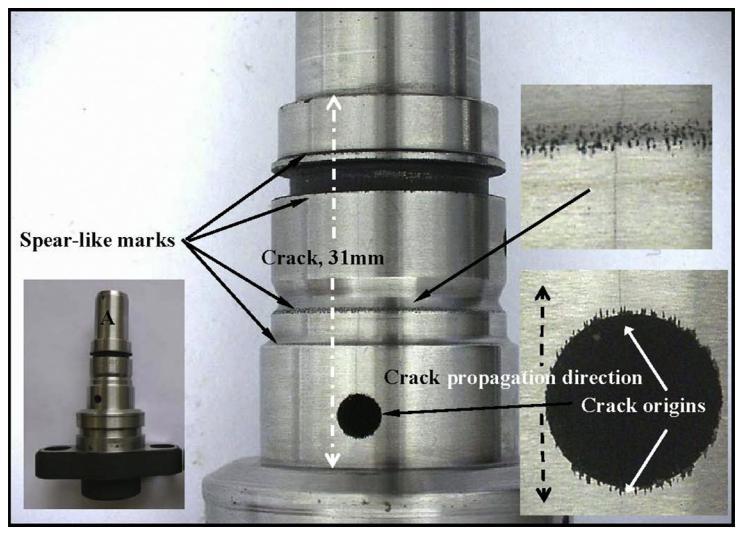
FIGURE 17.10

Cracked plunger-sleeve.

The plunger-sleeves were examined both visually and with the aid of a stereomicroscope. This examination revealed that all the cracks appearing on the failed plunger-sleeves were along the axial direction of the plunger-sleeve and through the oil-hole. A representative cracked plunger-sleeve is shown in Figure 17.10. The crack at the upper and lower edges of oil-hole was not well aligned and the width of the crack decreased in distance from the oil-hole. It was concluded that the crack originated from the upper and lower edges of oil-hole and propagated oppositely along the axial direction. A lot of black spear-like marks along the axial direction were found at the fringe of oil-hole and the transitional steps of different journals (seen in Figure 17.10).

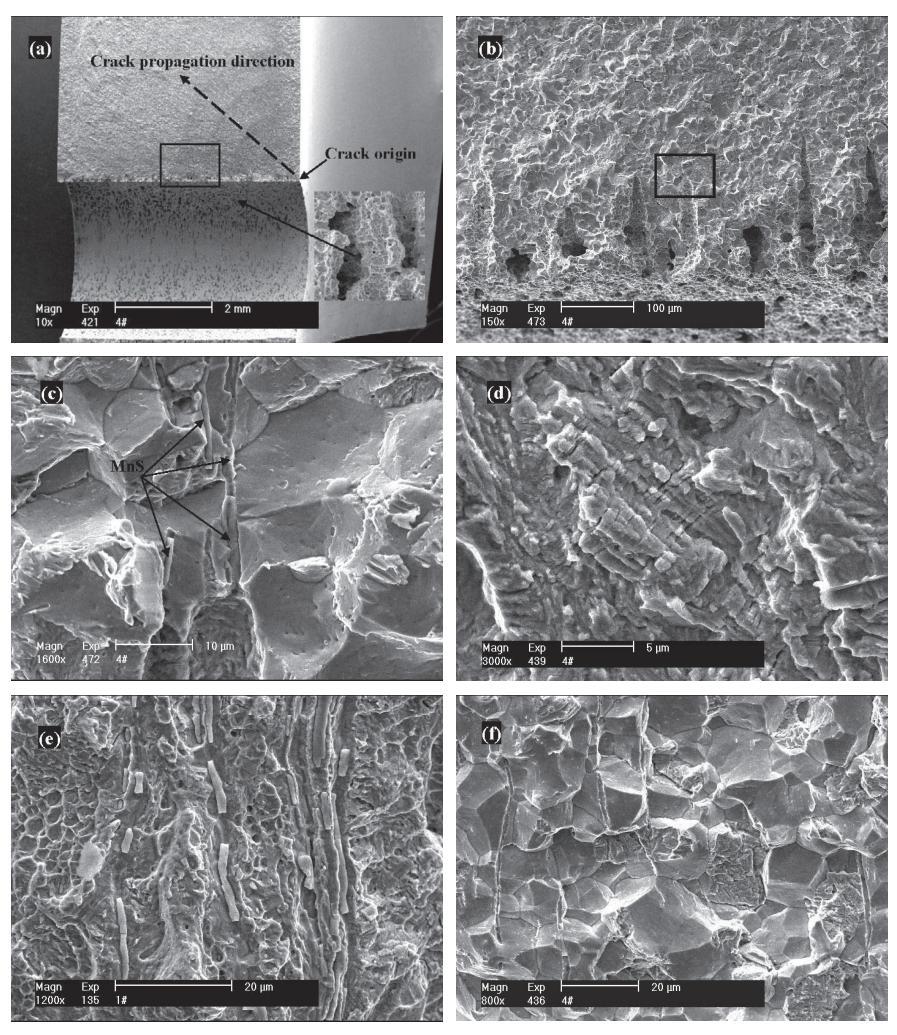
FIGURE 17.13

It was noted that a lot of pits along the axial direction are presented on the internal surface of oil-hole (seen in Figure 17.13a).

SEM observation on fracture surface: (a) general view, (b) boxed region in (a) showing intergranular cracking and spear-like pits and openings, (c) boxed region in (b) showing spear-like pits connecting with elongated MnS inclusions, (d) crack propagation region showing fatigue striations, (e) middle region on the fracture surface showing axial banded structure, and (f) intergranular fracture morphology in carburized depth of external circle.

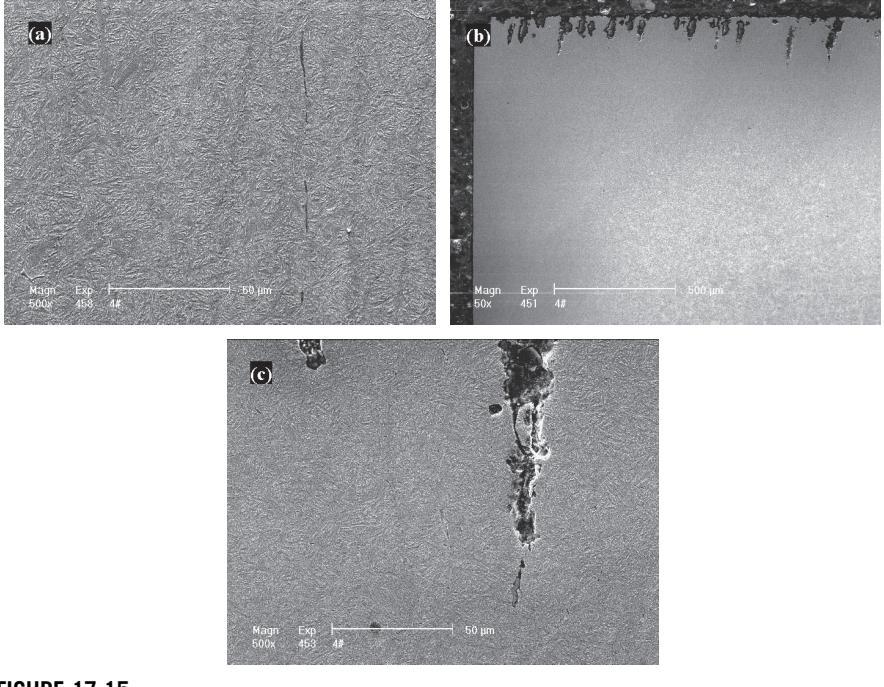
FIGURE 17.15

Microstructure of failed plinger-sleeve: (a) core, (b, c) surface layer region of oil-hole.

austenite (Figure 17.15b and c), which is normal microstructure of the grade of the steel. It was noted that the spear-like openings at the edge of oil-hole were always aligned to MnS stringers (Figure 17.15b and c). In other words, the spear-like openings propagated along MnS-inclusion stringers.

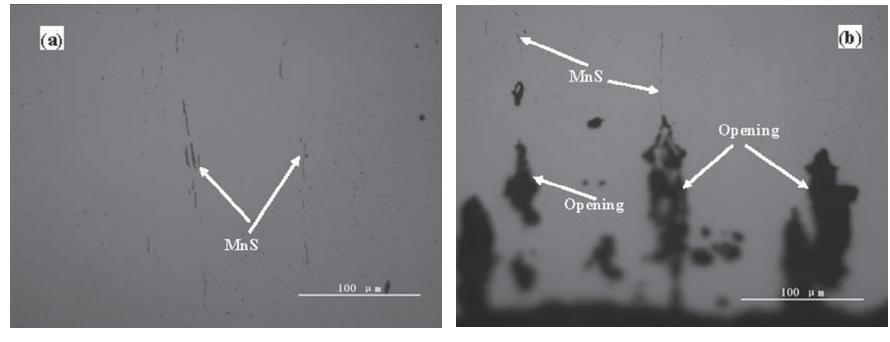
FIGURE 17.16

OPM observation on the nonetched specimens showing MnS morphology in core and in carburizing layer: (a) core and (b) edge at oil-hole.

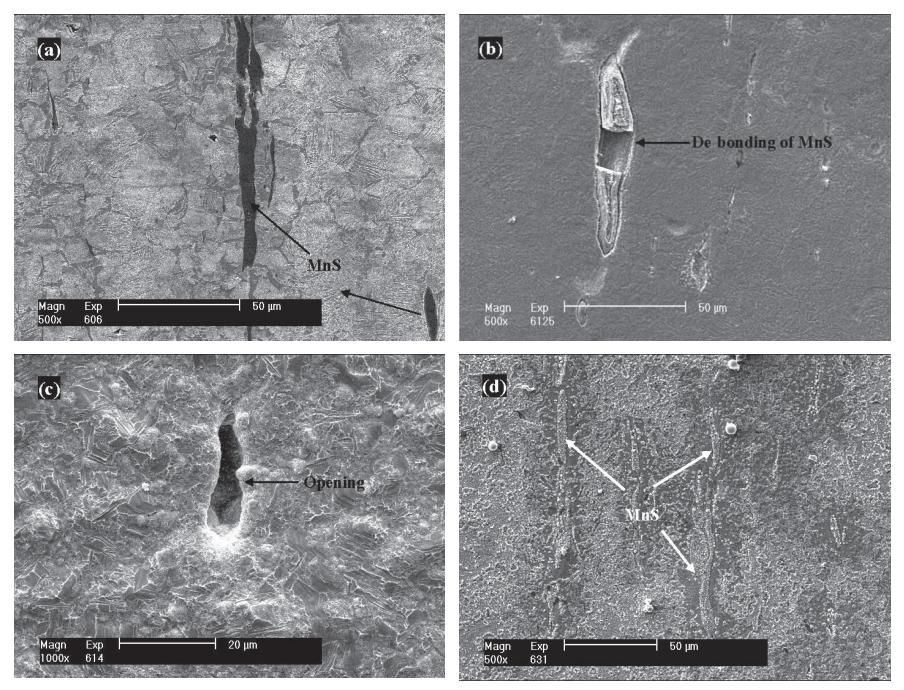
Evolution of MnS inclusions on subsurface in process of oxidation and solid carburizing tests: (a) showing MnS stringers in original material, (b) showing MnS inclusion debonded and pulled out from matrix after oxidizing at 800 °C for 5 min, (c) showing MnS inclusion pulled out from the matrix completely and forming the opening after oxidizing at 920 °C for 240 min, and (d) showing complete MnS-inclusion morphology after solid carburizing at 920 °C for 240 min.

that were solid-carburized and gas-carburized (Figure 17.17d). It is suggested that the reaction of MnS inclusion with oxygen was mainly responsible for pulling-out MnS inclusions from the matrix and formation of pits.

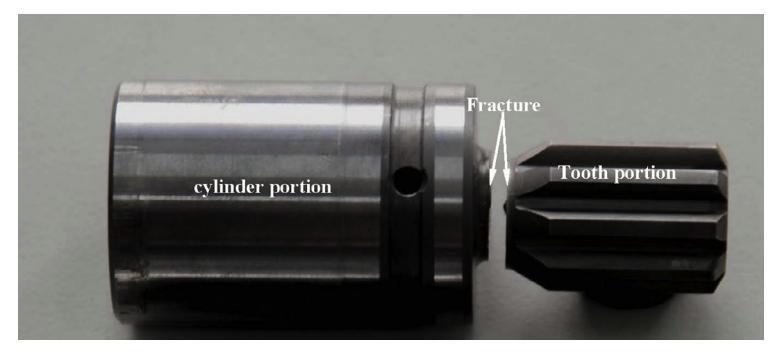
A truck diesel engine splined-shaft fractured after being in service for 7-8 h. The asreceived fractured splined-shaft is shown in Figure 17.18. It can be seen that the transverse fracture occurred at the root fillet between the tooth portion and the cylinder portion and no obvious macro-plastic deformation was observed. The failed splined-shaft was made from 20MnCr5 steel. The external surface of a spline-shaft is required to be carburized. The surface hardness is specified as HV_{10} 675-770 and the depth of carburized layer as 0.30-0.80 mm.

Fractured splined-shaft.

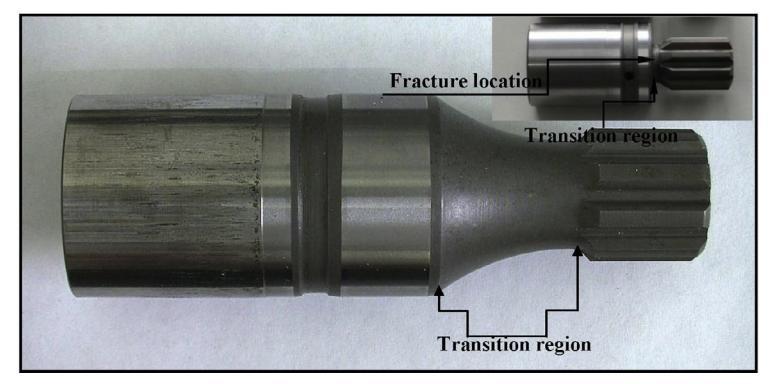
In service, the splined-shaft bears torsion load. In general, the torsion shear stress increases from the center of the shaft to the surface along the radial direction. The outmost surface of the splined-shaft bears greater shear stress. Literature indicates that cracks usually form 45° under torsional nature of loading imposed on a component [19], while, the failed splined-shaft was not in this instance. The tooth end of splined-shaft was fully bound up by the sleeve and the shaft end was fixed tightly in the internal hole of the driving gear. From the design construction of the splined-shaft, the axial free length is relatively short (merely 6.0 mm at the fillet, see in Figures 17.18 and 17.22), equivalent to a pure notch in construction.

Improved splined-shaft with long transition between the tooth and the shaft.

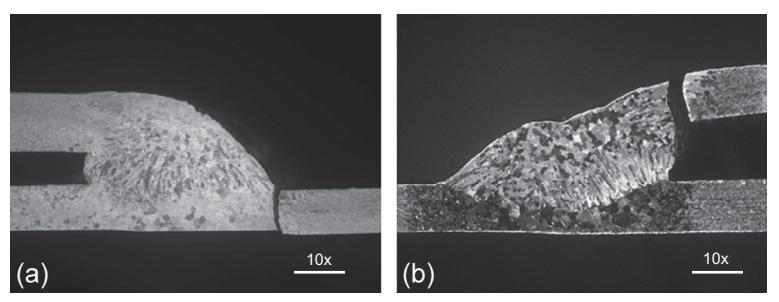
FIGURE 18.2

Welds are used to join pipes to other pipes or components such as catalytic converters, resonators, and mufflers. The weld is both a geometric and metallurgical stress riser. The heat affected zone in the parent material around the weld is an area of large grains which has lower fatigue life. The most common failures occur by initiating at a weld toe and propagating through the parent material in the heat affected zone of the weld or at the weld root and propagating through the weld and/or the parent material. Both the weld toe and root create a geometric notch that is a stress riser for fatigue initiation. The difference in microstructure between the weld, the parent material, and the heat affected zone in the parent material is a metallurgical stress riser. Examples of these failures can be seen in Figure 18.2a and b.

Fatigue failure at (a) weld toe and (b) weld root.

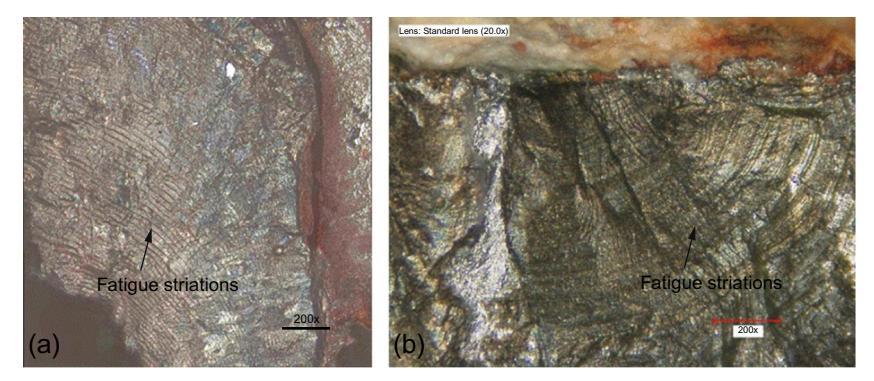
Fatigue is evidenced by striations on the fracture surface as seen in Figure 18.3a and b. Striations are not always visible under lower magnification. Larger striations

FIGURE 18.3 Fatigue striations on fracture surfaces.

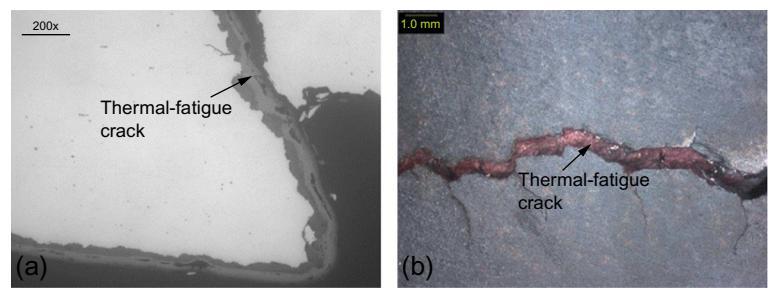
Thermal fatigue occurs at elevated temperatures and usually in combination with mechanical fatigue. Thermal fatigue consists of oxidation penetrating the material and forcing open a crack. Continued heating will propagate the crack through a cycle of oxidation opening the crack. These are typically trans-granular with multiple branch cracks filled with oxidation. Examples of thermal-fatigue cracks are shown in Figure 18.4a and b.

FIGURE 18.4 Thermal-fatigue cracks.

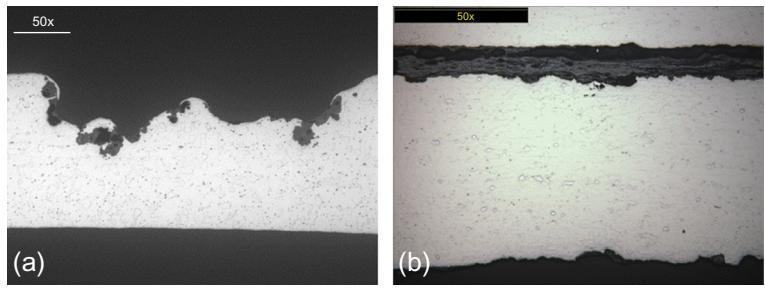
FIGURE 18.5

(a) Pitting corrosion on ferritic stainless steel and (b) crevice corrosion between two layers.

perforating and by acting as an initiation site for cracking [26]. Unlike general metal loss, which is defined as relatively uniform thinning over a significant area, localized metal loss such as pitting and crevice corrosion can vary significantly within a given area. Pitting corrosion is the most common and usually occurs at a surface imperfection as small as inclusions in the raw steel corrosion. Once corrosion initiates at a location, it can serve as a catalyst for more rapid corrosion resulting in a pit. Early in a corrosion environment, it is not unusual to see multiple spots of corrosion with adjacent areas having no corrosion attack. With continued exposure, the corrosion will eventually spread over an entire part. Crevice corrosion occurs when two materials are placed together and moisture wicks between the layers. This condition results in accelerated corrosion due to the trapped moisture and any corrosive materials in the moisture. Examples of pitting corrosion and crevice corrosion are shown in Figure 18.5.
