Handbook of Materials Failure Analysis With Case Studies from the Aerospace and Automotive Industries Handbook of Materials Failure Analysis With Case Studies from the Aerospace and Automotive Industries

Abdel Salam Hamdy Makhlouf

Mahmood Aliofkhazraei

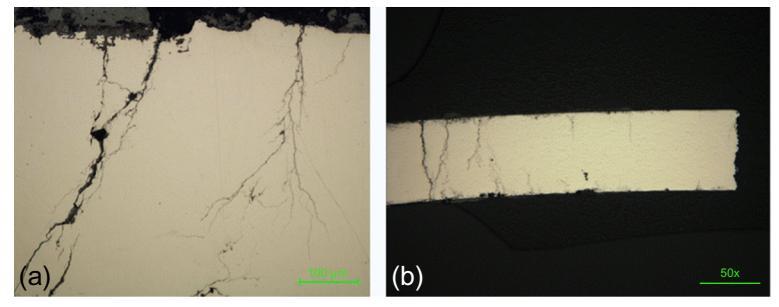
While austenitic or 300 series stainless steels have superior corrosion resistance to the ferritics due to the addition of nickel in the alloys, the cost is usually higher and the risk of stress corrosion cracking is present. Stress corrosion cracking (SCC) occurs in materials that are susceptible (like austenitic stainless steel), under stress, and exposed to halogens including chlorides found in road salt or ocean air. The stress may only be residual stress from forming the material as well as static and dynamic stresses on the exhaust system on the vehicle. SCC cracks usually start very small and may open up as the stress on the material increases. The cracks are usually trans-granular and often have multiple branch cracks. Ferritic stainless steel is not susceptible to SCC. Figure 18.6 shows the stress corrosion cracking patterns in austenitic stainless steels.

FIGURE 18.6 Stress corrosion cracking (SCC) in austenitic stainless steels.

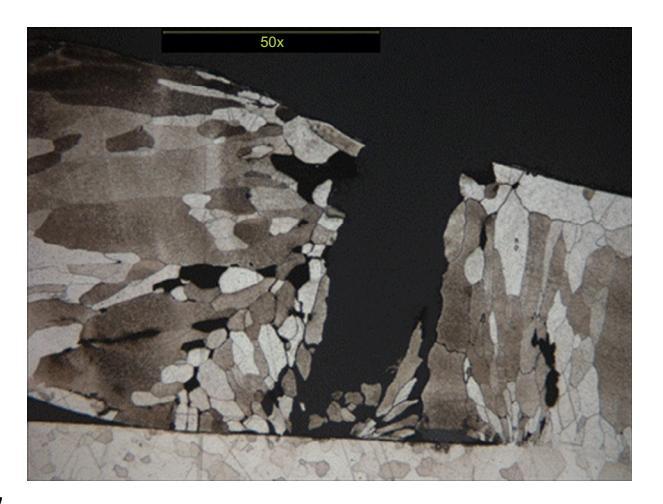
FIGURE 18.7

failure. Ferritic stainless steels used in exhaust systems are stabilized with titanium and/or niobium (also known as columbium) in combination with low carbon content. Titanium and niobium have a greater affinity for carbon than chromium so that titanium and/or niobium carbides and/or nitrides are formed preferential to chromium carbides/and or nitrides. This allows the chromium to be available to provide corrosion resistance. Austenitic stainless steels are also susceptible to sensitization. Improper gas shielding during welding may allow nitrogen from the air to be absorbed in the weld. The excess nitrogen can exceed the needed ratio of carbon/ nitrogen to titanium/niobium resulting in sensitization. Figure 18.7 shows the inter-granular corrosion due to sensitization of a ferritic stainless steel weld.

Inter-granular corrosion due to sensitization of a ferritic stainless steel weld.

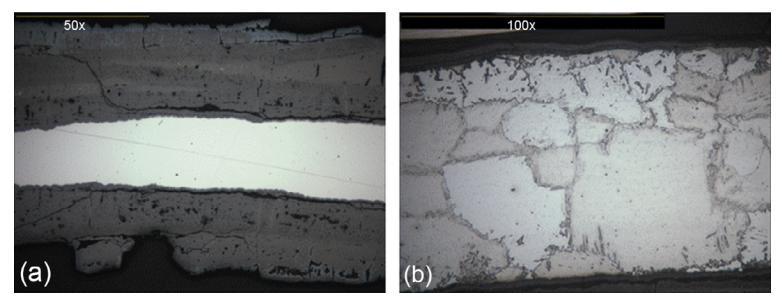
FIGURE 18.9

(a) Heavy oxidation from high temperatures and (b) grain growth and grain boundary liquation.

will also result in exaggerated grain growth and may result in a condition known as grain boundary liquation. Figure 18.9a and b shows the severe oxidation and grain boundary liquation, respectively.

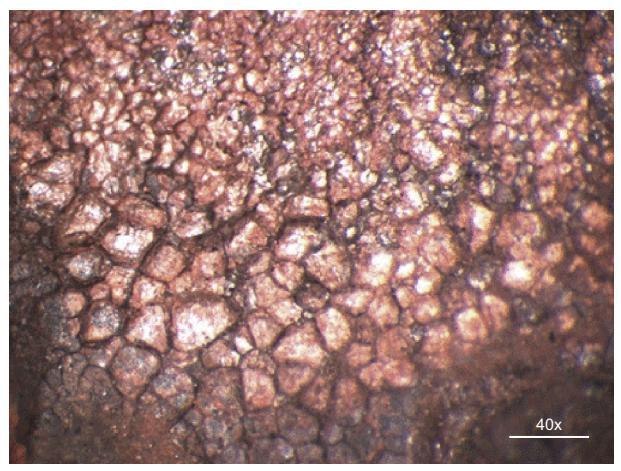
The use of urea as a redundant for SCR systems has introduced another corrosion concern. Ammonia is formed in the process and at high temperatures can result in intergranular corrosion termed as "dusting." This condition has been found in the lower alloy content ferritic stainless steels and austenitic stainless steels and is more severe at elevated temperatures. Higher chromium content ferritics stabilized with niobium has been found to be the optimum material for urea applications. Figure 18.10 shows the corrosion pattern caused by urea dusting in a 409 stainless steel.

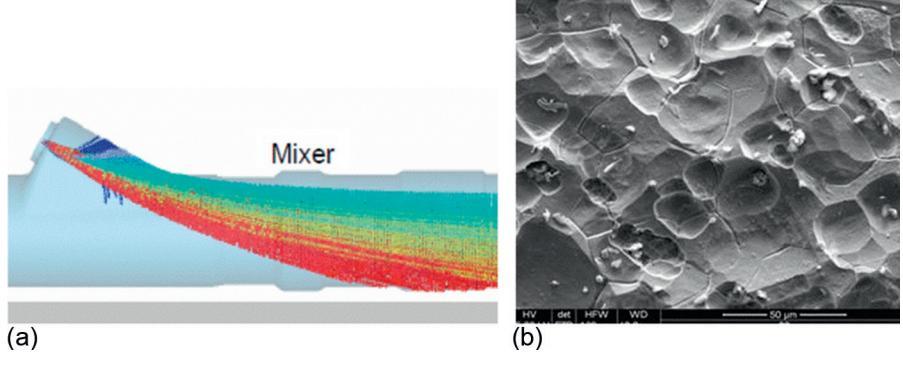
FIGURE 18.11

(a) Spraying simulation and (b) damage erosion-corrosion inner surface of an exhaust system.

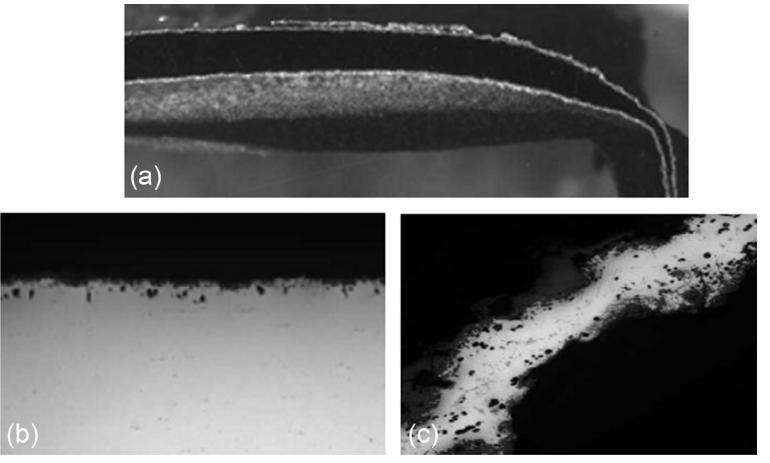
FIGURE 18.12

High-temperature oxidation-erosion, (a) wall-thinning, (b) modest eroded surface, and (c) severely eroded surface.

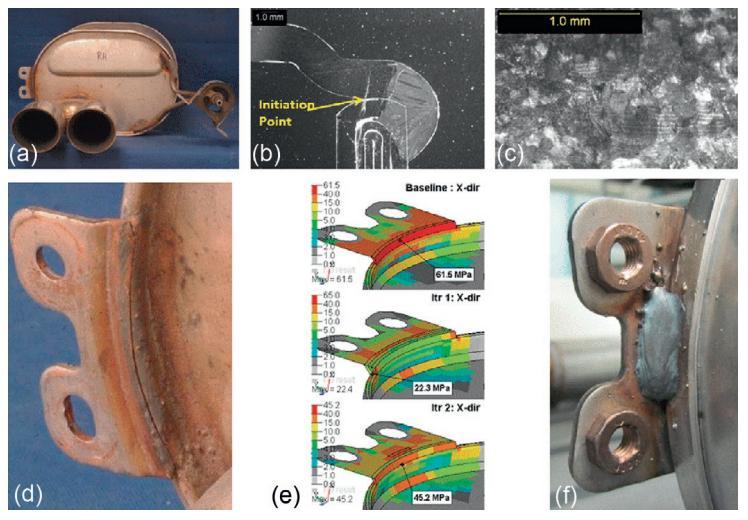
FIGURE 18.17

(a) Right-hand (RH) muffler assembly, rear view, (b) bracket weld cross-section, (c) fatigue striations, (d) baseline weld, (e) stress contour plot, x-direction, and (f) iteration2: bracket with 15 mm weld.

the parts showed that the failures were the result of fatigue and the cracks initiated at the root of the weld, Figure 18.17b, and propagated through the bracket to head bead weld. The weld cross-section, with the initiation point noted on the image, is also shown in Figure 18.17b. Fatigue striations were visible on the fracture surfaces and are shown in Figure 18.17c. The originally designed weld setup consists of a weld extending the full length of the bracket on the rear face (when in vehicle position) after failure is shown in Figure 18.17d.

To remedy the failures, additional welds were considered to lower the stress on the bracket weld. FEA analysis was performed on the original weld design (Baseline), Figure 18.17d the original weld with the addition of a full-length weld on the front bracket face (Iteration 1), and the original weld with the addition of a 15 mm weld centered on the front bracket face (Iteration 2). The FEA analysis showed a stress reduction in Iteration 1 and Iteration 2 when both axial force and torque were applied to the bracket. Figure 18.17e shows a stress contour plot of x-direction axial force between the three weld scenarios with the area of highest stress noted. After consideration for the manufacturing and assembly process, the 15 mm weld was selected for additional testing as it showed a reduction in stress and had a reduced chance of interfering with the function of the bracket.

Bench testing of brackets with the original weld and Iteration 2 samples was performed to compare the fatigue durability of the two weld designs. The Iteration 2 test parts exceeded the cycles of the baseline parts in both vertical and longitudinal testing and the new weld design was implemented to resolve the bracket failures. Figure 18.17f shows the forward edge of the bracket from a left-hand (LH) muffler after the application of the 15 mm weld.

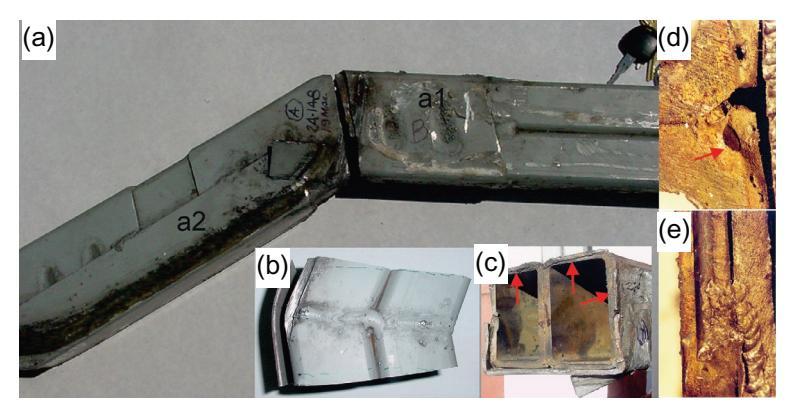
FIGURE 19.1

Failure of the transversal stiffener in a front-engine transit bus. (a) Shows the failed part, which was reinforced by plates which were welded onto the original design (a1 and a2). (b) Shows a reference part without failure. (c) Presents the cross-section of the failed part. The arrows indicate the weld material, which covers the structural section only superficially. (d) Indicates a low-quality joint, with inclusions and discontinuities between the weld and base metal and incomplete penetration of the weld material into the union between the two hollow sections. (e) Likewise indicates an incomplete weld which fails to fully join both sides of the structural section.

In the case of the transverse stiffener, square butt joints were produced from the same material as used in the original product; one set of samples was manufactured using the E6013 electrodes used by the subcontractor and one set using E7018 electrodes as deemed more appropriate by the present authors. Five tensile samples were produced from each set, with the welding seam at the center. For the E6013 electrode, an ultimate tensile strength of 380 MPa was obtained with an elongation at failure of 4.6%, for the E7018 electrode, the values were 470 MPa and 7.2%, respectively. In the first case, fracture occurred in the weld, in the second case, it was the base material that failed in a ductile manner.

In both cases presented above, the failure mode was fatigue (Figures 19.3 and 19.4). In the first one, fatigue propagation was strictly limited to the weld material for the simple reason that the metallurgical union between weld and base material was almost nonexistent, as seen in Figures 19.1c and 19.5a. Only a thin overlay connects the two halves of the structural section. In the same way, the reinforcement plates applied to the original design are so poorly welded that their effect is negligible. The reason for the failure is the selection of the welding electrodes, which provide insufficient strength and poor penetration of the base material by the welding seem, but allow relatively fast production rates. The problems are exacerbated by the extremely poor execution of the welds, as evidenced by their macroscopic appearance and the presence of oxide inclusions and shrink porosity.

It is concluded that in the first case, extreme cost-cutting through materials selection and the use of unqualified labor is entirely responsible for the failure. In the second case, process control is also insufficient and the use of underqualified labor may be a factor. However, considering the specific initiation sites for fatigue, design changes may be required to provide additional stiffness to the frame around the doors of the bus, with the goal of reducing the stress concentrations in the corners of the unions between the hollow sections.

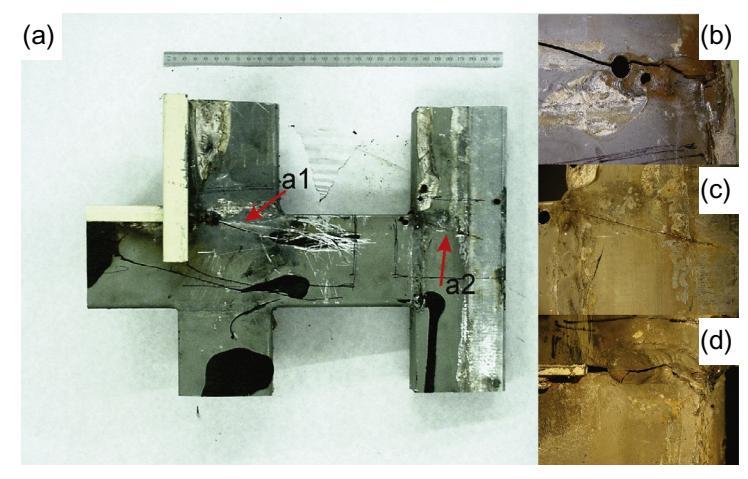
FIGURE 19.2

Cross and T-junction of the portal of the descent door of a transit bus. (a) Presents the assembly with cracks marked by arrows a1 and a2. (b) Gives a close-up of crack a1, which runs through a hole drilled in the profile. The origin of the crack is found in the weld joint seen in the left-hand side of (b); the holes, which were drilled to affix accessories in the bus interior after production did not seem to affect the propagation of the fatigue cracks in any significant manner. (c) Presents a close-up of crack a2, while (d) shows the origin of the crack in the weld material of the T-joint.

failed T and cross unions of welded sections retrieved from the frame around the descent (rear) door (notice the cross union consists in fact of two separate T-joints).

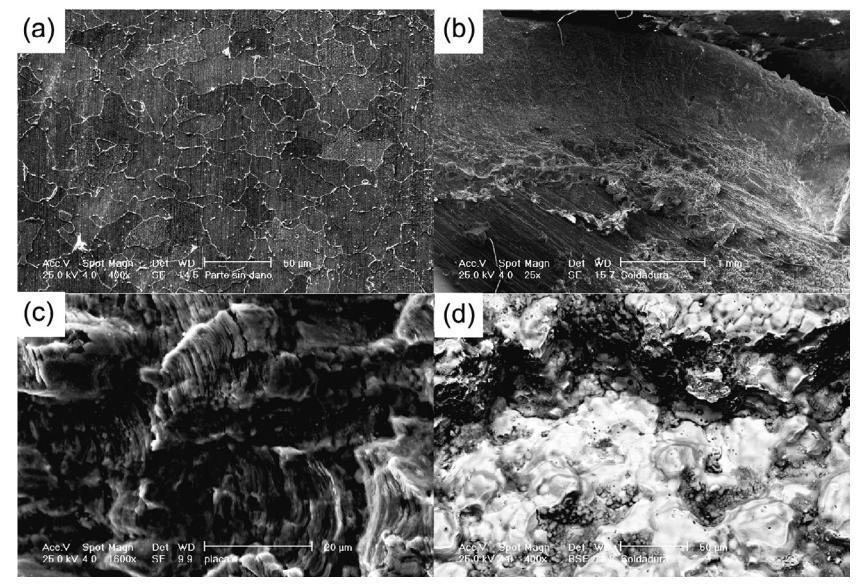
SEM-images corresponding to the failure shown in Figure 19.1. (a) Shows the typical microstructure of a low-carbon steel. (b) Presents a fatigue failure of the weld, as evidenced by the detail in (c) The lower part of (b) presents the surface of the structural profile which still shows the cutting marks produced when the section was cut to size during manufacturing and was not affected by the welding. (d) Shows a part of the fracture surface within the weld material where oxide inclusions and shrinking porosity are found.

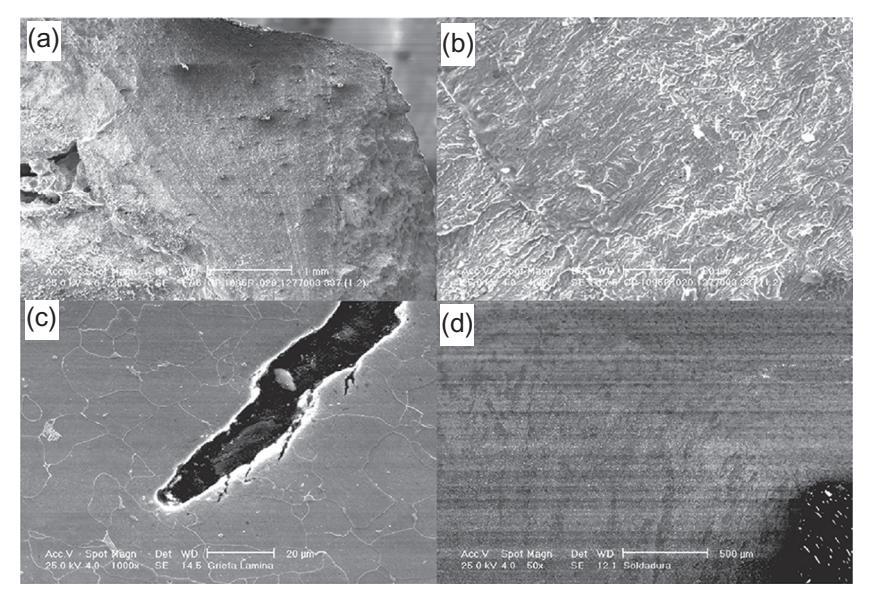
FIGURE 19.4

SEM-observations of the hollow structural sections of Figure 19.2. (a) Shows fatigue crack propagation through the profile wall, the complex propagation pattern as observed in (b) indicates a strong shear component in the loading cycle. (c) Shows a blunted crack tip in a typical low-carbon steel microstructure. (d) Shows the weld, the HAZ and base material in a continuous transition which indicates the formation of a sound metallurgical joint.

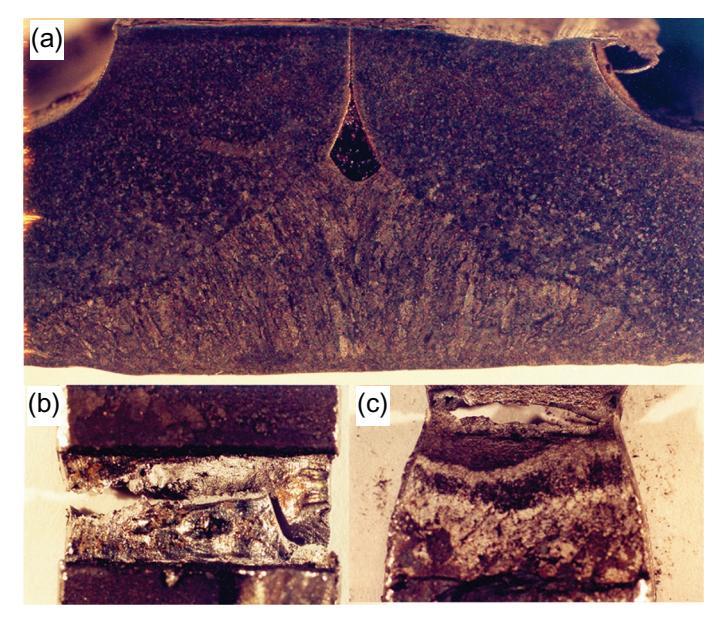
FIGURE 19.5

(a) Presents a cross-section of the welds used in the transversal stiffener. No weld penetration is observed, the heat-affected zone is small and recognized by some limited grain growth. (b, c) Represent butt joints after tensile testing. In (b), the E6013 electrodes used in production were employed; the sample fails through the weld material. In (c), an E7018 electrode was used, which causes tensile failure to occur in the base metal while the weld material is intact.

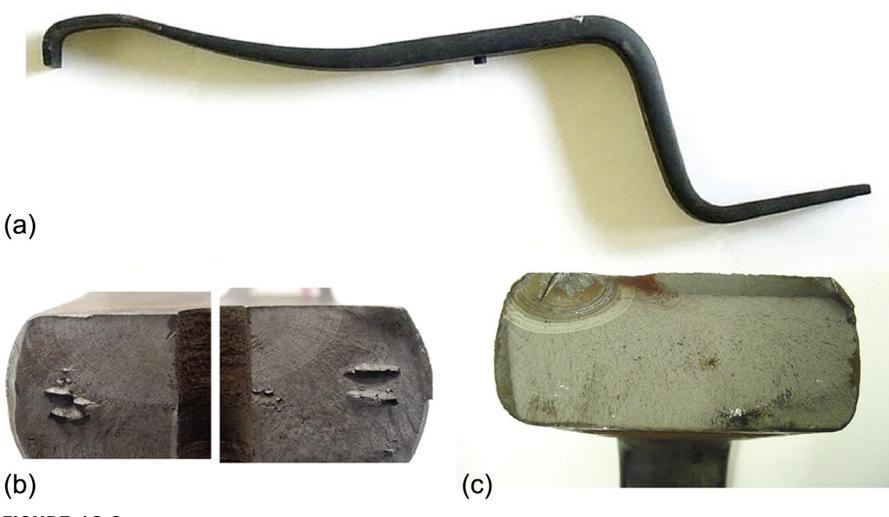
(a) Represents the original design of the Z-bar. The horizontal dimensions of the part, as pictured, are 1.2 m. The pin at the center locks into the top of the rear axis assembly.(b) Presents the failure due to the addition of a bolt to the right of the pin, the bolt was used to add a reinforcing plate to the original design. Notice the delamination failure in parts of the section outside the concentric fatigue marks. (c) Corresponds to fatigue failure initiated by fretting between the reinforcement plate and the original part.

pin locking into the rear axis assembly, which is allowed to pivot when the bar is bent. Two clamps (not shown) assure rigid contact between the rear axis assembly and the Z-bar. The horizontal extension at the right supports an air suspension unit. Figure 19.6a presents the original design of the part. Fracture occurred systematically in the sharp bend to the right of the central pin. As an improvised remedy, this section was "reinforced" by drilling two holes through the section and retrofitting a steel plate with bolts. After this "correction," failure became even more frequent. The reasons can be seen in Figure 19.6b, c. In Figure 19.6b, the corners of the drilled hole serve as the stress concentrators for fatigue. In Figure 19.6c, fretting wear between the bolted plate and the original Z-bar served as the fatigue initiator.

Chemical analysis indicated that the material corresponds to the required AISI5160 specification. However, a hardness of 39 HRC was measured, as compared to the design specification of 44.5-48.5 HRC. This corresponds roughly to a yield strength of 1.2 GPa as compared to the 1.4 GPa specified in the design. Additionally, the material showed a strongly banded microstructure with large longitudinal inclusions. The latter are the cause of the delamination features observed in the brittle fracture zone of Figure 19.6b.

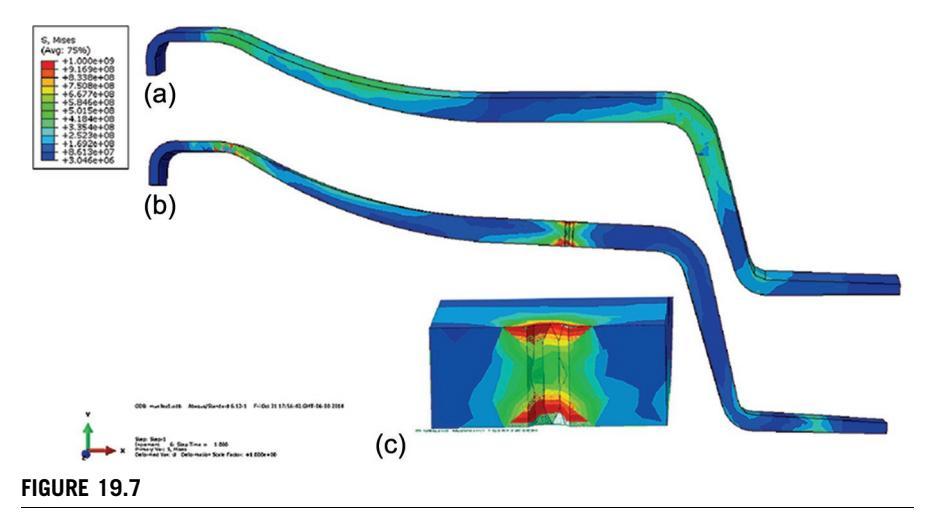
Figure 19.7 represents the finite-element analysis of the original design as well as the effect of the additional hole. It is seen that in the curved sections of the bar, the stress reaches 500 MPa. Given the strength of the material as derived from hardness

Finite element analysis of the Z-bar. (a) Represents the original design. The simulation was made for loads of 75 kN, which is twice the static design load. Stresses of 500 MPa are reached in the bent parts of the bar. (b) Presents the same simulation with a single bolt hole. Its presence alters the distribution of the stresses and provides stress concentrations (c) at the point where fatigue initiation was observed (Figure 19.6b).

measurements, this stress level could be below the fatigue limit of the material. However, dynamic effects were taken into account by multiplying the static service load by a factor of 2. This factor may be too low to simulate operation conditions, especially if road conditions are bad. A full analysis of the vehicle dynamics would be required to answer these questions into detail. Also, overloading of the bus cannot be excluded. The large inclusions, the banded microstructure, and the insufficient hardness of the material may also be contributing factors in the failure. A simulation with the bolt hole present shows the significant stress concentration at the position of fatigue initiation seen in Figure 19.6b. The absolute values of the stresses in this case are not representative, as the precise data on the reinforcing plate were unknown to the authors. However, comparison of Figure 19.6 to Figure 19.7 is sufficient to explain why the "correction" of the design exacerbated the failure problem, as a new stress raiser was introduced at a critical position of the component.

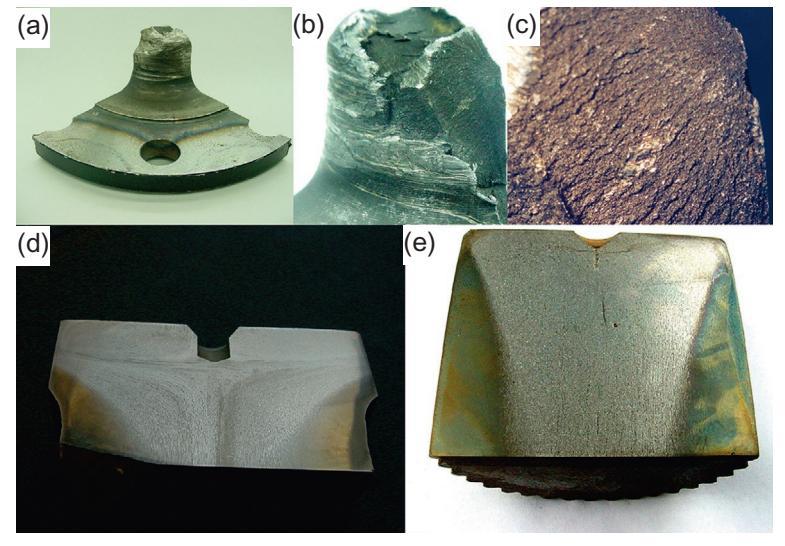
Fractured truck axle. The fracture originated from a flaw which was almost cut away by improper handling of the part before starting a professional failure analysis (a, b). The fracture surface has a complex morphology and emanates from a single point near the surface, as shown in (c). Macro-etched sections of a reference part (d) and of the opposite end of the axle (e) provide an impression of some of the metallurgical aspects of the case. The quenching depth can easily be determined; (d) shows clear evidence of the complex flow pattern induced by the forging process, while (e) indicates a strongly banded microstructure with centerline porosity and inclusions.

along the interlocked halves of the broken shaft. The geometry of the fracture is significantly more complex than what is expected in fragile failure under torsion (Figure 19.8b). The Chevron-marks in Figure 19.8c point toward the initial flaw.

Metallographic analysis of the shaft indicated poor metallurgical quality of the steel. In Figure 19.8d and e., macroetching revealed a banded microstructure with centreline porosity. Both effects indicate inadequate cooling conditions after ingot casting and, while the former defect can be eliminated by prolonged homogenization, porosity, and the accompanying oxide film remain present even after forging. Porosity and large inclusions were also present in a reference piece which was chosen at random from available stock. Additional evidence of poor steel quality was found in the form of a 10-mm long internal crack intersecting the fracture surface (which means the crack was originally longer that what could be measured) (Figure 19.9a). Abundant oxides were present in the crack zone (Figure 19.9b), while oxide-free parts showed the presence of two parallel microcracks, bridged occasionally by transverse cracks (Figure 19.9c). Martensite colonies were not intersected by the defects, but delimited by them, indicating the flaw was present before quenching.

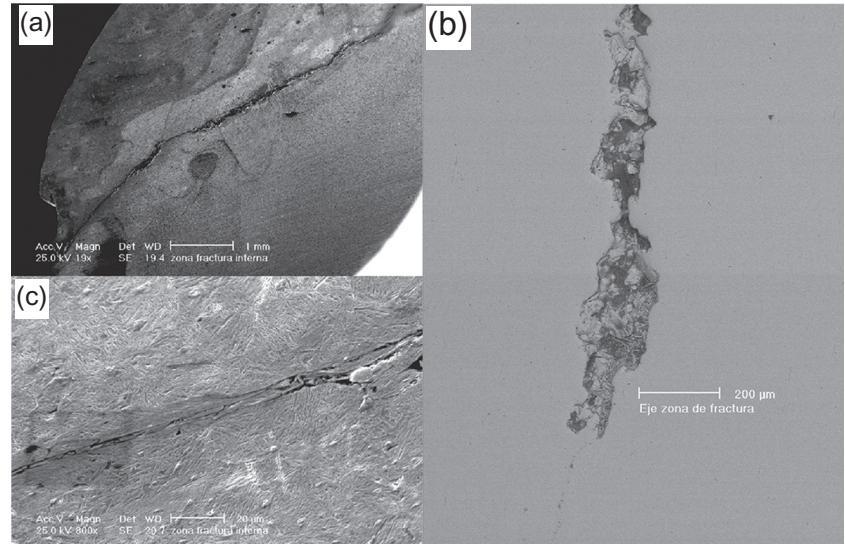
SEM-observation of truck axle. (a) Shows a large flaw intersecting the fracture surface which is at the left. (b) Shows significant oxide inclusions, (c) shows the thin cracks connecting different zones of oxide inclusions along the defect.

The composition corresponds to AISI1048 carbon steel with enhanced manganese content as specified by the client. Hardness was found to be low in the center of the shaft (10.5 HRC), At 11 mm from the surface 31HRC was found, 10 points below minimum specifications and at the surface, HRC63 was measured, slightly above the specified range of 54-60 HRC. The very low value in the center is probably caused by the slowly cooled, coarse microstructure but is not likely to have a large effect on the failure case at hand.

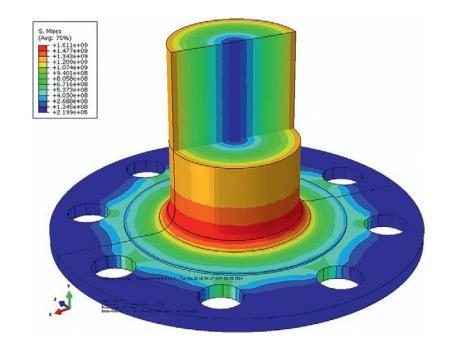
Finite element analysis (Figure 19.10) shows that the crack initiation site is outside the zone of maximum stresses. The exact nature of the initial flaw cannot be reconstructed, because it became part of the fracture surface and was partially obliterated by undue handling of the failed part. However, the presence of a second flaw, at least 10 mm in extent in the same zone, explains the reasons for failure. The base material used in the forging is ingot cast; continuously cast material is always to be preferred due to its better homogeneity and smaller grain size. Large inclusions also point to a poor metallurgical quality of the base material. According to the flow patterns, very large strains are found in the fracture zones (Figure 19.8d). Large shear strains are responsible for the propagation of shear cracks which initiate at the oxide inclusions and connect stringers of the same. Although some uncertainty exists with respect to the critical stress intensity of circumferential flaws under torsion conditions, similar defects (but of lesser size) were found to be responsible for the fatigue failure of the axle of a high-speed train carriage [6].

Finite element analysis of the failed axle. Maximum stresses are found at the fillet between the axle and the flange. The fracture initiated outside the zone of maximum stress, indicating that the presence of the pre-existing flaws was responsible for the failure, not sudden overload which would have caused fracture initiation at the fillet.

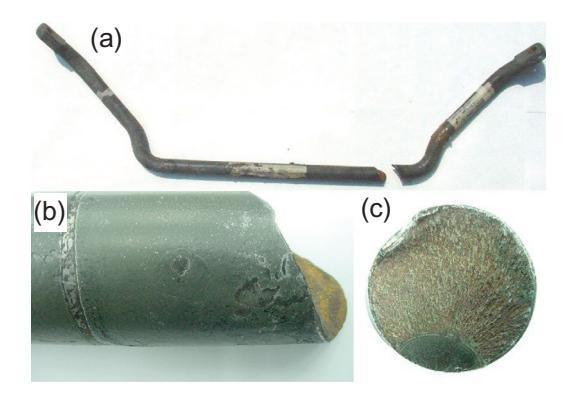
FIGURE 19.11

(a) Represents the entire torsion bar. The horizontal dimensions of the part, as pictured, are 2.4 m. The bar is attached by pins to the wheel assembly on both ends and supported to the chassis by clamps which are separated from the bar by rubber sleeves. (b) Shows the position of the clamps. Point-like contact damage and fretting damage are observed at the surface in the fracture zone. (c) Shows the concentric fatigue pattern and the chevron marks from the ensuing brittle failure.

Failure occurred in three different coaches in short succession. The coaches had between 333,000 and 375,000 km of service. The torsion bars show a typical pattern of a semi-elliptical fatigue crack emanating from a point at the surface followed by brittle fracture under torsion (Figure 19.11). Brittle fracture occurs at relatively small extents of fatigue crack propagation. In two out of three cases studied, the initiation point had the characteristic features of an indentation and together with other types of surface damage it was concluded that metal-metal contact occurred in this zone, which corresponds to the area where the bar is clamped to the chassis. In the third case, fatigue was initiated outside the clamping zone, at a point where the curvature of the bar was strongest. The material of the bar corresponds to AISI 5155 steel with increased Cr-content and shows a homogenous bainitic microstructure, with very limited banding and without large inclusions. A uniform hardness of 44HRC was measured, indicating a high-quality material subject to excellent thermal treatment.

Material quality or manufacturing defects could be excluded as failure causes. The fact that one of the bars failed at the point of maximum curvature indicates that insufficient attention was paid to the effect of curvature as a stress raiser. The other two cases are somewhat more complex, because, while there is clear evidence of localized contact provoking surface damage to the torsion bars, such contact is supposedly prevented by the presence of a rubber sleeve. The surface damage could be unequivocally identified with the fatigue crack initiation.

An explanation can be found by the fact that coaches operating on long-distance services from central Mexico (2200 m above sea level) to the coast manage a continuous sequence of sharp curves in temperatures which are generally above 30 °C and, during certain seasons, above 40 °C. The accumulated heat caused by cyclic compression of the rubber, combined with the impossibility to transfer this heat to the environment, leads to thermal degradation of the sleeve [7–10], to the point where it no longer fulfills its intended function.

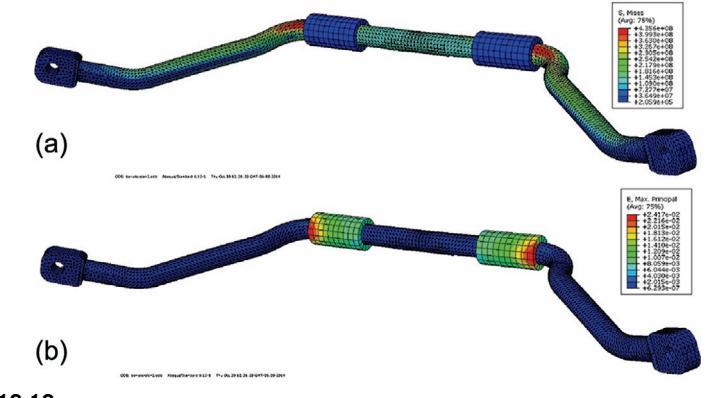
FIGURE 19.12

Finite element models of the torsion bar. (a) Represents the Von Mises equivalent stresses which are maximum at the points of maximum curvature of the part. (b) Represents the strain in the sleeves, which can take fairly high levels.

Finite element simulations of the torsion bars are presented in Figure 19.12. Figure 19.12a shows the stress analysis under operating conditions of a torsion bar, taking into account the presence of rubber sleeves at the point where the bar supports the chassis. The maximum stress occurs at the point of maximum curvature, which corresponds to the failure of one of three cases studied. Figure 19.12b shows the corresponding strains. If the rubber sleeves are substituted by two rigid supporting points, maximum stresses occur at these contact points while the stress in the curvature of the bar is unchanged.

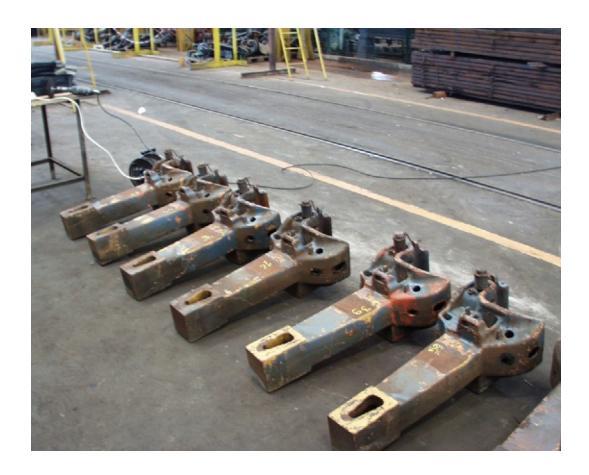
FIGURE 20.2

A significant number of failures have occurred in mechanical components (couplings) of the coal freight trains (Figure 20.2) which led to disruption of service and economic losses. The couplings were obtained by sand casting process, with ASTM A148 90-60 specifications [11], and the owner being a multinational thermoelectric company, Tejo Energia S.A Company.

Out of service cast steel railway couplings.

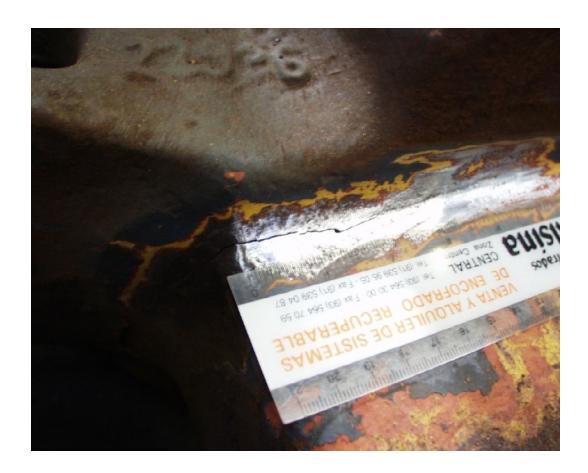
Crack localization.

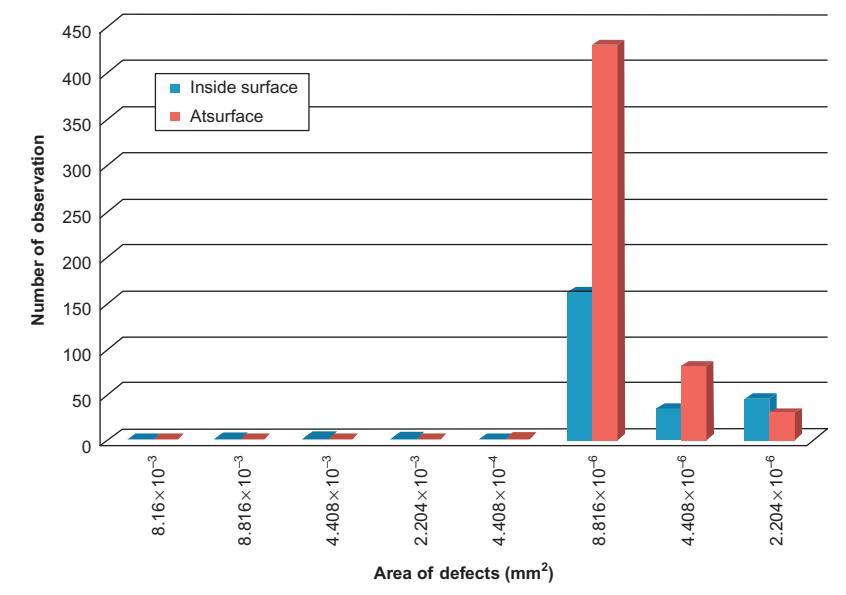
Of the analyses that were carried through descriptive statistics, it was verified that of the defects observed of nonmetallic inclusions, porosities, and shrinkage cavities types, 64.4% were inside of the component and 78.75% were at the surface and belonged to

Total of nonmetallic inclusions, porosities, and shrinkage cavities defects observed.

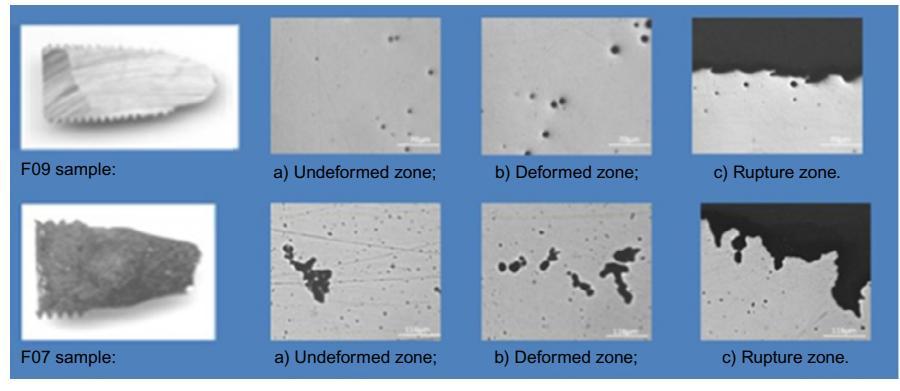
FIGURE 20.7

Microscopy observations of longitudinal sectional view of specimens tested to the fatigue were made. The results of specimens 7 and 9 can be observed in Figure 20.7. The conclusions of the microscopy observation was that there is a direct relationship between fatigue resistance, size distribution, and porosity, expressed by a marked decrease in the fatigue life of samples containing larger pores and distribution of non-metallic inclusions.

Microscopy observations of longitudinal sectional view of F07 and F09 fatigue specimens.

component must present a raised level of health in order to avoid the significant increase of the dimension of defects that occurs when the component is requested to the fatigue criteria.

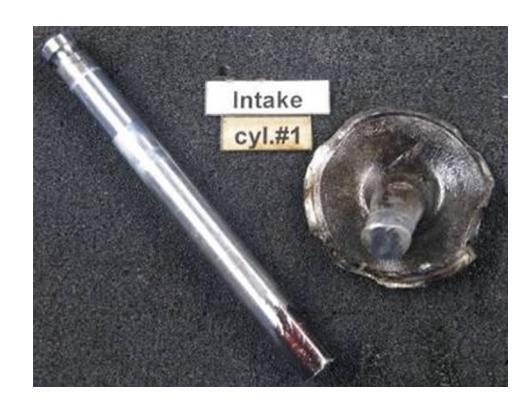
FIGURE 21.3

This part presents a case study for a failure analysis of a broken intake valve. This fracture took place in a gasoline engine (designed for passenger cars) during an endurance test (entitled 500 h general cycles). During this durability test, the engine torque reduced sharply and therefore, the test was stopped after 161 h. After more investigations, it was observed that one of intake valves in the cylinder number 1 was broken. This event also caused other damages on the piston and the cylinder head. These failures in the intake valve are shown in Figures 21.3 and 21.4.

The broken intake valve in a gasoline engine during an endurance test [2].

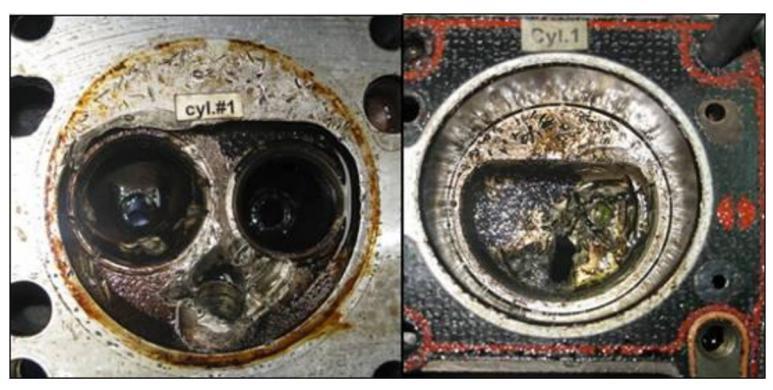
Damages on piston and cylinder head faces according to failures [2].

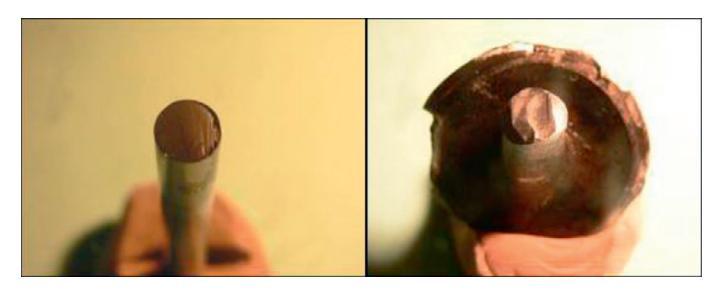
FIGURE 21.6

In the first step, the fracture surface of the broken intake valve was investigated as shown in Figures 21.6 and 21.7. In these figures, beach marks can be observed due to cyclic loadings and the fatigue fracture. As it is known, the valve rotates when the engine works and a reversed bending load is applied to the valve shaft. The fracture surface on the valve shaft shows macroscopic lines, which illustrate the cracks growth path. On the other side of the valve shaft, the fracture surface was damaged due to the impact after the failure in the engine.

The fracture surface of the broken intake valve with beach marks [2].

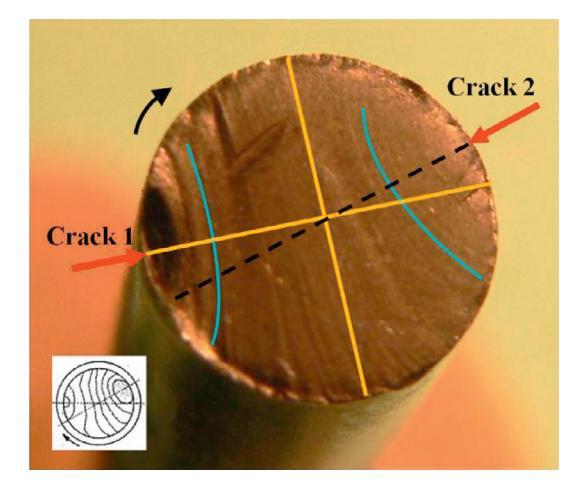
A visual inspection of beach marks on the valve shaft surface shows two crack initiation zones (as illustrated in Figure 21.5, in two left and right sides). These regions are demonstrated with arrows (entitled "Crack 1" and "Crack 2") in Figure 21.5. As shown in Figure 21.5, cracks initiate at the outer surface of the valve shaft. This phenomenon occurs mostly in HCF regime. Then, this pattern shows a fully reversed bending as the loading type in the valve system [12]. In other words, the mean stress is zero and the stress ratio is minus one (R = -1). This bending force is applied due to the misalignment, reported in Table 21.2. As mentioned before, this misalignment can be produced by thermal deformations due to hot working of the engine.

Beach marks and crack initiation zones on the valve shaft surface [2].

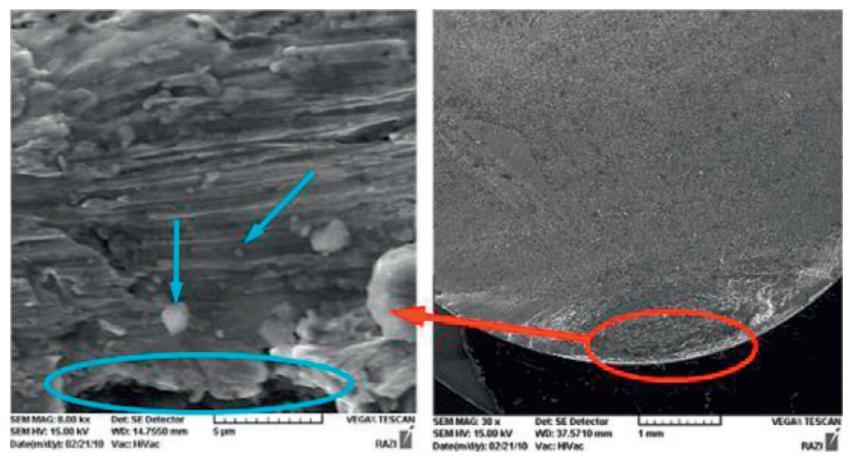
FIGURE 21.8

SEM images of the fracture surface are shown in Figure 21.8. A defect near the outer surface of the valve shaft (shown in the right side of Figure 21.8 which is that

region entitled "Crack 1" in Figure 21.7) existed which could cause a crack initiation. This zone is a three-dimensional dislocation which has become active during the fatigue failure. In addition, the oxide and carbide particles can be probably observed (shown by arrows in Figure 21.8) near the crack initiation zone.

SEM images of the fracture surface with different magnifications [2].

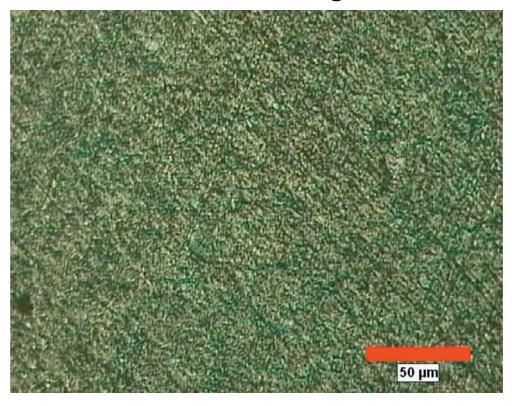
FIGURE 21.9

In Figure 21.9, it can be seen that the microstructure of the valve shaft material consisted of a tempered martensite [3,12]. This microstructure confirms the heat treatment process, which is also revealed by the hardness. As mentioned before, the material of the intake valve shaft is made of 1.4718 steel (X45CrSi9-3) which includes chrome and silicon elements [9].

The microstructure of the valve shaft made of 1.4718 steel (X45CrSi9-3) [2].

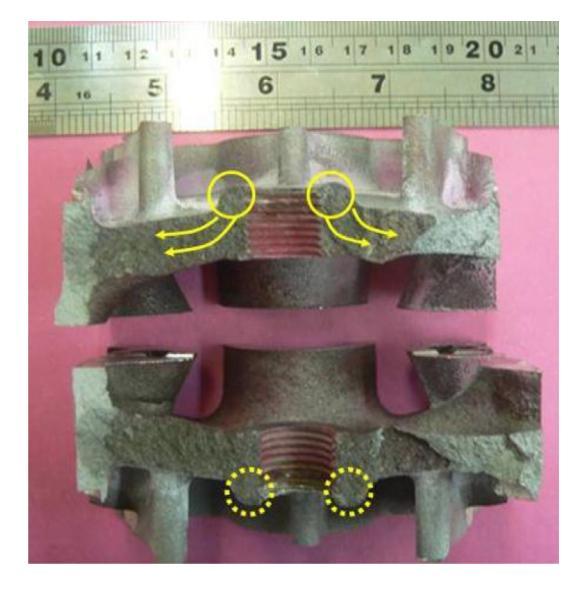
FIGURE 21.13

The cracked zone was fully opened to investigate the fracture surface. Figure 21.13 shows crack origins and the direction of the propagation. The visual inspection revealed pores around the hole because of poor quality of the casting process, which

The surfaces after opening cracked zone [13,14].

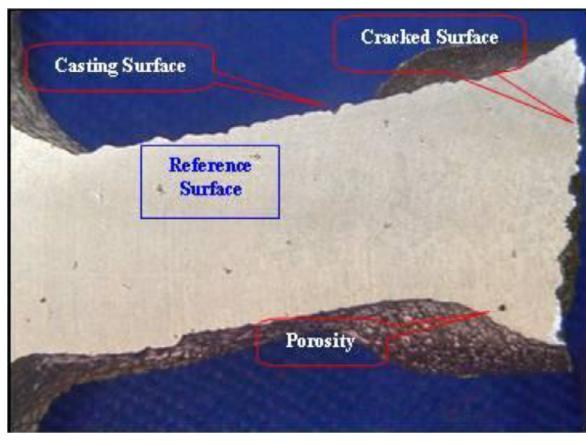
To investigate the microstructure and the heat treatment of the cylinder head material, a part of the cylinder head near the cracked zone was separated (as shown in Figure 21.14). Fractographical pictures [18,19] were taken after grinding, polishing, and etching the specimen surface in Keller's reagent for 10 s. In Figure 21.15, it is seen that the microstructure of the cylinder head material consisted of a solid solution of aluminum-silicon (the rich phase was made of aluminum) and a uniform distribution of a eutectic silicon phase and intermetallic phases. In general, the microstructure conforms to the standard [20,21], but pores, which are near the surface, could be a place of the stress concentration and could be a site of crack initiations during cyclic thermomechanical loadings.

According to the standard [20], the allowable limit for the porosity is 5% in a reference surface (which is 3 mm by 4 mm). In addition, 500 μ m is the limit between micro- and macro-porosities. A macro pore is a pore, which could be seen visually without any microscope. The porosity was measured as 3% for the surface in Figure 21.14, which is below the standard limit [20]; however, the diameter of pores

The zone below cracked surface [13,14].

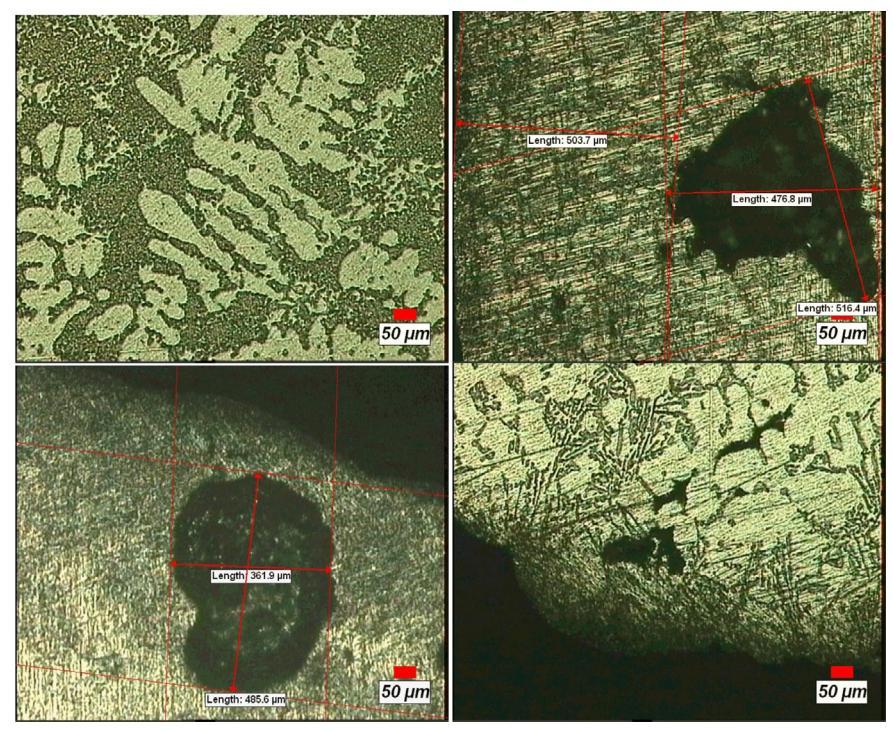
FIGURE 21.15

Microstructures of cracked zones [13,14].

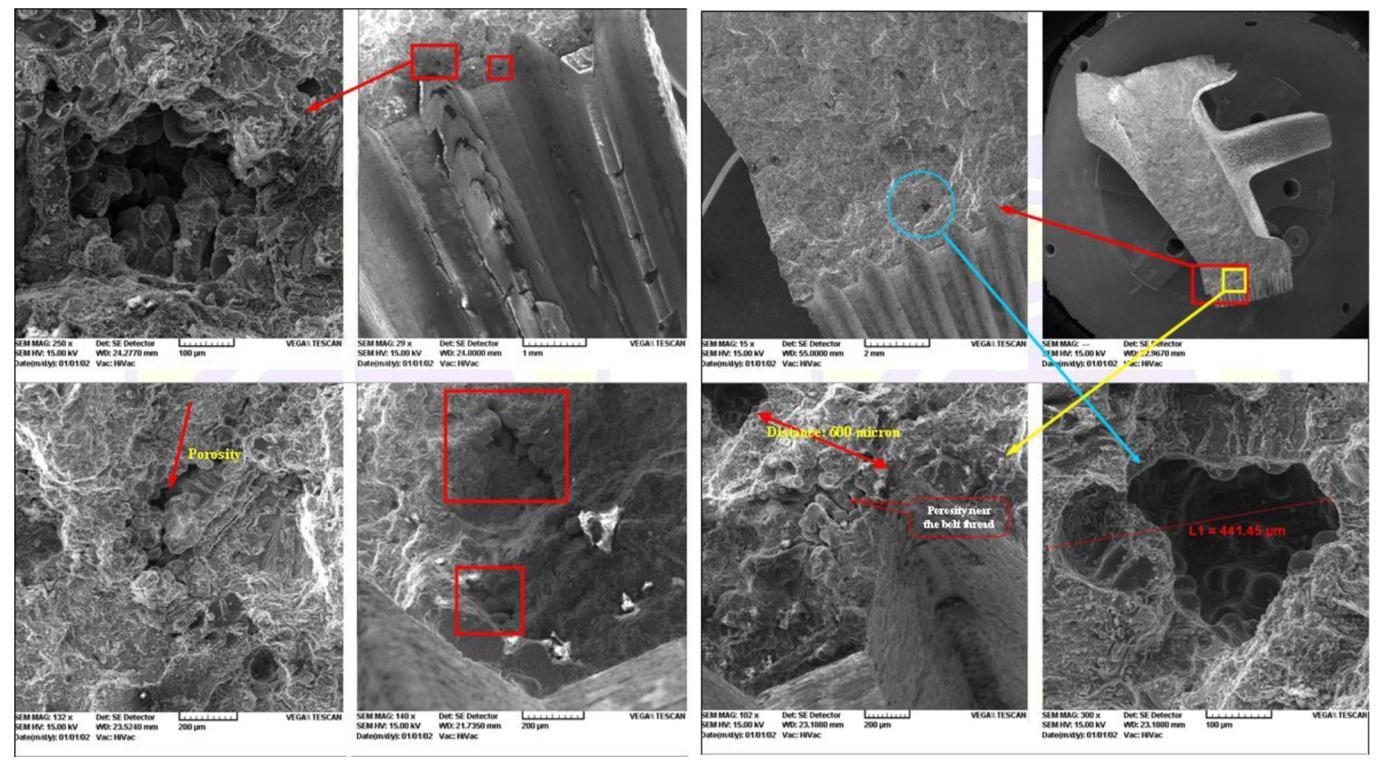
FIGURE 21.16

To investigate the cracked surface more accurately, a SEM investigation was conducted, and results are shown in Figure 21.16 with different magnifications. According to Figure 21.16, casting defects and pores were observed near threads. It should be mentioned that the diameter of pores was about 450 μ m.

Results of SEM investigations near the cracked surface [13,14].

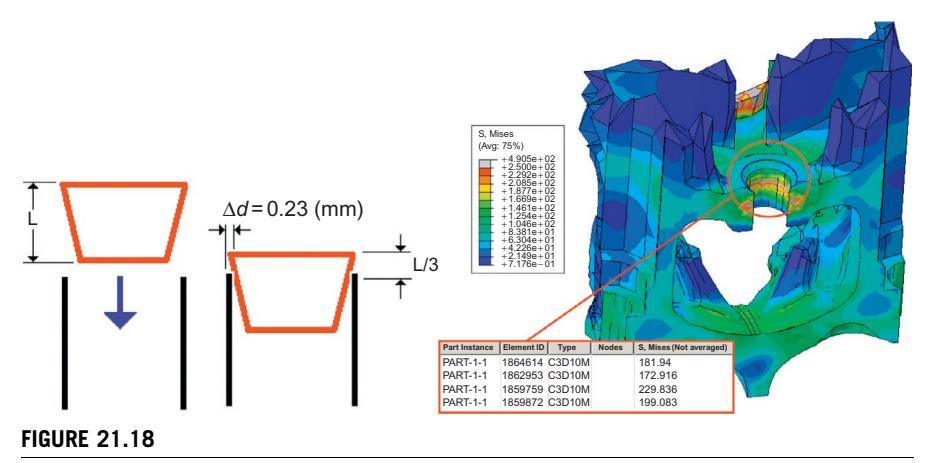
Dimensions of the bolt and the hole and Von-misses stresses around the hole [13,14].

However, these defects could not lead to a premature fracture of the cylinder head; the main reason for cracking was the high stress and the plastic strain due to the bolt assembly in the hole, which could be a cause of crack initiations. Subsequently, pores near the surface of threads as well as cyclic thermomechanical loadings on the cylinder head could be a cause of the crack growth. To prevent this failure mode in the cylinder head, the hole could be eliminated, the type of the bolt could be changed, or the fastening torque could be adjusted.

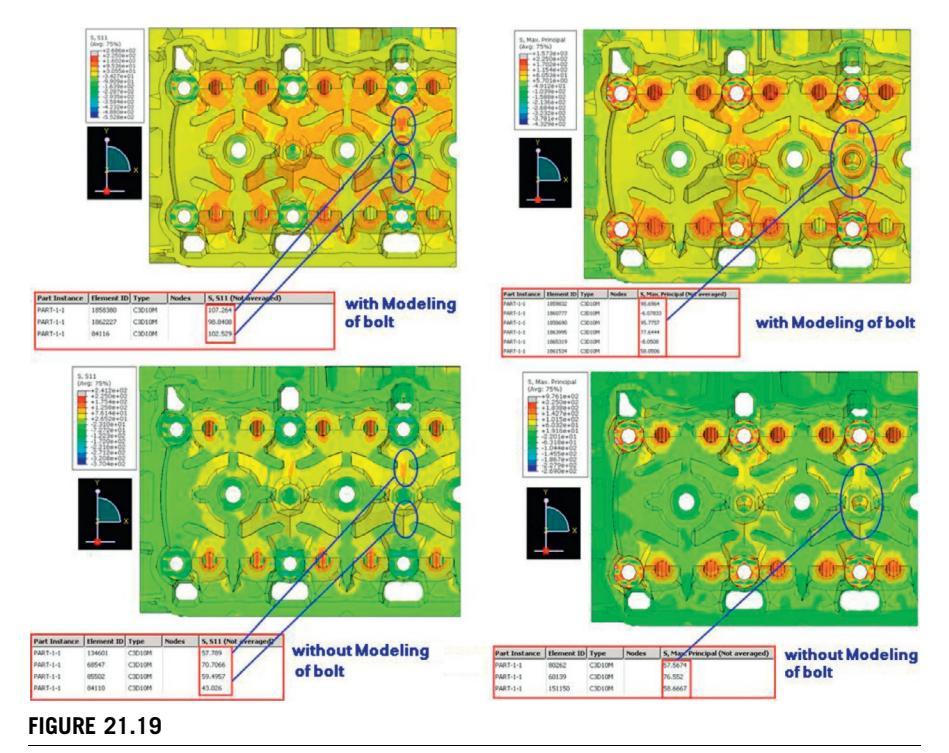
Stress distributions including stress component in *x*-direction and maximum principal stress around the hole [13,14].
