COMPOSITE HULL FOR AN AMPHIBIOUS VEHICLE

Design, Fabrication, and Testing of a Composite Hull for a Tracked Amphibious Vehicle Phase I and II Final Report

Martin Marietta Corporation
Aero & Naval Systems
103 Chesapeake Park Plaza
Baltimore, Maryland 21220

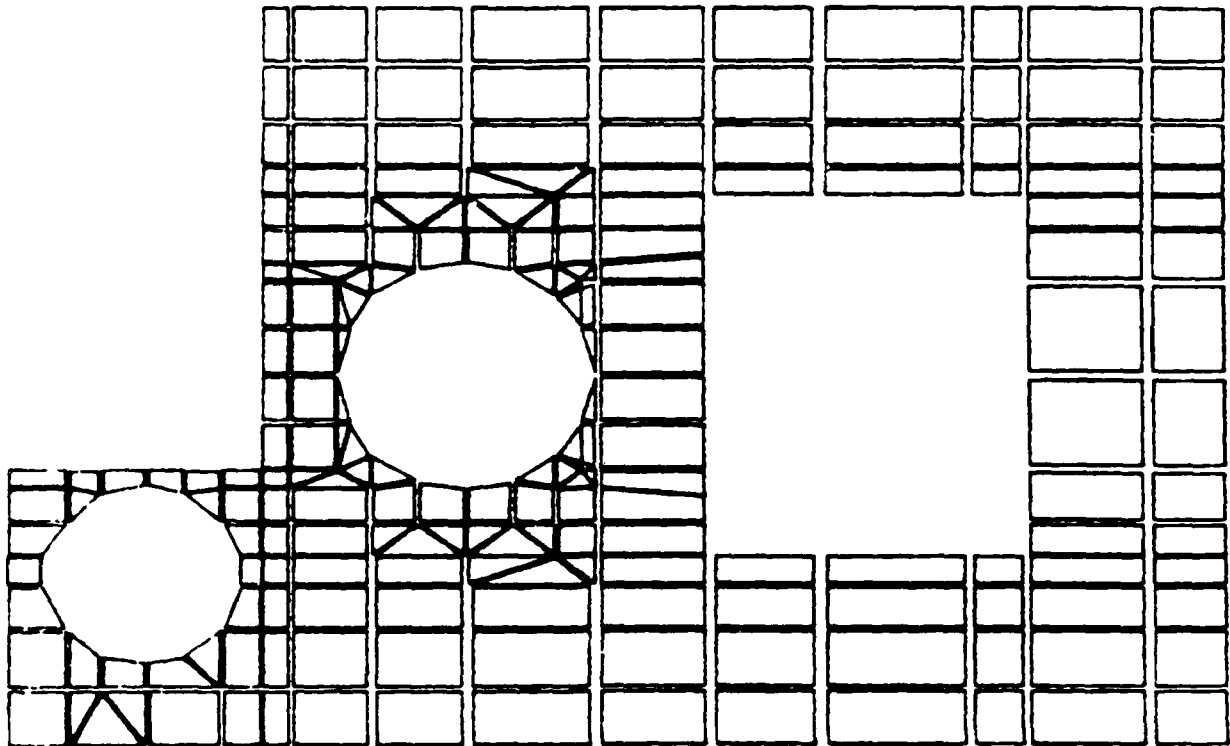
Figure 4-5. Top View of Finite Element Model

The M113 hull was modeled primarily with QUAD4 and TRIA3 isoparametric membrane/bending elements. The composite laminate was input through the use of the PCOMP bulk data card. MAT8 cards were used to input the anisotropic material properties of the composite material. The NASTRAN program generates the required PSHELL cards containing the membrane and bending stiffnesses for the plate elements. A total of 1303 QUAD4 and 120 TRIA3 elements were used. CBAR elements were used for the wheel arms and stiffening rings around the cutouts. CONROD elements were used for the tie down and lifting cables. Figures 4-2 through 4-5 outline the FEM elements.
